Martin's Meadows Solar Project

Water Body Site Investigation Report

October 18, 2012

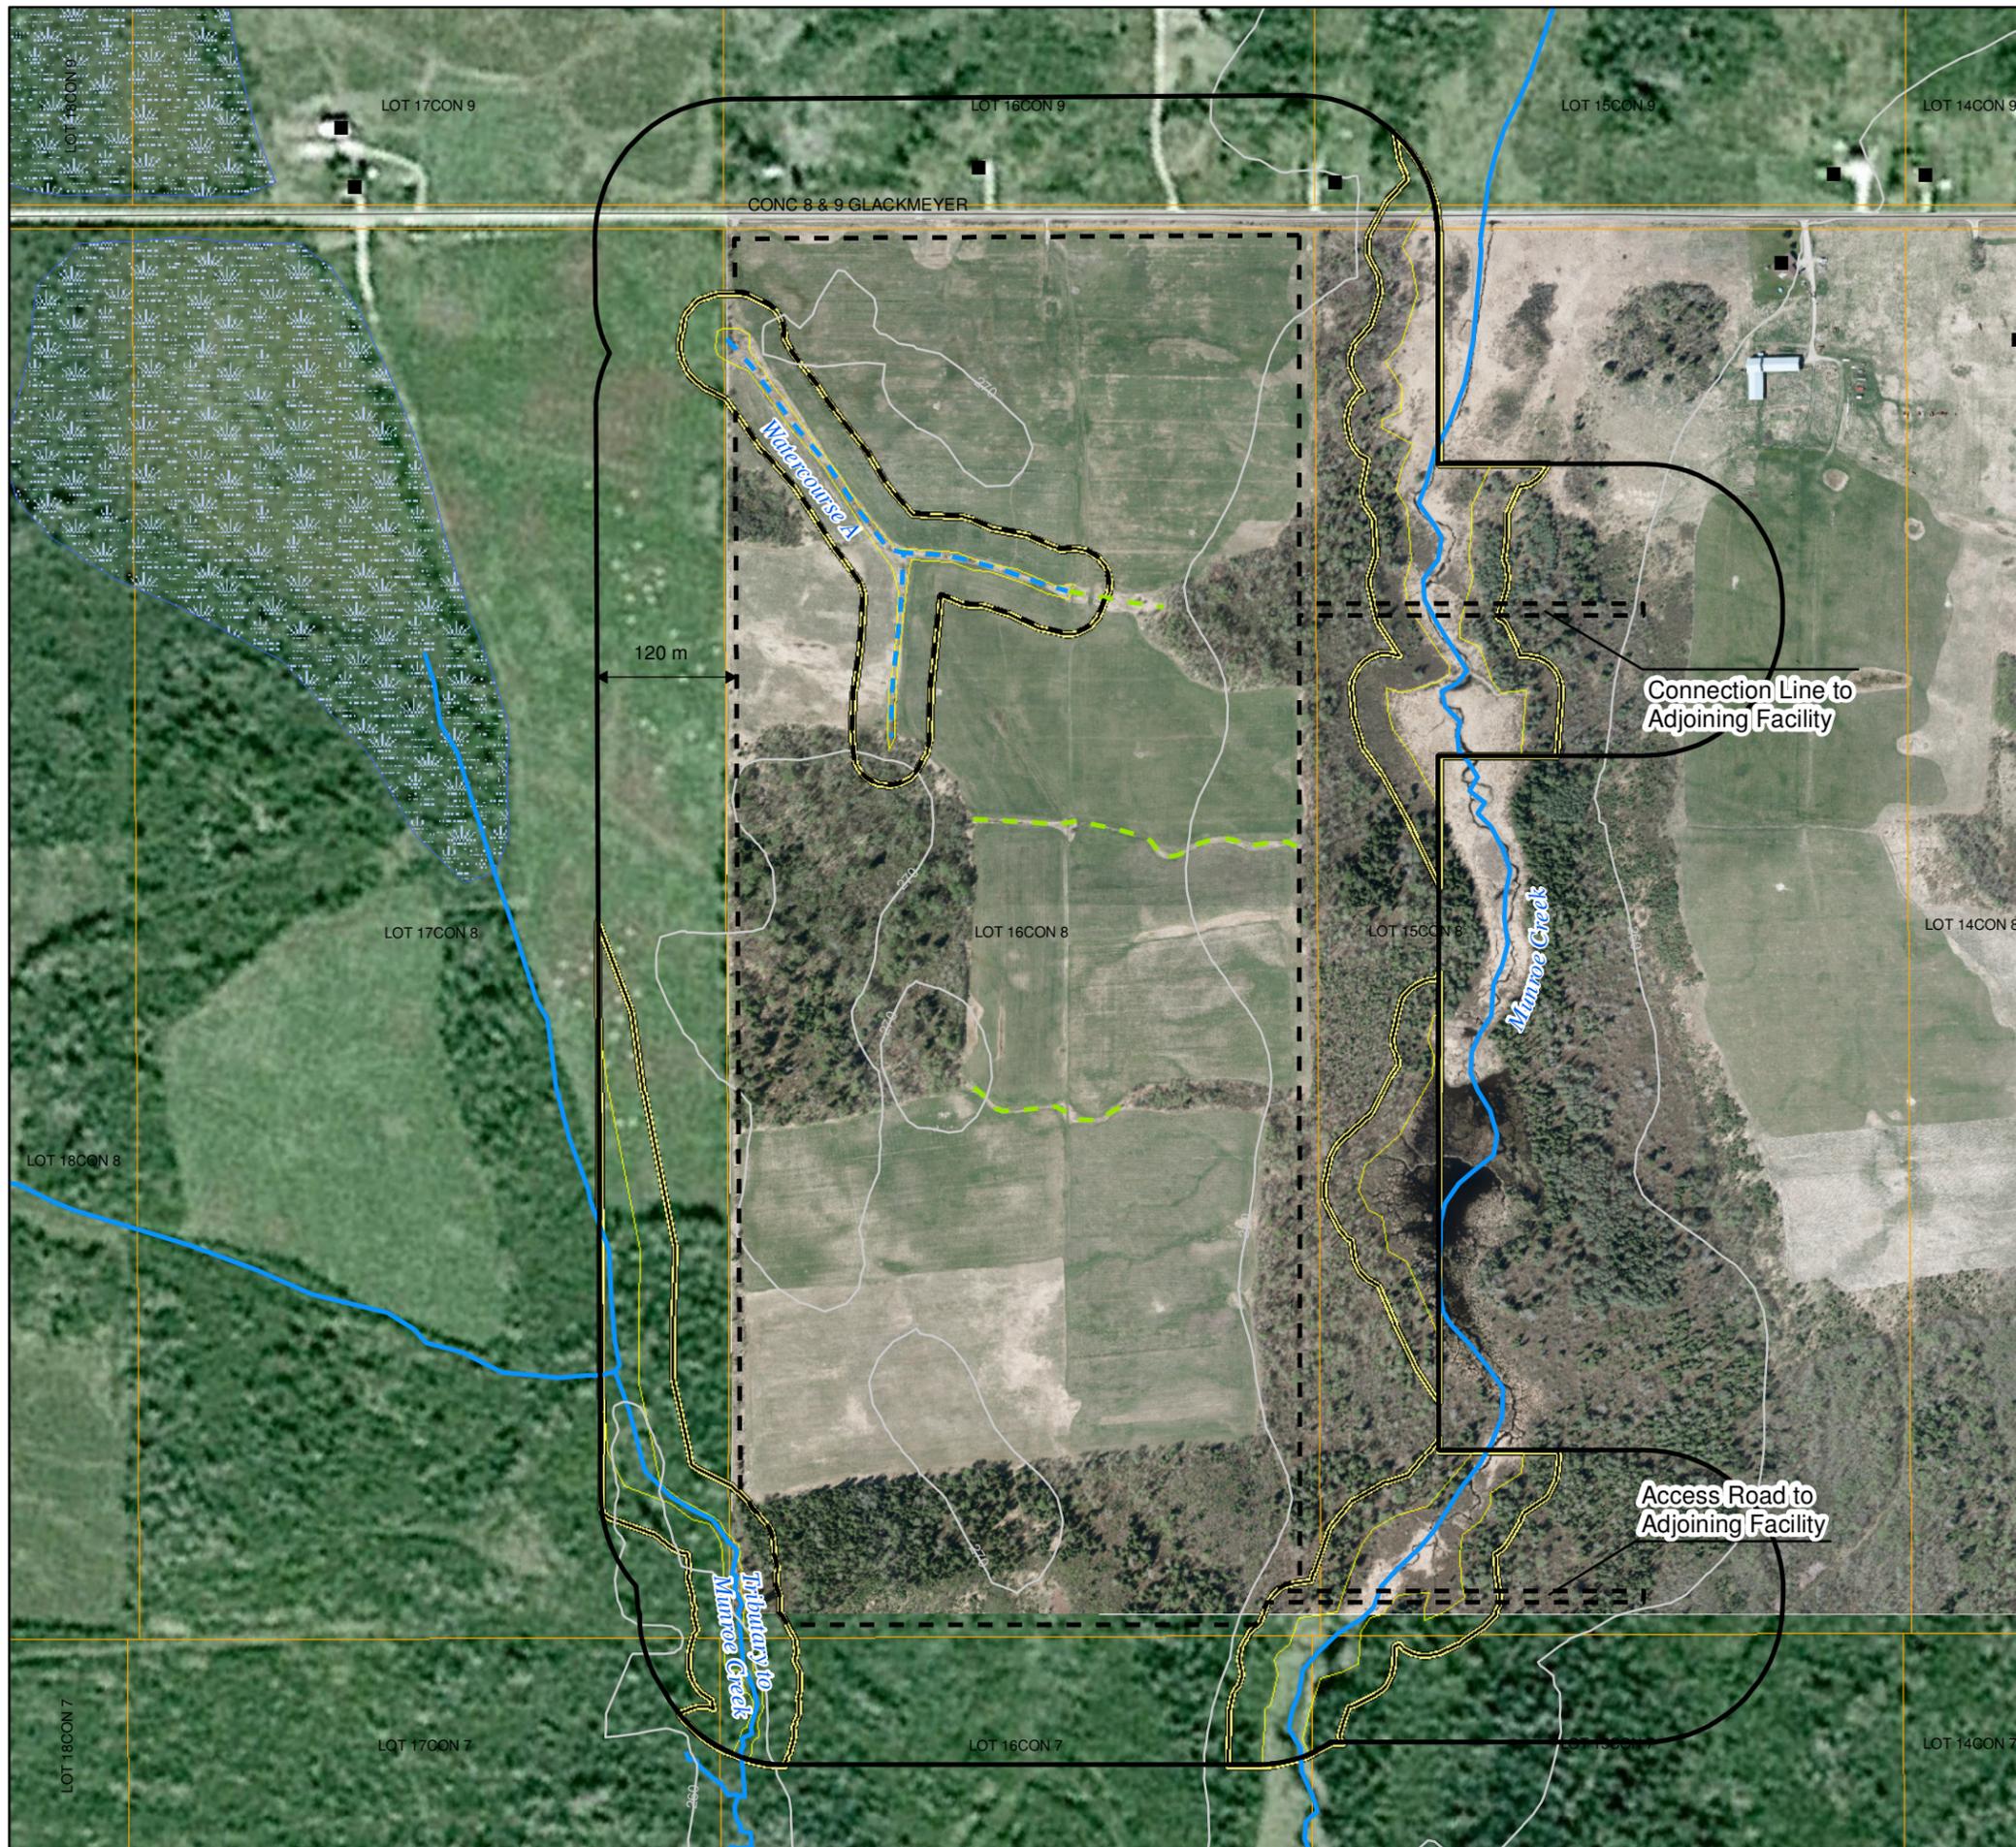
Figure 1.1
 Northland Power Inc.
Martin's Meadows Solar Project
 Water Body Site
 Investigation Results **HATCH**

In addition, a watercourse not previously identified during the records review (hereinafter referred to as Watercourse A) was discovered on the northeast portion of the Project Location (Figure 1.1). An assessment of Watercourse A is also been provided in the following sections. Several other grassed swales, which do not meet the definition of a water body per the REA Regulation, were observed during the site investigation (Figure 1.1). These are also described in the following sections.

During the site investigations, the presence of the Tributary of Munroe Creek was confirmed, and it appeared to be an intermittent stream (Figure 1.1). The proposed Project Location is situated outside of the 30 m setback area of the average annual high water mark of the tributary (Figure 1.1). Therefore, an EIS will be required to assess the potential negative effects of the Project on the creek and lands within 30 m of the average annual high water mark.

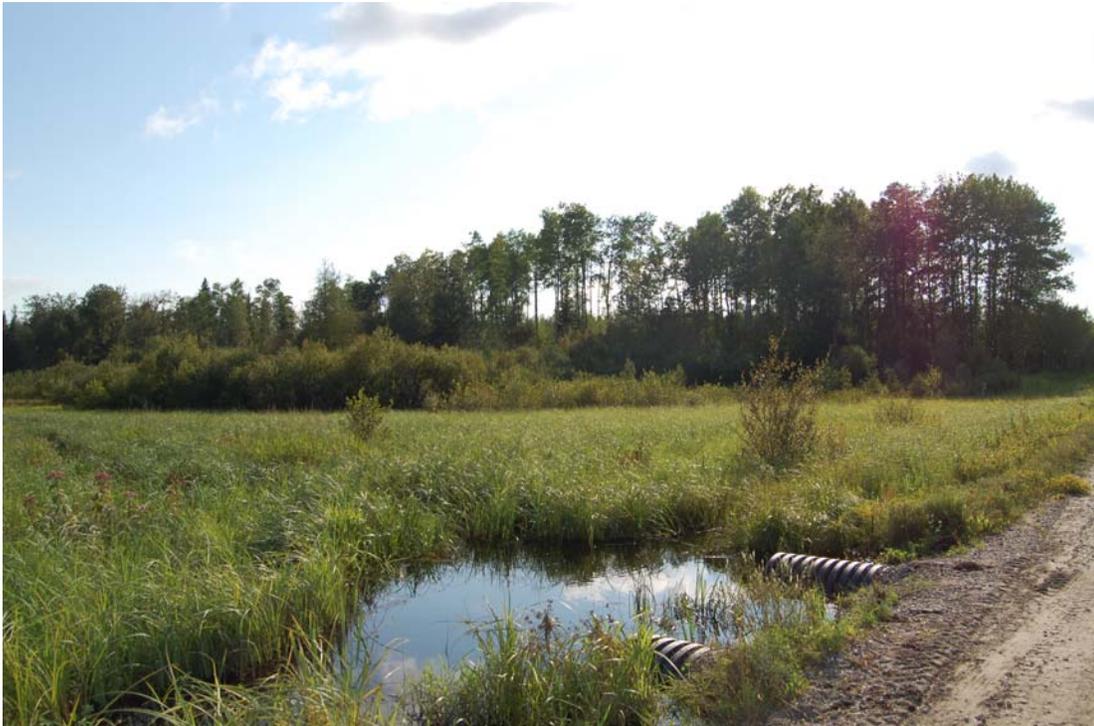
During the site investigations, the presence of Munroe Creek was confirmed, and it was determined to be a permanent stream. Munroe Creek flows in a relatively wide, low lying valley, with abundant wetland vegetation, surrounding by wooded areas adjacent to the agricultural fields on the adjacent properties. This wetland is comprised of emergent vegetation and dominated by broadleaved cattails, grasses and sedges. The meadow marsh type wetland is bordered by a shrub thicket swamp

dominated will willow and dogwood species. Beaver activity is evident at several locations along the creek, with several dams creating online ponds. In these areas, the average annual high water mark is > 100 m across. In other areas not affected by beaver activity, the average annual high water mark is approximately 30 m across, due to the meadow vegetation surrounding the main creek channel. A photograph of the wetland area of Munroe Creek, adjacent to the road is shown in Figures 4.1 and Figure 4.2.

Figure 4.1 View of Munroe Creek from the South Side of Glackmeyer Concession Road 9

Munroe Creek meets the definition of a water body, as outlined in the REA Regulation (Section 1.2). The average annual high water mark of Munroe Creek would be located a minimum distance of 30 m from the solar panel Project location. However, it would be crossed by the proposed access road and connection lines to the adjoining solar facility (Figure 1.1). Therefore, an EIS will be required to assess the potential negative effects of the Project on the creek and lands within 30 m of the average annual high water mark.

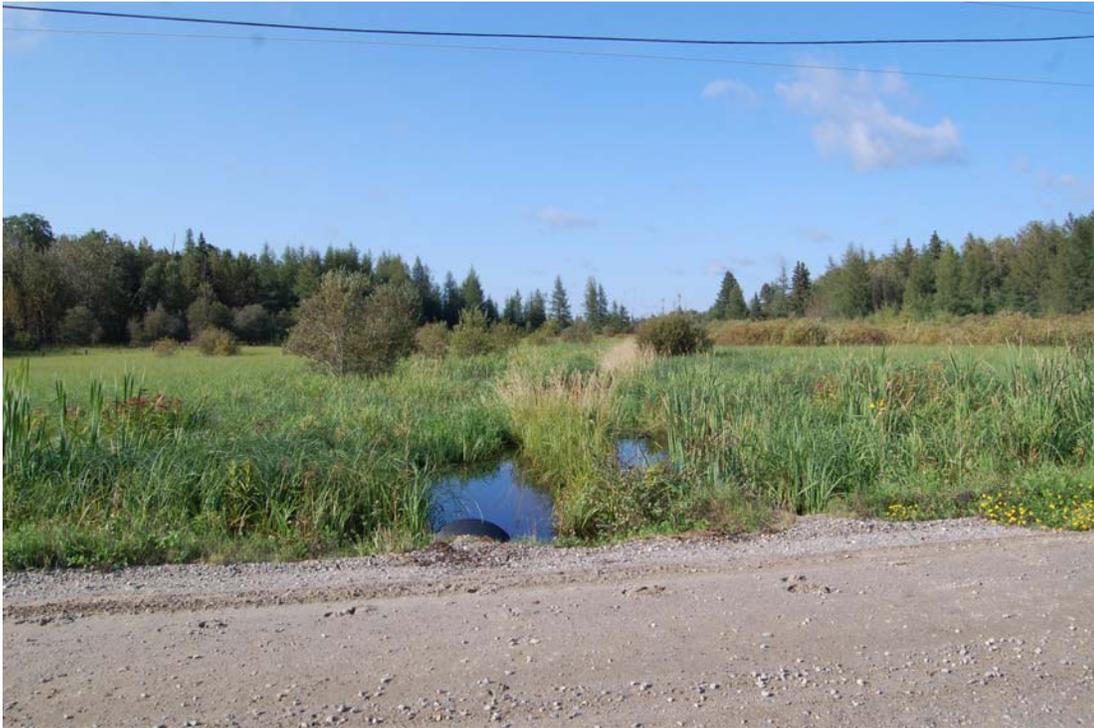
Figure 4.2 View of Munroe Creek from the North Side of Glackmeyer Concession Road 9

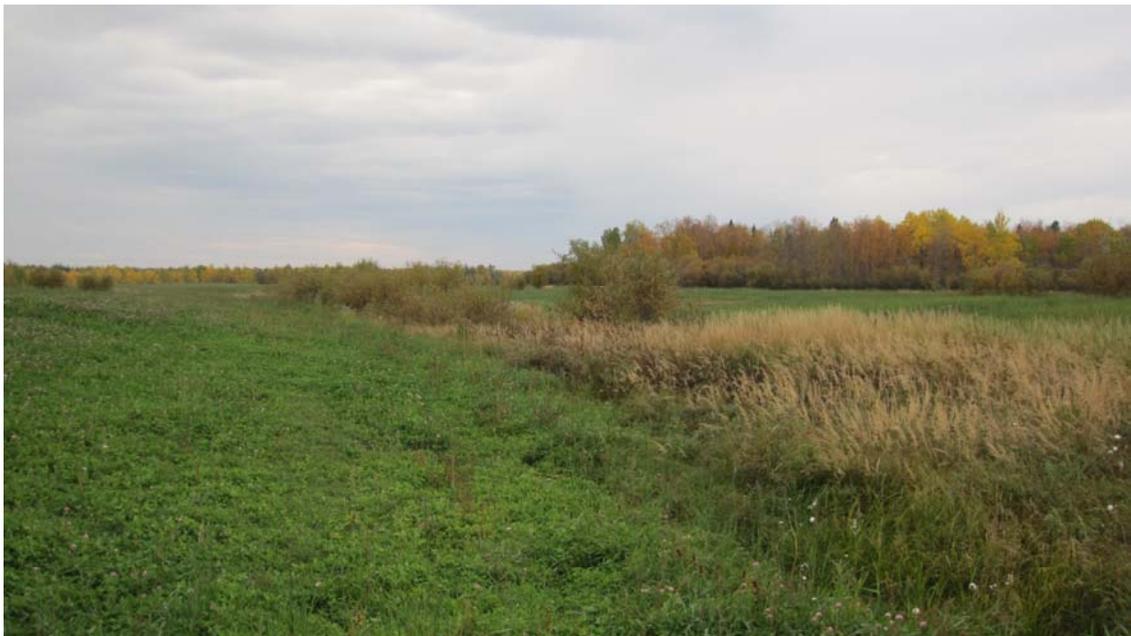
The presence of Watercourse A, an intermittent stream, was confirmed during the site investigations. Watercourse A occurs on the northwestern portion of the Project Location. It appears to be a man-made ditch that utilizes the natural contours of the land to help facilitate surface water drainage from the adjacent agricultural fields (Figure 4.3). It was determined to be an intermittent stream that likely receives flow after heavy precipitation events, and is dry the remaining months of the year. The watercourse did not appear to be connected to the municipal ditch. This watercourse has in-stream and riparian vegetation that consists of grasses, sedges, rushes and shrubs, such as small-fruited bulrush, broadleaved cattail, and scattered shrubs including alder and dogwood. The Project Location and adjacent fields appear to be actively used for hay production. The channel itself is approximately 1 to 2 m in width, with an average annual high water mark of approximately 6 m across. Watercourse A follows the property line south, before making a slight bend southeast on the Project Location (Figure 1.1).

Figure 4.3 View of Watercourse A, Facing South

The site investigation confirmed that Watercourse A is a water body feature. The proposed development area will occur within 30 to 120 m of the average annual high water mark of Watercourse A (Figure 1.1). Therefore, an EIS will be required to assess the potential negative effects of the Project on the creek and lands within 30 m of the average annual high water mark.

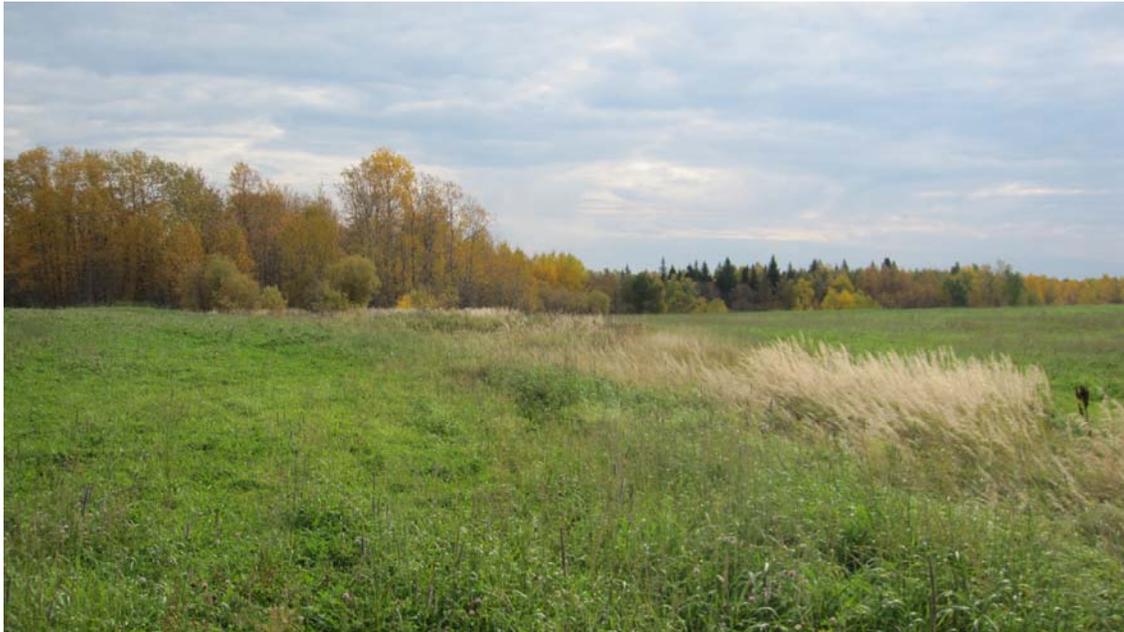
The watercourse transitions into a grassed swale (i.e., non-water body) as it extends southeast, just after it connects to a 0.5-m culvert and associated water crossing, likely used by the farmer to easily access different sides of the agricultural field (Figure 1.1). The grassed swale is relatively shallow (i.e., can be driven/tilled through), contains grassy vegetation that is not water dependant and has a width that covers a span of approximately 15 m (Figure 4.4). As such, this segment adjacent to Watercourse A was not considered an intermittent stream (or a water body feature), as per the REA regulation (Section 1.2). The grassed swale continues southeast until it dissipates into the woodland that is located on the western boundary of the Project Location (Figure 4.4).

Figure 4.4 View of Watercourse A After Existing Farmer's Water Crossing Where it Transitions into a Grassed Swale, Facing Southeast

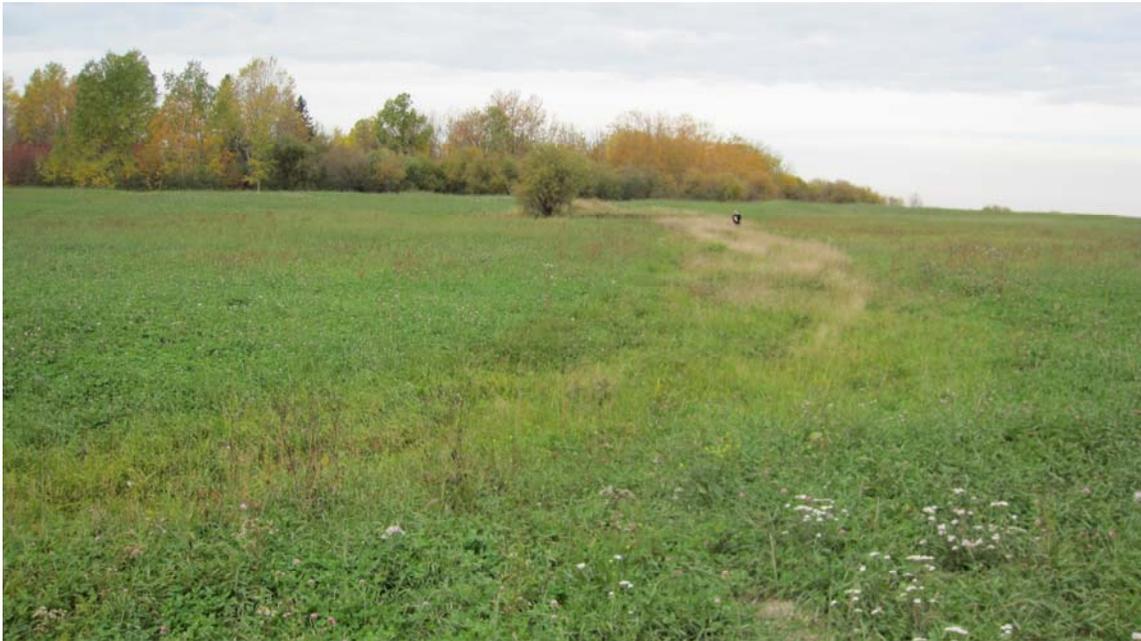
During the site investigations, two grassed swales were identified on the central portion of the Project Location (Figure 1.1). These grassed swales are situated in an east-west manner, respectively, between the woodland on the west side of the Project Location and the woodland/Munroe Creek valley to the east. The swales exist in areas of low topography on the agricultural fields, and likely receive occasional stormwater runoff inputs from the surrounding land. The swales are very shallow (i.e., can be driven/tilled through) and range in width along their length, from several meters to approximately 10 m. No standing water was observed within the grassed swales during the time of the site investigations. The majority of water runoff caught in the swales is likely absorbed by

vegetation, or dries up within. Vegetation within the swales included primarily grasses with some forbs (Figure 4.5).

These grassed swales were not found to be water body features. As per the REA Regulation, temporary channels for surface drainage, such as furrows, or shallow channels that can be tilled or driven through, are not considered intermittent streams or water bodies (Section 1.2)

Figure 4.5 View of Grassed Swale on Central Portion of Project Location, Facing West
