# Empire Solar Project Water Body Site Investigation Report

Empire Solar Project

H334844-0000-07-124-0274

October 18, 2012

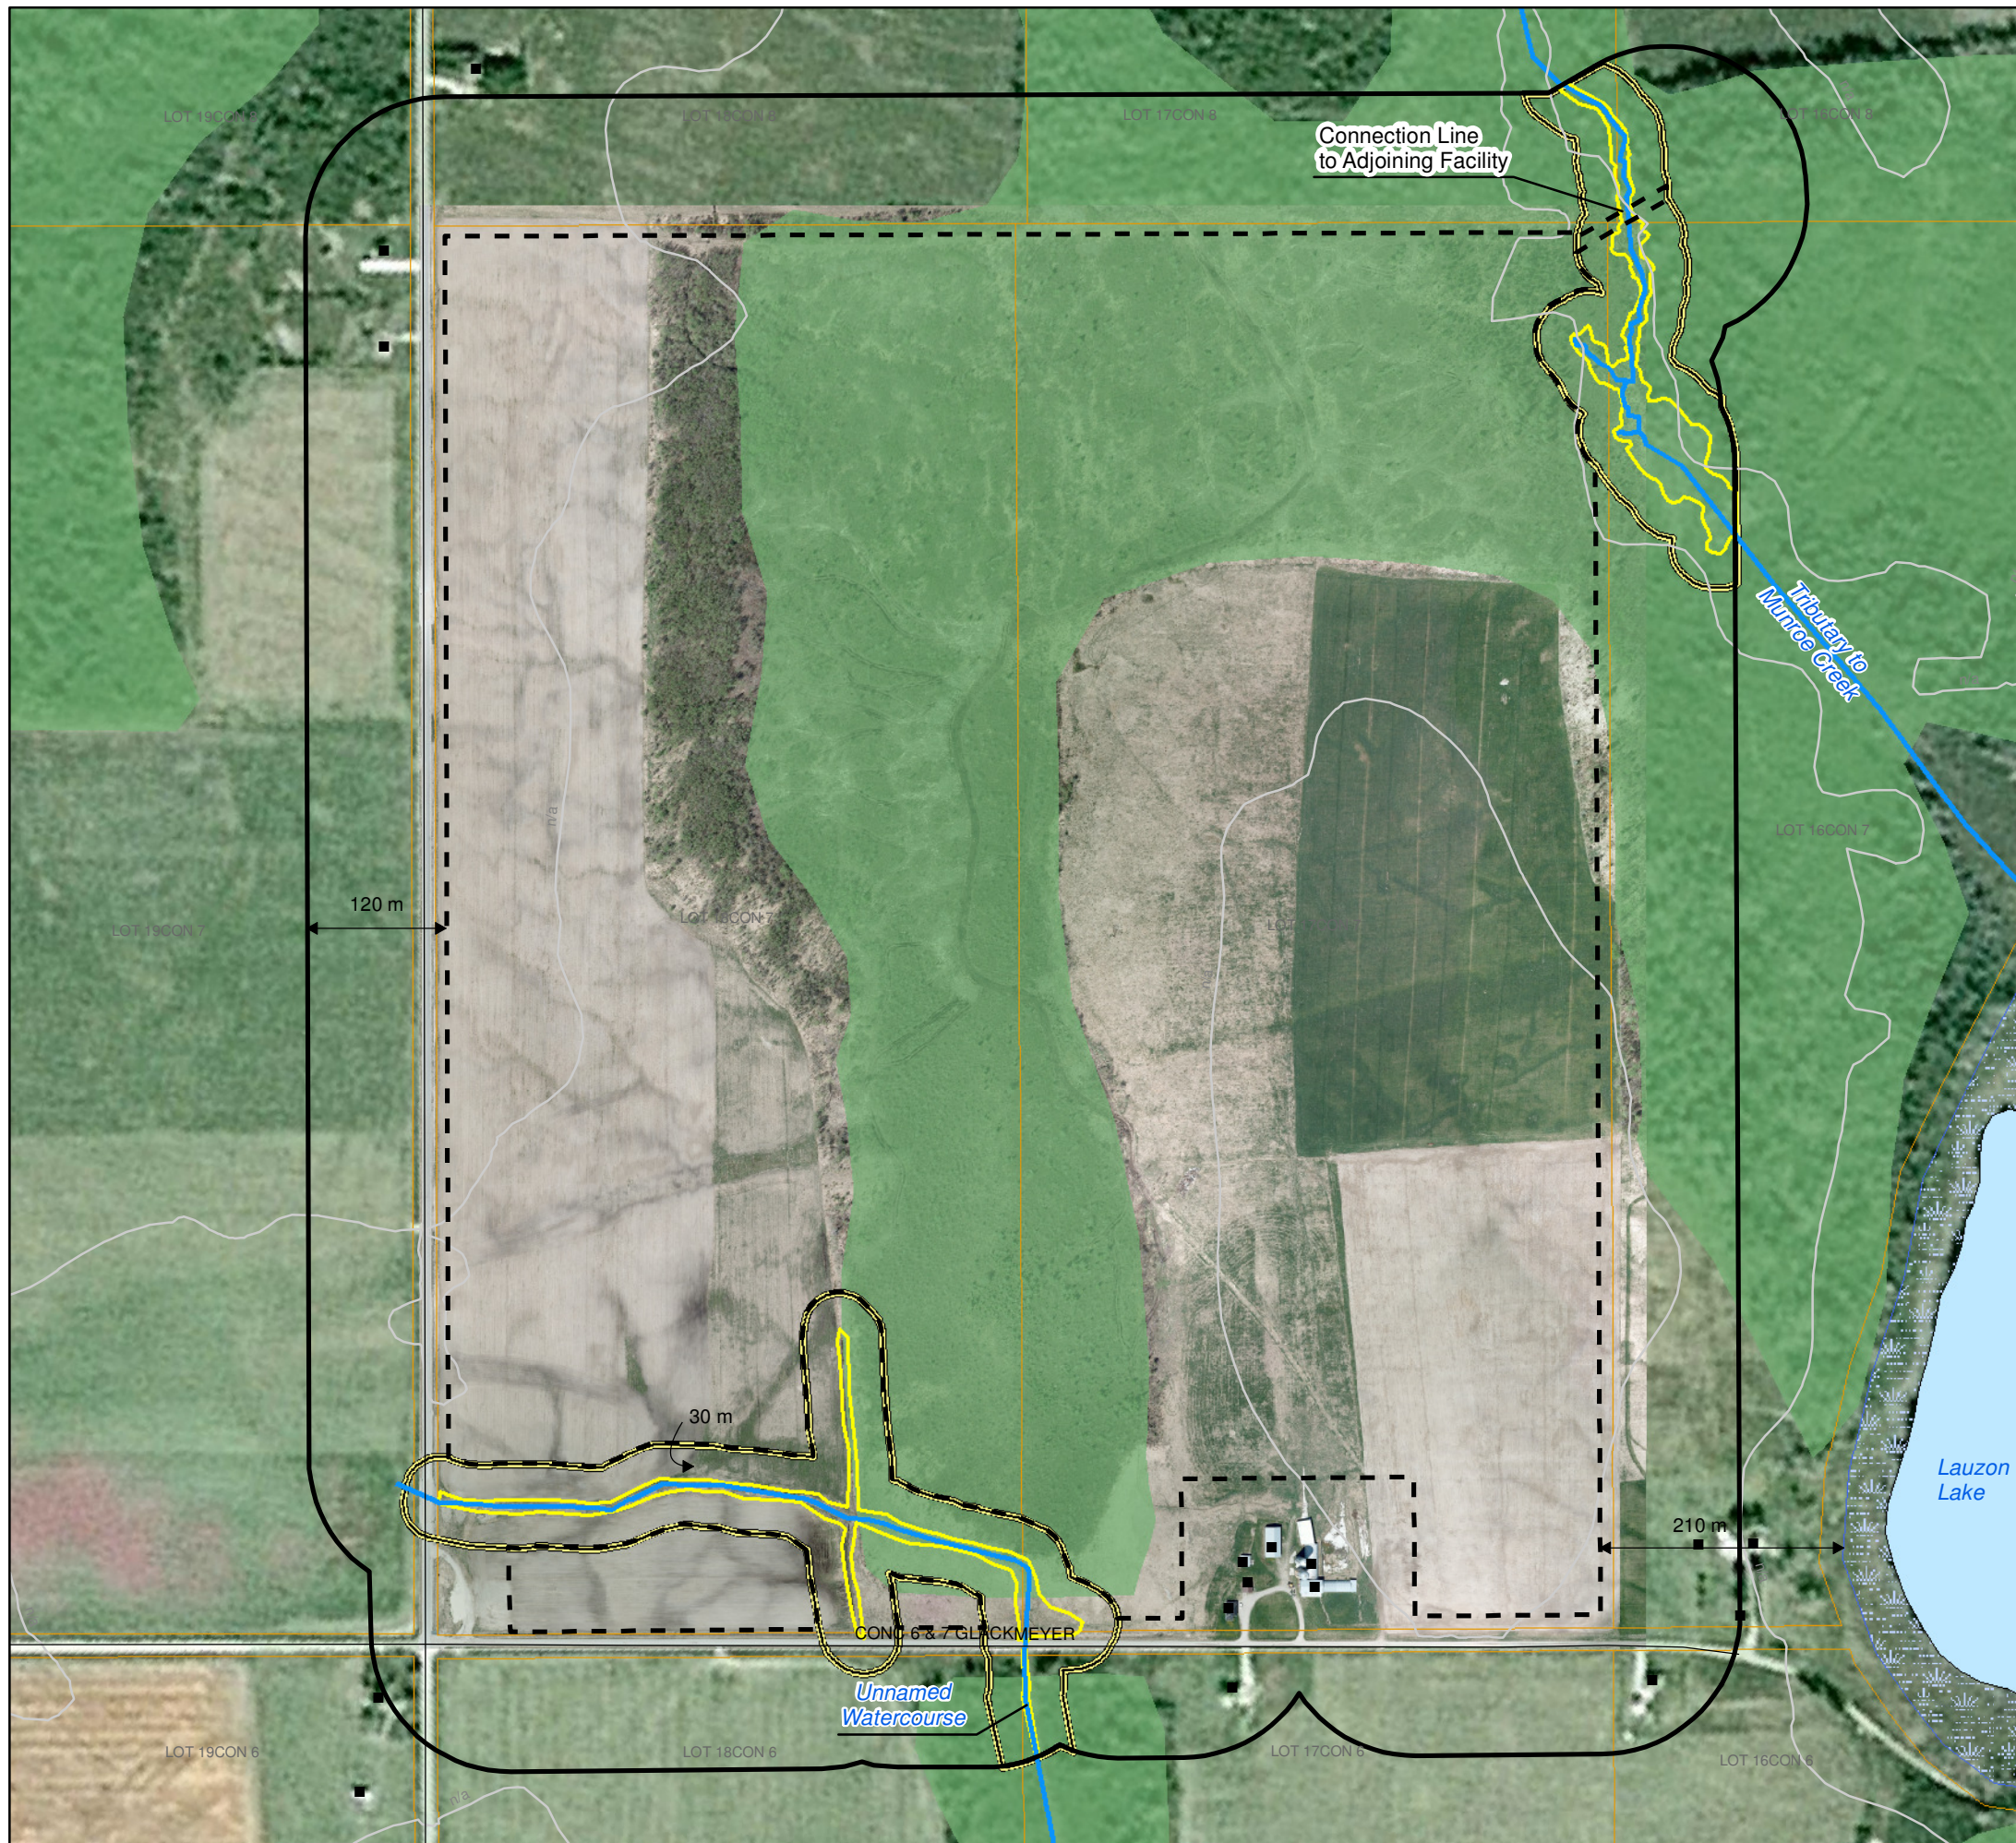
Figure 1.1  
 Northland Power Inc.  
**Empire Solar Project**  
**Water Body**  
**Site Investigation Results**

The average annual high water mark of the Unnamed Watercourse on the property was assessed during the site investigation and was found to be the top of banks of the channel for the western most portion of the watercourse and the limit of wet meadow vegetation adjacent to the channel area in the eastern portion of the watercourse. The surrounding vegetation is dominated by grasses, sedges and rushes which provide evidence of annual flooding during higher flow events. The average annual high water mark, associated 30-m setback limit and the proposed solar panel footprint boundary are shown in Figure 1.1. The proposed development footprint will be located between 30 and 120 m from the Unnamed Watercourse; therefore, an Environmental Impact Study (EIS) will be required.

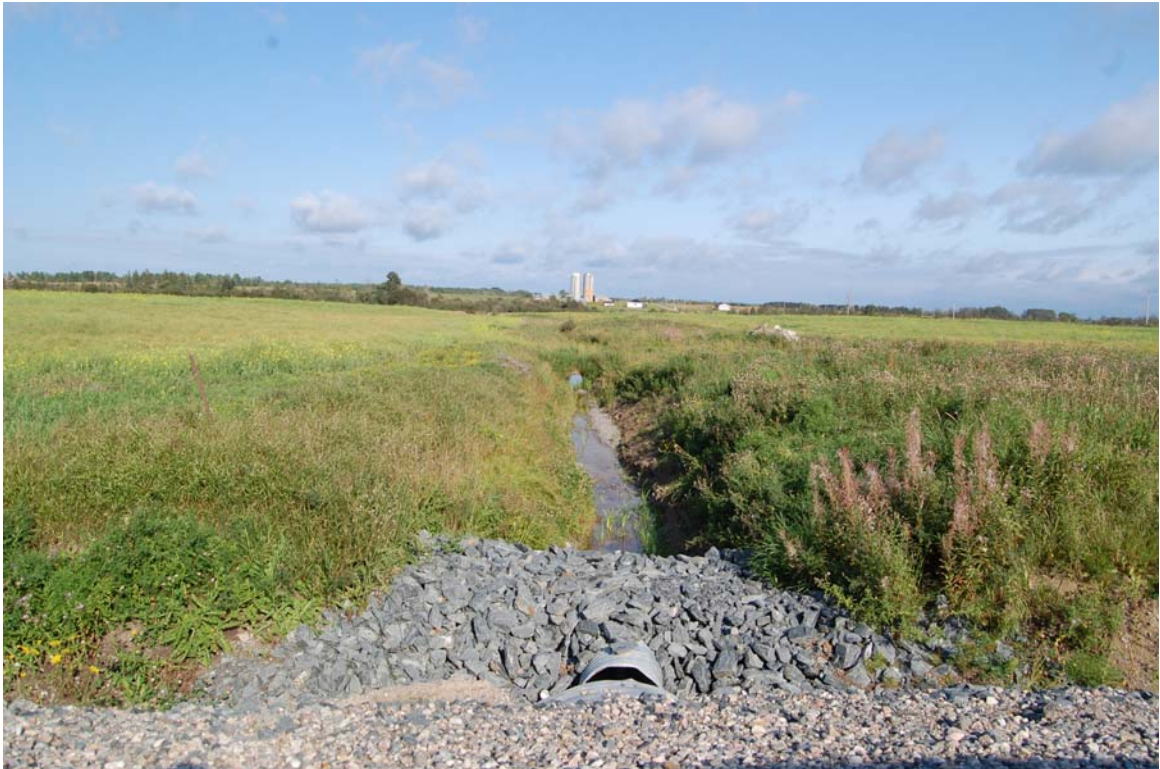
**Figure 4.1** View of Western Portion of Unnamed Watercourse Facing East from Western Property Line

The Land Information Ontario (LIO) mapping obtained for the *Water Body Records Review Report* (Hatch Ltd., 2012) indicated that the Unnamed Watercourse originates in the open field approximately 30 m west of the Project location and flows in an easterly direction through the property on which the Project is located. Along the western boundary of the property the watercourse is present as a defined channel, approximately 2 m wide. Little standing water was present within this portion of the watercourse during the August 2010 site investigation. A photograph of this portion of the watercourse is shown in Figure 4.1.

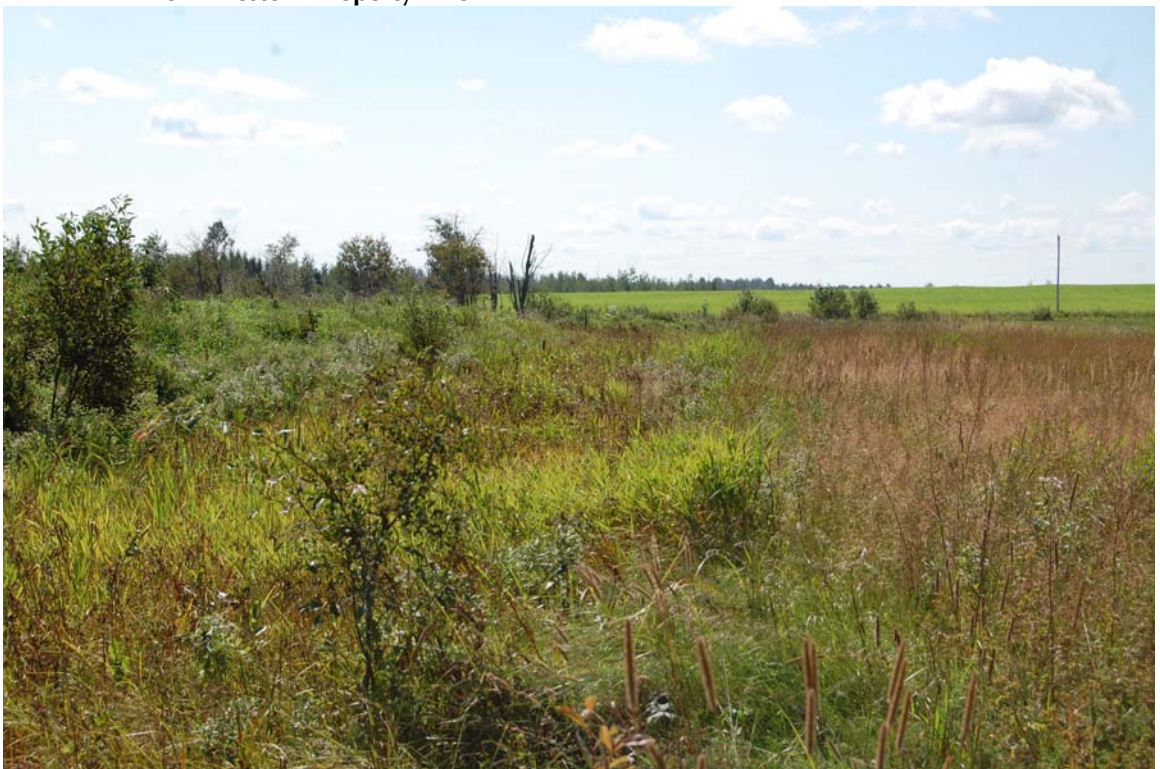
**Figure 4.2** View of Meadow Marsh Community on the Project Location

A tributary of the Unnamed Watercourse originates in the woodland in the centre of the Project Location. Once the watercourse reached the woodland in the middle of the project location it diffused out and the defined channel disappeared. This area was defined as a meadow marsh, a photo of which is provided in Figure 4.2.

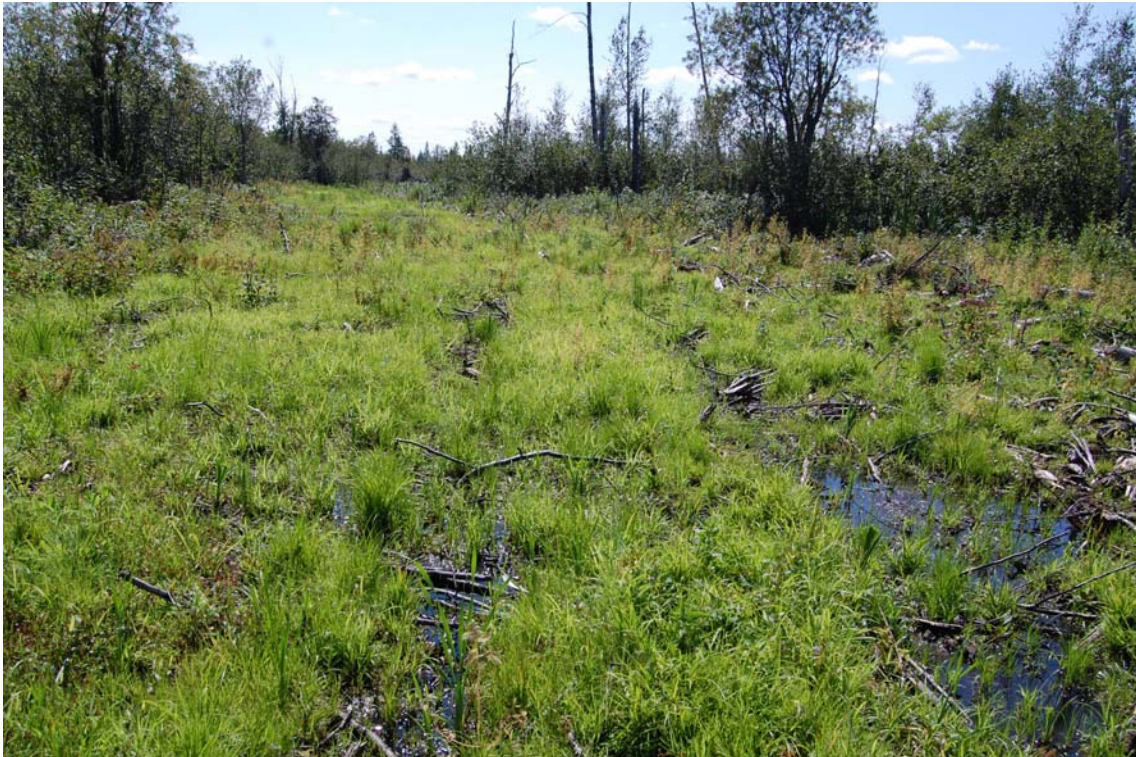
**Figure 4.3 View of Machinery Tracks Filled with Water Within the Woodland**

The woodland had at one point been cleared of all merchantable timber. Tracks left from the machinery cause pooling within the woodland. These features do not meet the definition of water body set out in the REA regulation. These tracks occurred throughout the woodland and were often covered in vegetation and downed vegetation and can be seen in Figure 4.3.
