# APPENDIX C

## Photographs and Field Notes

## C1: Photographs

McLean’s Mountain  
Windfarm

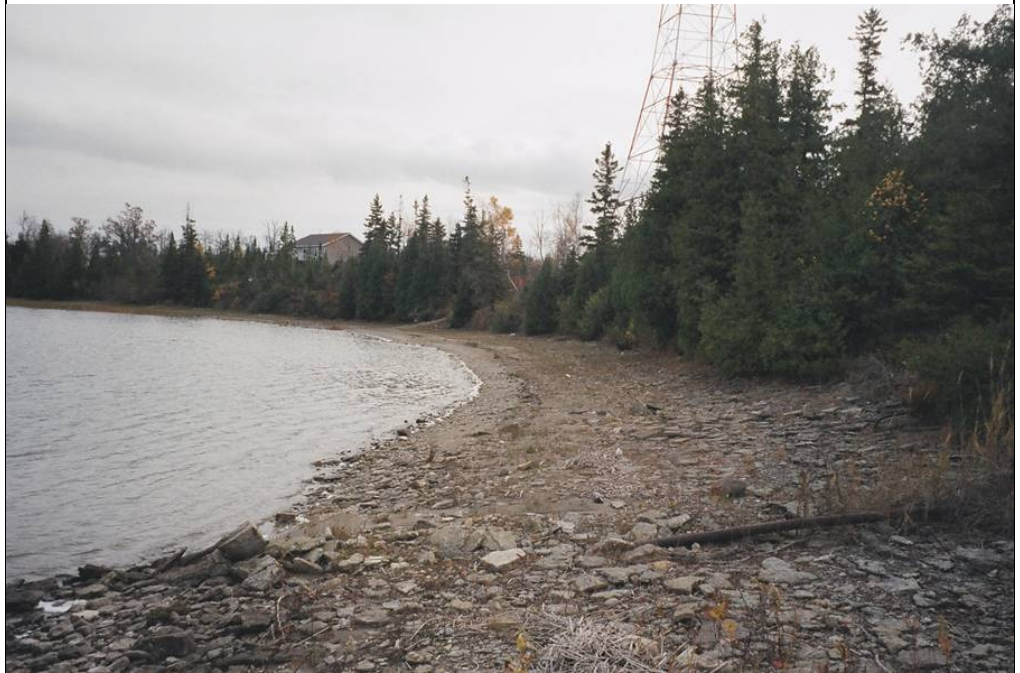
**Photo 1**

October 26, 2004  
North Channel:  
Station #11

Photo taken from  
the south (Little  
Current) side of the  
channel, looking  
east from the swing  
bridge at the shore.

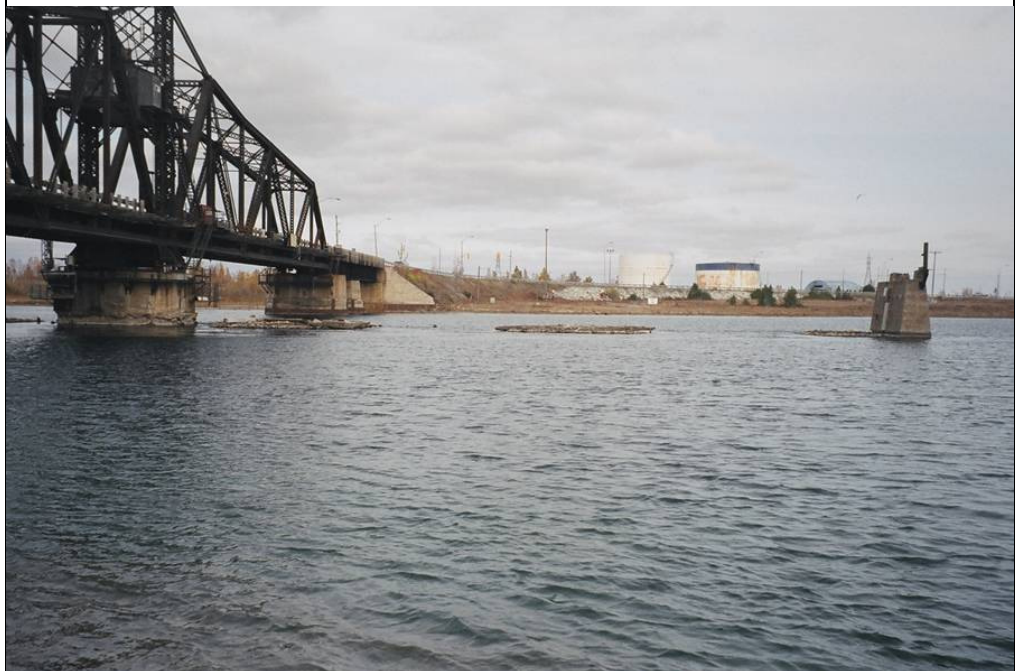
**Photo 2**

October 26, 2004  
North Channel:  
Station #11

Photo taken from  
the south (Little  
Current) side of the  
channel, looking  
north across the  
channel.

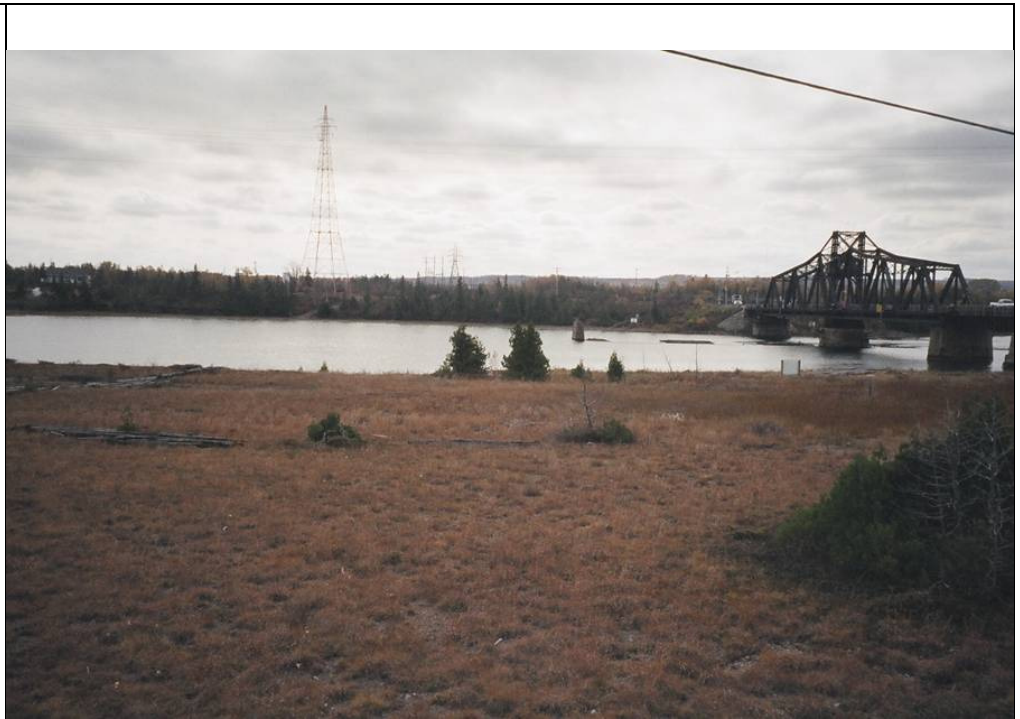
**Photo 3**

October 26, 2004  
North Channel of  
Lake Huron  
Station #11

Photo taken from  
the north side of the  
channel, looking  
south at the shore  
area and channel.

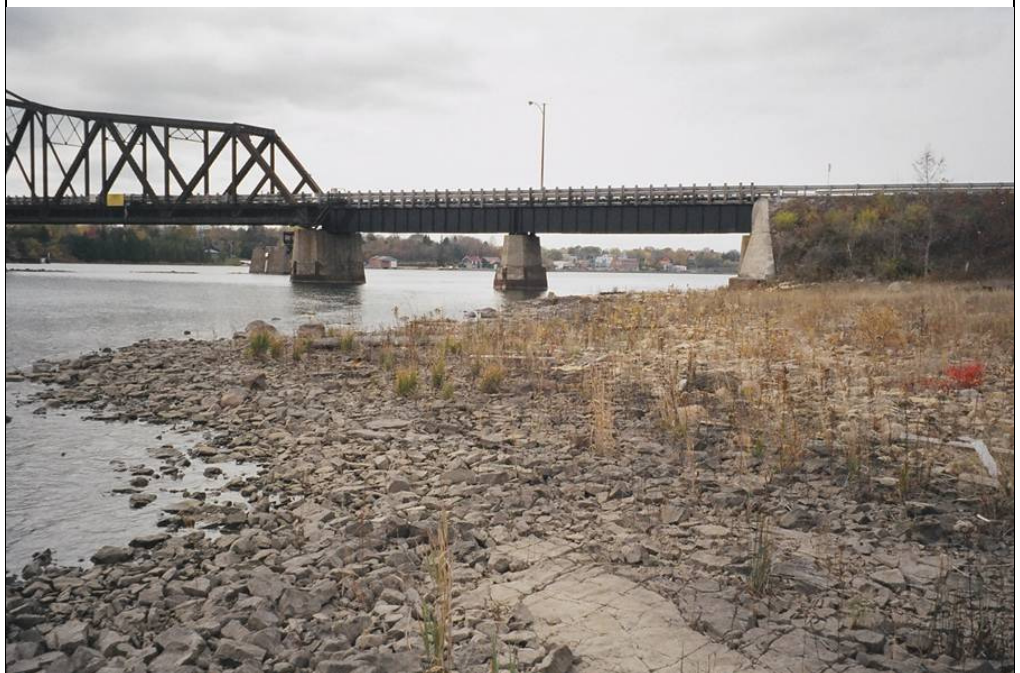
**Photo 4**

October 26, 2004  
North Channel of  
Lake Huron  
Station #11

Photo taken from  
the north side of the  
channel, looking  
north at the swing  
bridge and  
shoreline.

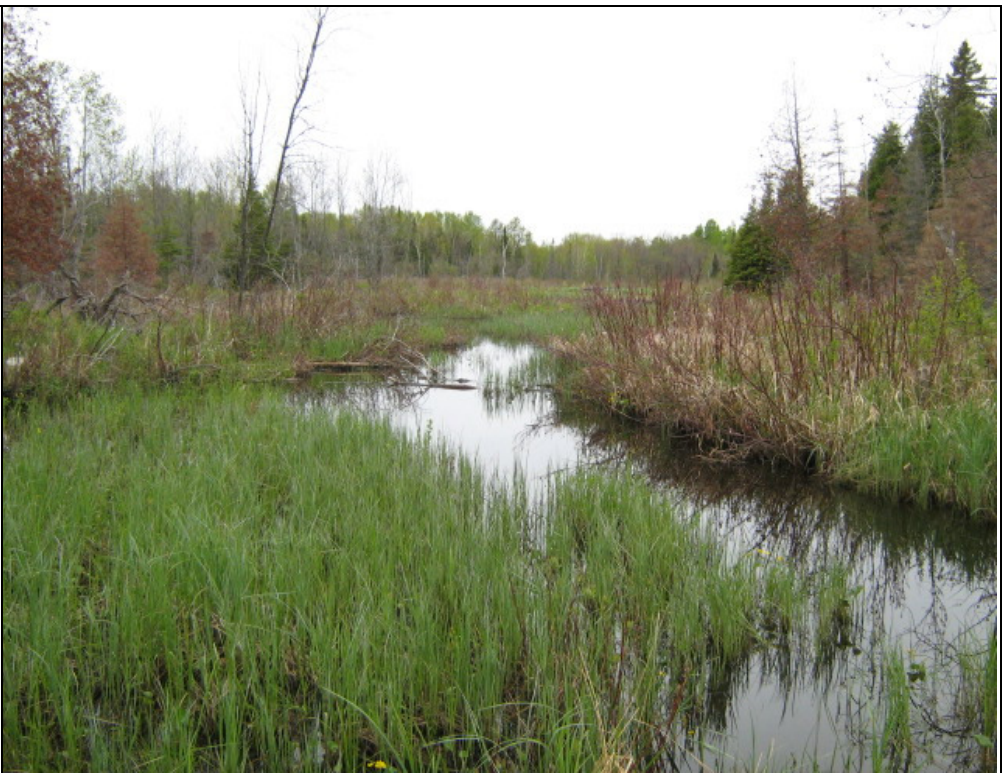
<p><b>Photo 5</b></p> <p>McLean’s Mountain Wind Farm</p> <p>May 7, 2010</p> <p>Perch Creek Station #1</p> <p>Marsh area at downstream end of Perch Creek</p> <p>Looking downstream</p>

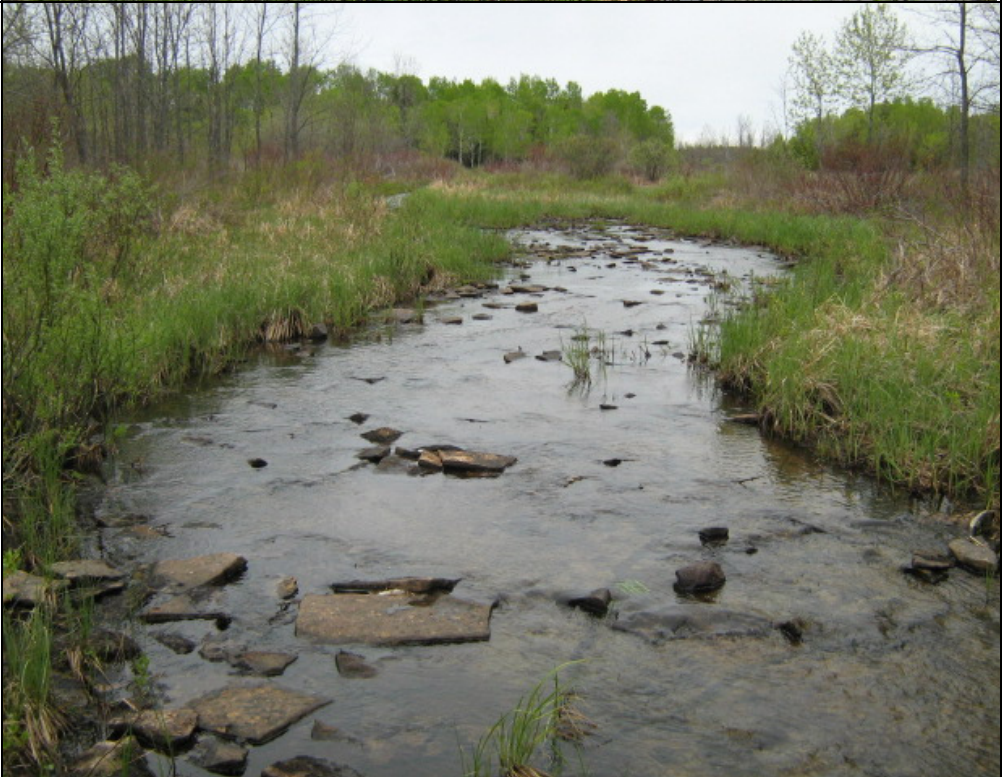
<p><b>Photo 6</b></p> <p>McLean’s Mountain Wind Farm</p> <p>May 7, 2010</p> <p>Perch Creek Station #1</p> <p>Looking upstream</p>

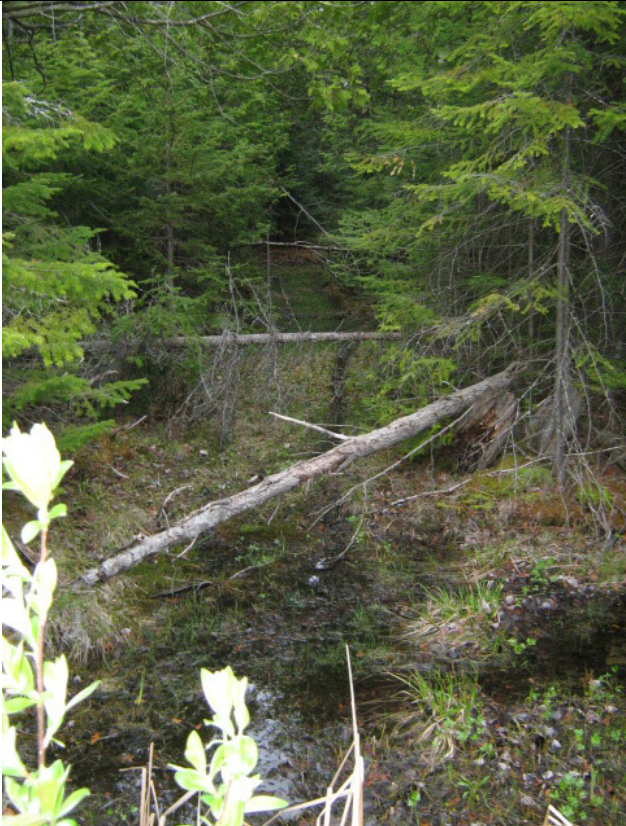
<p><b>Photo 7</b></p> <p>McLean’s Mountain Wind Farm</p> <p>May 7, 2010</p> <p>Tributary of Perch Creek Station #2</p> <p>Upstream grass channel with minimal flow</p> <p>Looking upstream</p>

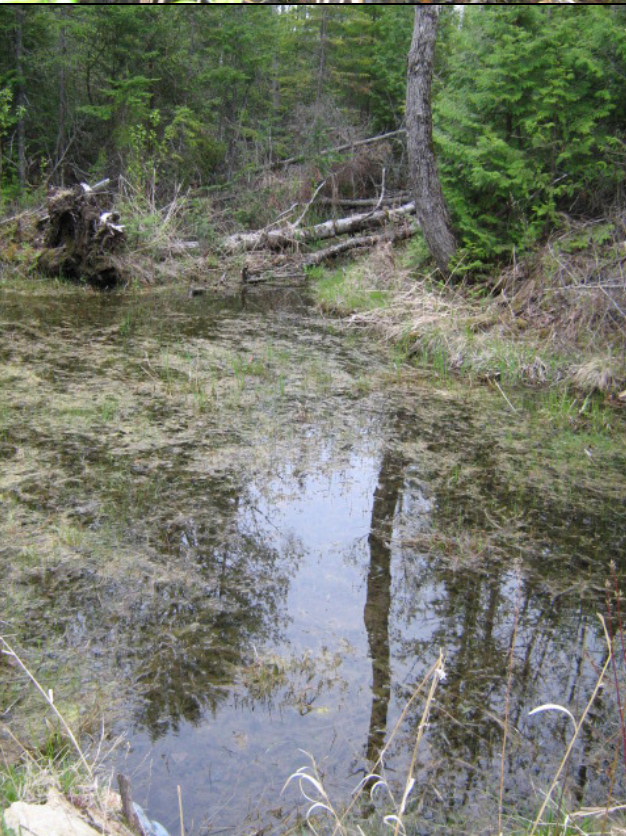
<p><b>Photo 8</b></p> <p>McLean’s Mountain Wind Farm</p> <p>May 7, 2010</p> <p>Tributary of Perch Creek Station #2</p> <p>Downstream culvert and open water wetland with small channel</p> <p>Looking downstream</p>

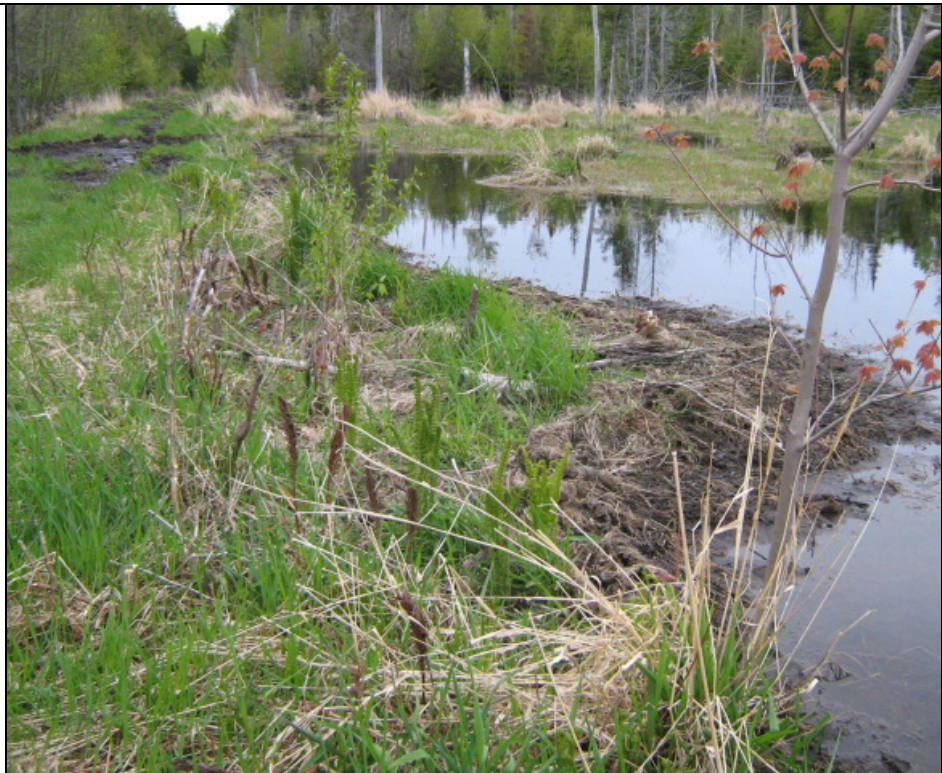
**Photo 9**

Tributary of Perch  
Creek  
Station #3

Blocked upstream  
double CSP culvert  
preventing flow  
downstream

Looking upstream

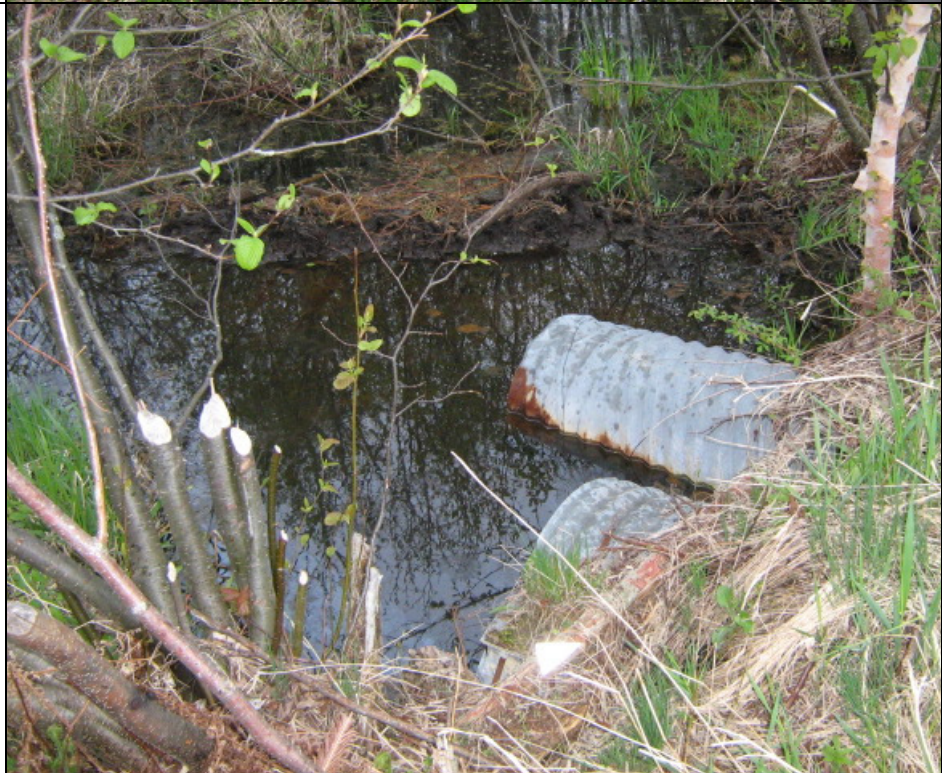
**Photo 10**

Tributary of Perch  
Creek  
Station #3

Double CSP culvert  
downstream

Looking downstream

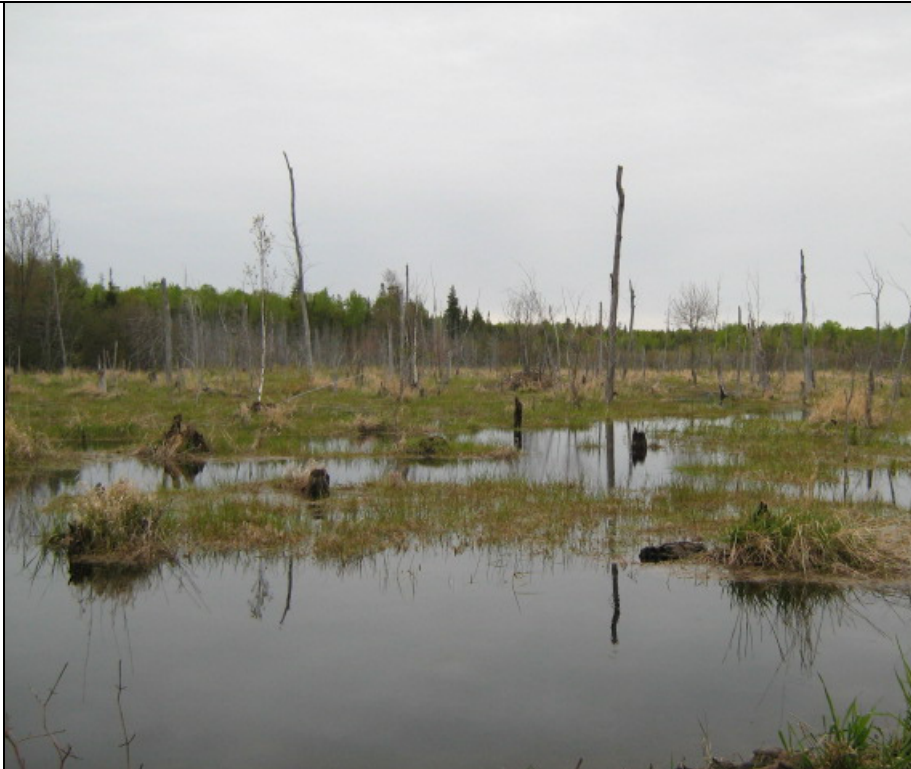
<p><b>Photo 11</b></p> <p>McLean’s Mountain Wind Farm</p> <p>May 7, 2010</p> <p>Tributary of Perch Creek Station #3</p> <p>Wetland area upstream of back road (extension of Guida’s Sideroad)</p> <p>Looking upstream</p>

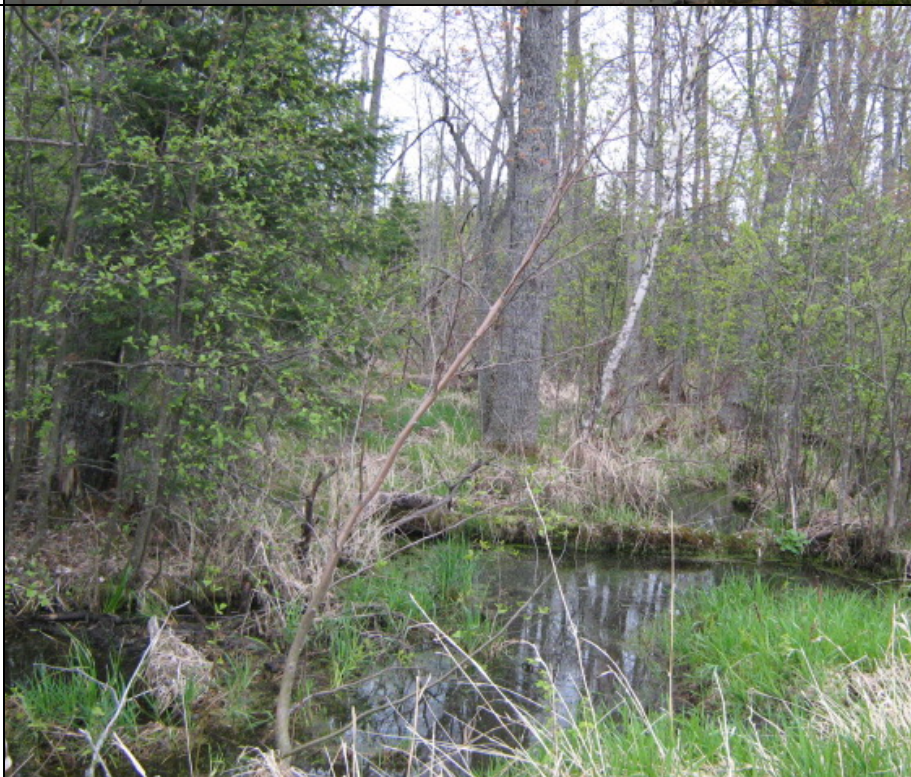
<p><b>Photo 12</b></p> <p>McLean’s Mountain Wind Farm</p> <p>May 7, 2010</p> <p>Tributary of Perch Creek Station #3</p> <p>Wetland area with braided channels downstream of back road (extension of Guida’s Sideroad)</p> <p>Looking downstream</p>

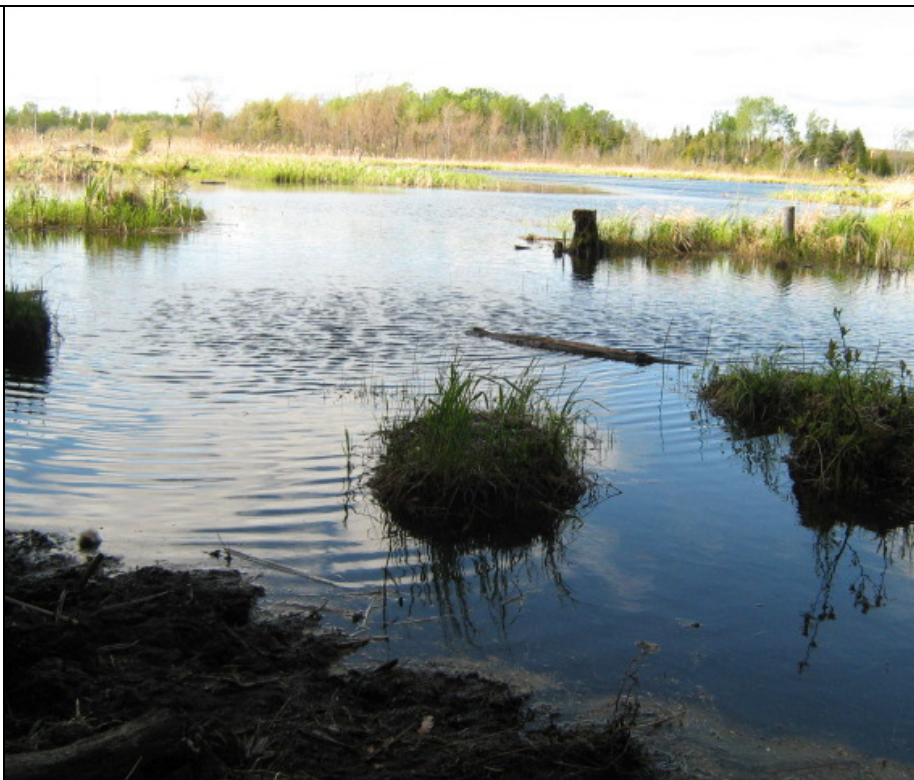
<p><b>Photo 13</b></p> <p>McLean’s Mountain Wind Farm</p> <p>May 6, 2010</p> <p>Tributary of Perch Lake Station #4</p> <p>Open marsh wetland upstream of dry channel</p> <p>Facing upstream</p>

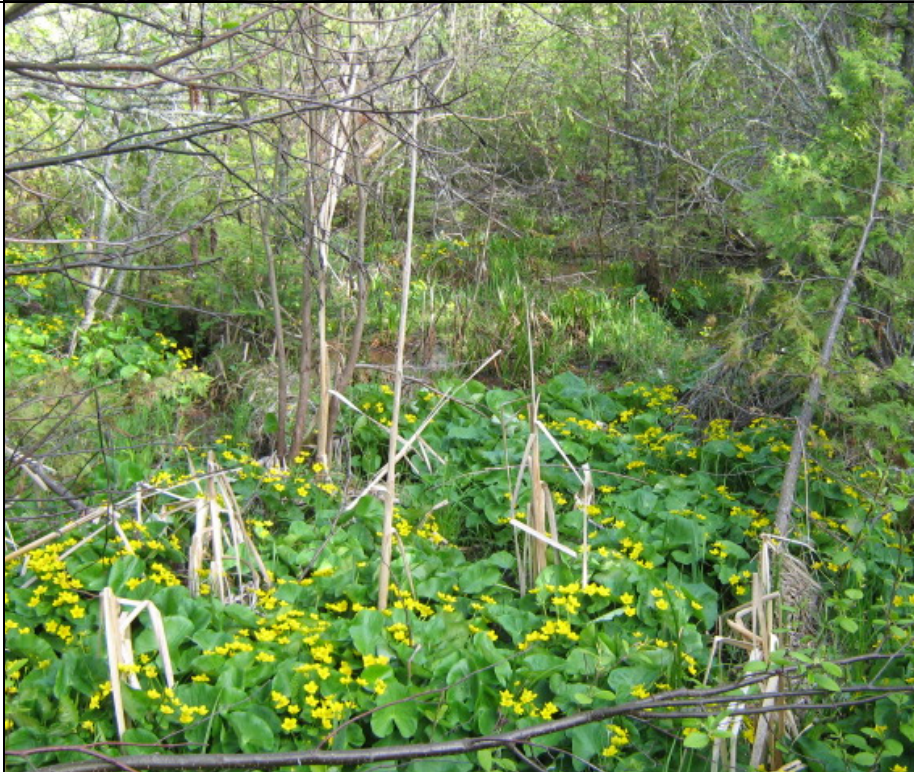
<p><b>Photo 14</b></p> <p>McLean’s Mountain Wind Farm</p> <p>May 6, 2010</p> <p>Tributary of Perch Lake Station #4</p> <p>Wet low lying area with standing water downstream of open wetland; no defined channel</p> <p>Facing downstream</p>

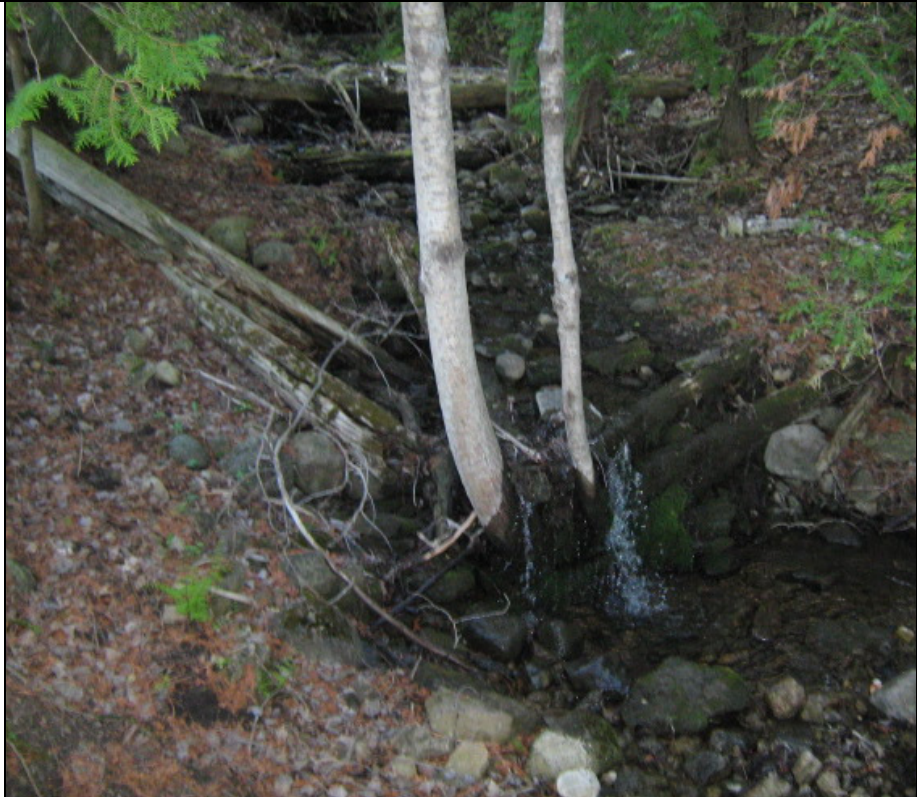
**Photo 15**

Tributary of Bass Lake  
Station #5

High gradient stream  
with multiple  
waterfall barriers

Looking upstream

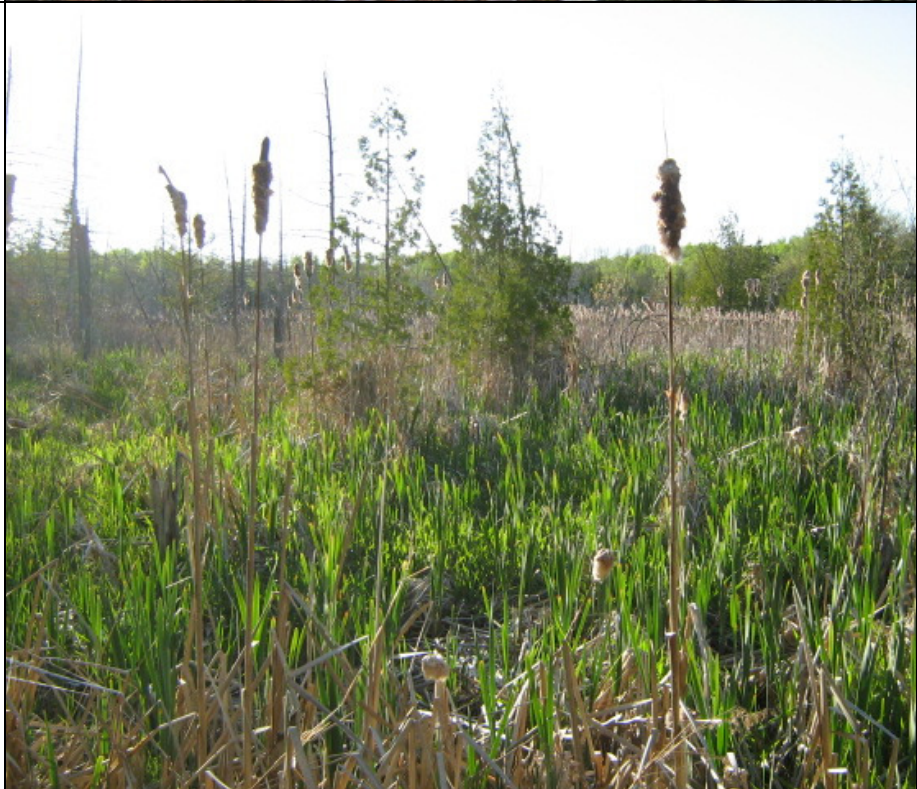
**Photo 16**

Tributary of Bass Lake  
Station #5

Cattail wetland area  
upstream

Looking upstream

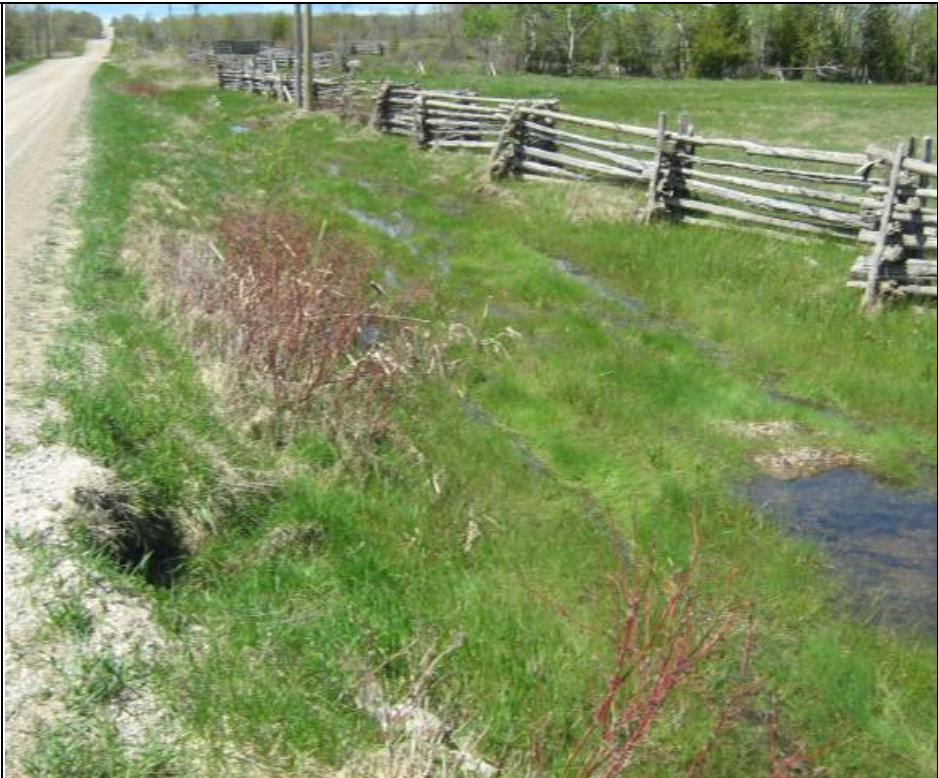
**Photo 17**

Tributary of Bass Lake  
Station #6

Channel formed by  
depressed tire marks  
with small flow  
through culvert north  
of Green Bush Rd.

Looking upstream

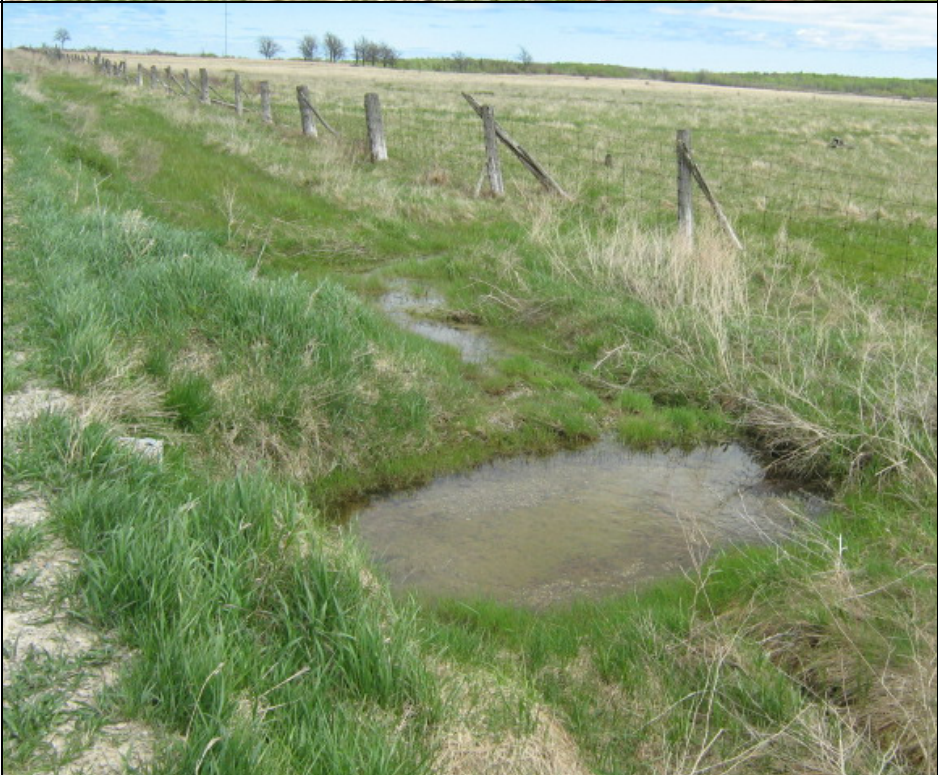
**Photo 18**

Tributary of Bass Lake  
Station #6

Pool and small  
channel flowing into  
farm field south of  
Green Bush Rd.

Looking downstream

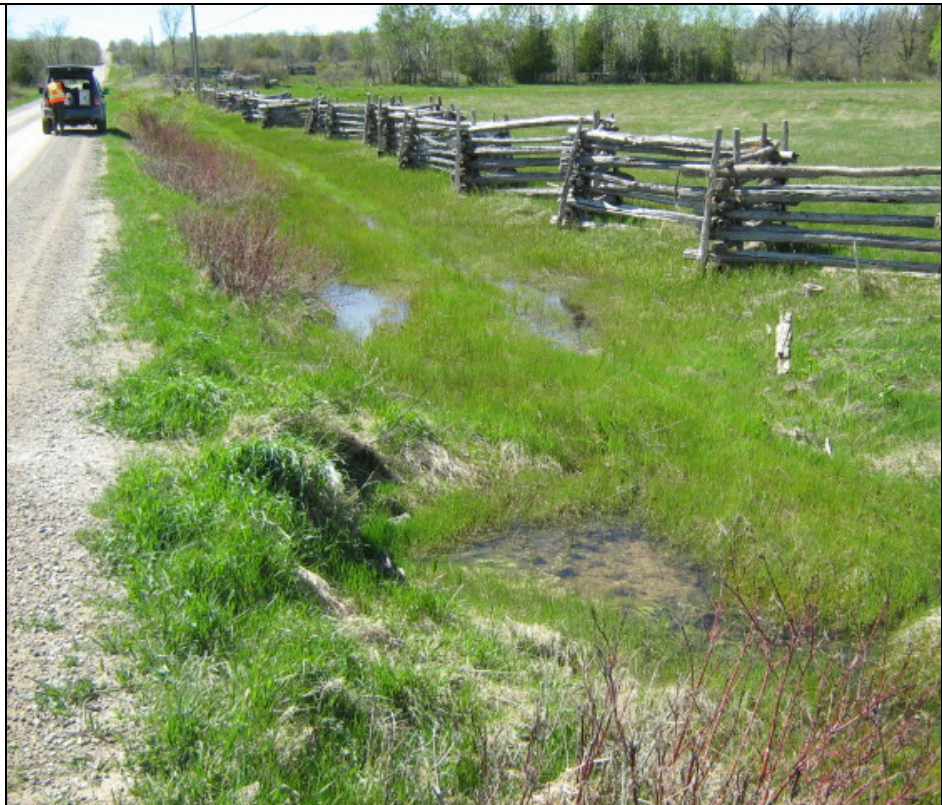
**Photo 19**

Tributary of  
Manitowaning Bay  
Station #7

Channel formed by  
depressed tire marks  
with small flow  
through culvert north  
of Green Bush Rd.

Looking upstream

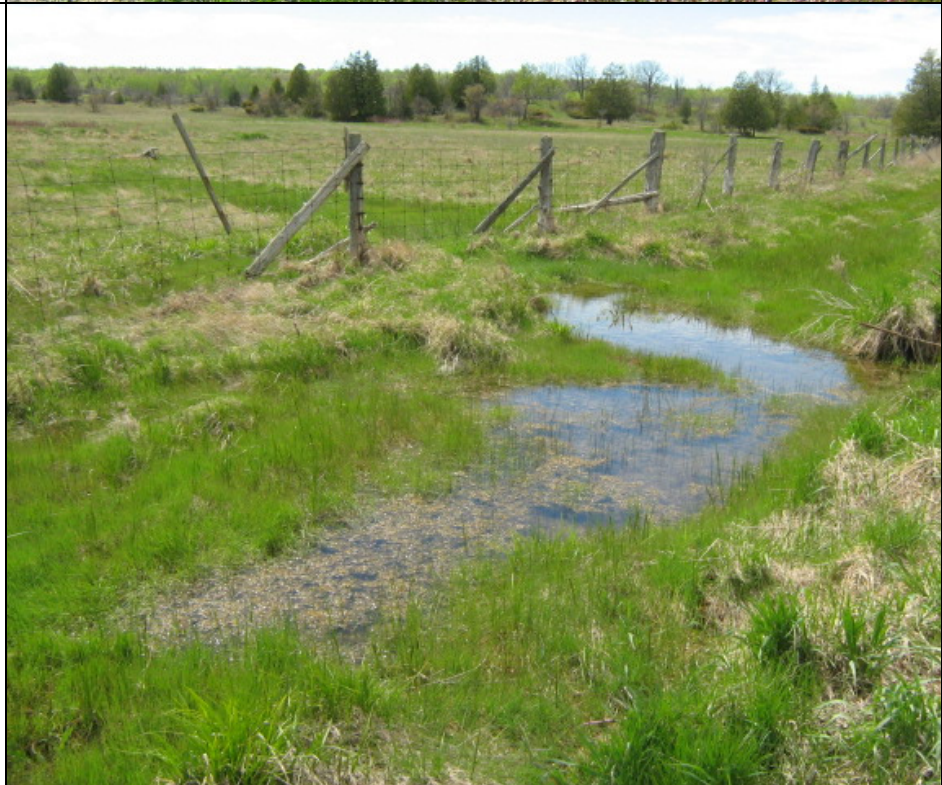
**Photo 20**

Tributary of  
Manitowaning Bay  
Station #7

Pool and small  
channel flowing into  
farm field south of  
Green Bush Rd.

Looking downstream

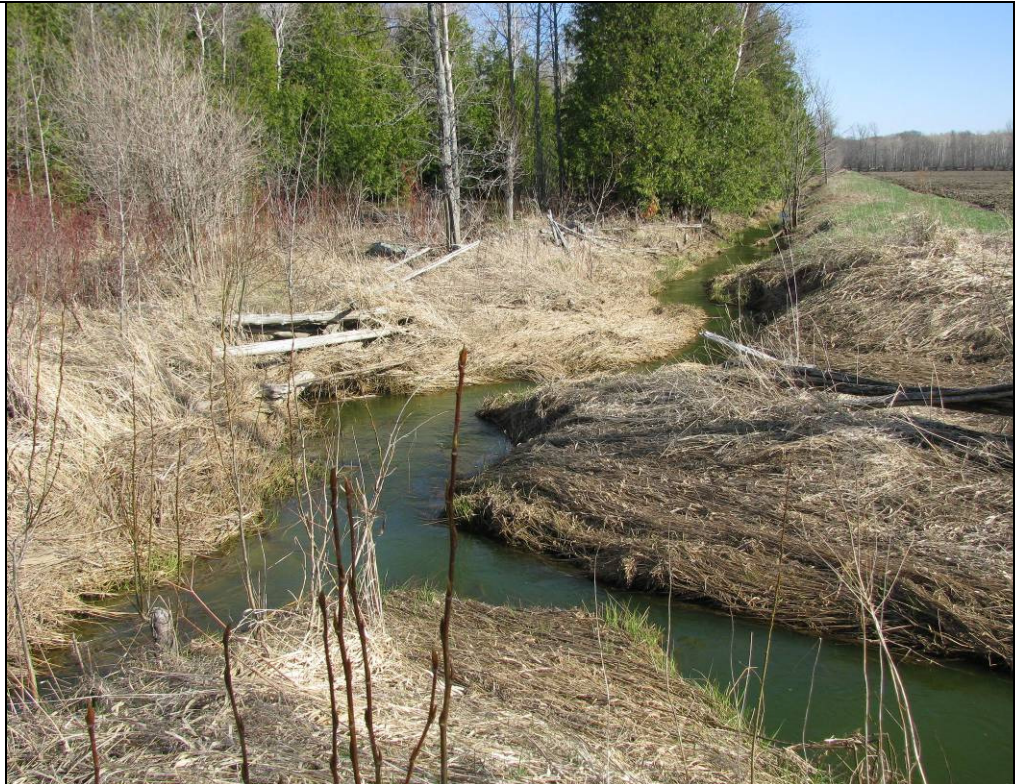
**Photo 21**

Tributary of  
Manitowaning Bay  
Station #9

West of Boozeneck  
Road.

Facing downstream

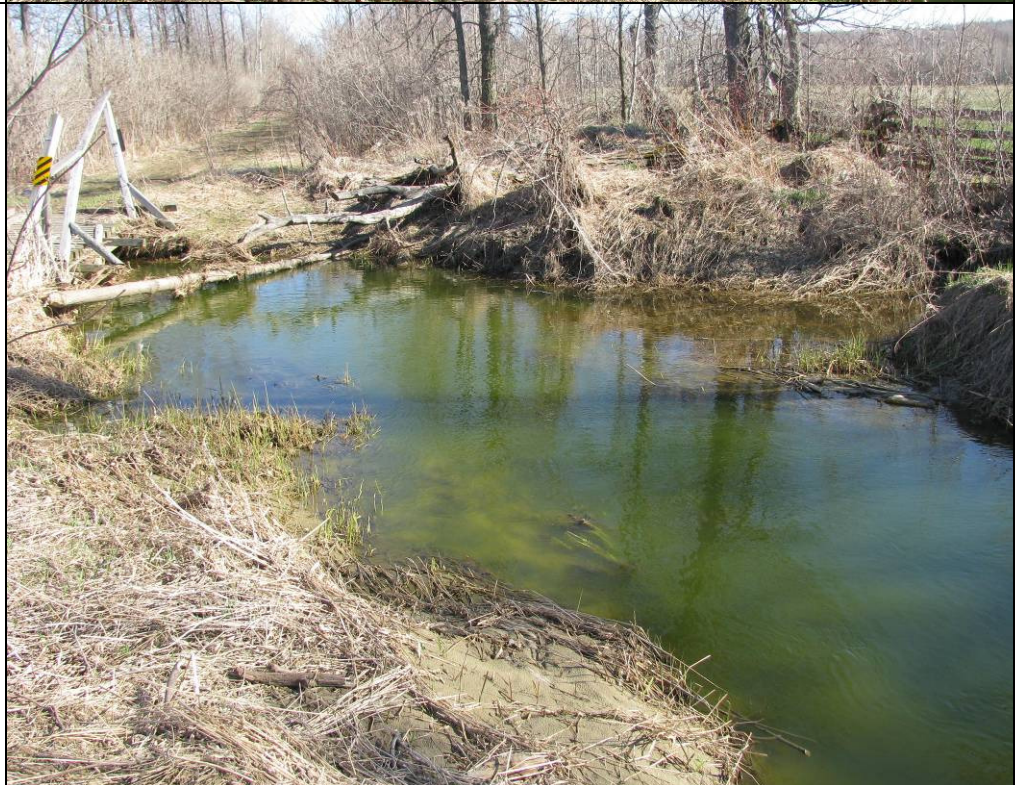
**Photo 22**

Tributary of  
Manitowaning Bay  
Station #9

Pond near Boozeneck  
Road Crossing.

Facing upstream

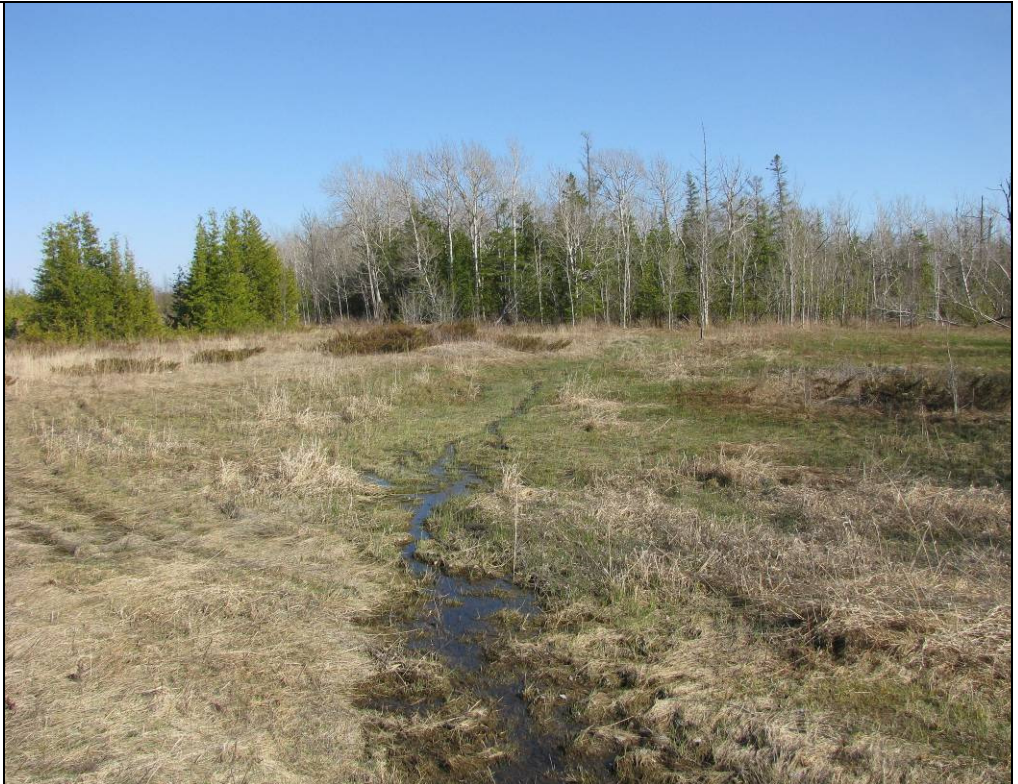
**Photo 23**

Unnamed Tributary  
Station #10

Grass channel on the  
south side of  
Harbourview Road.

Facing upstream

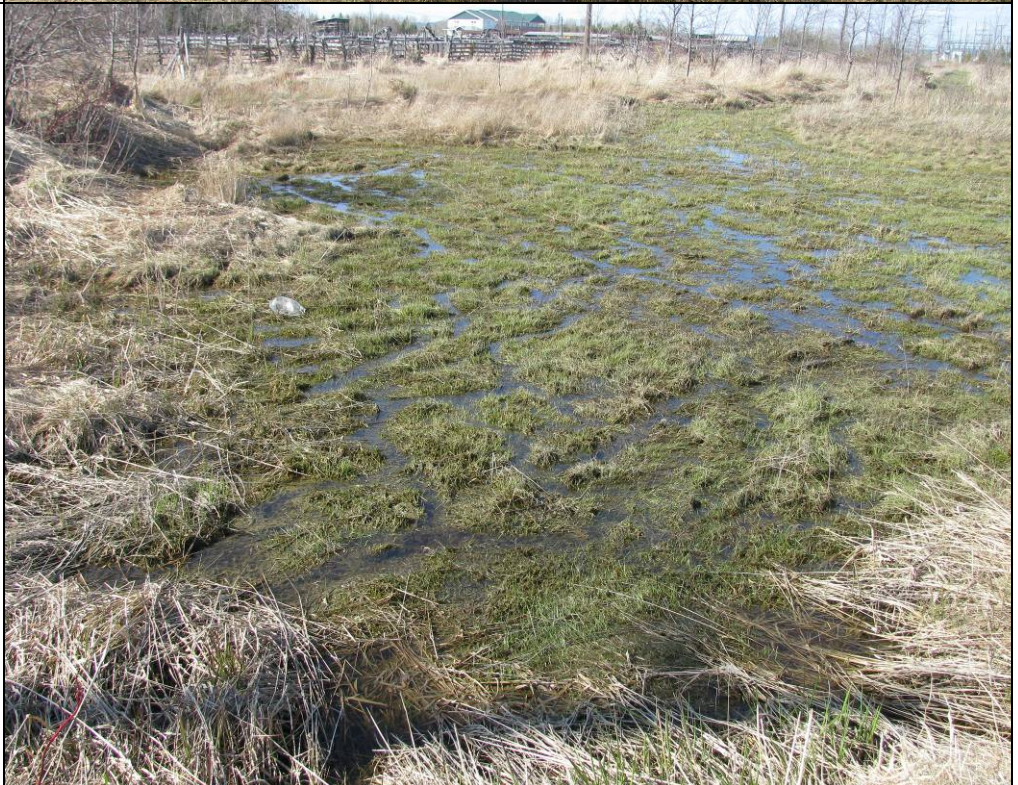
**Photo 24**

Unnamed Tributary  
Station #10

Undefined grass  
channel on the north  
side of Harbourview  
Road.

Facing upstream.
