Water Body Site Investigation Report

**Crosby Solar Project**

H334844-0000-07-124-0065 Rev. 0 April 5, 2011

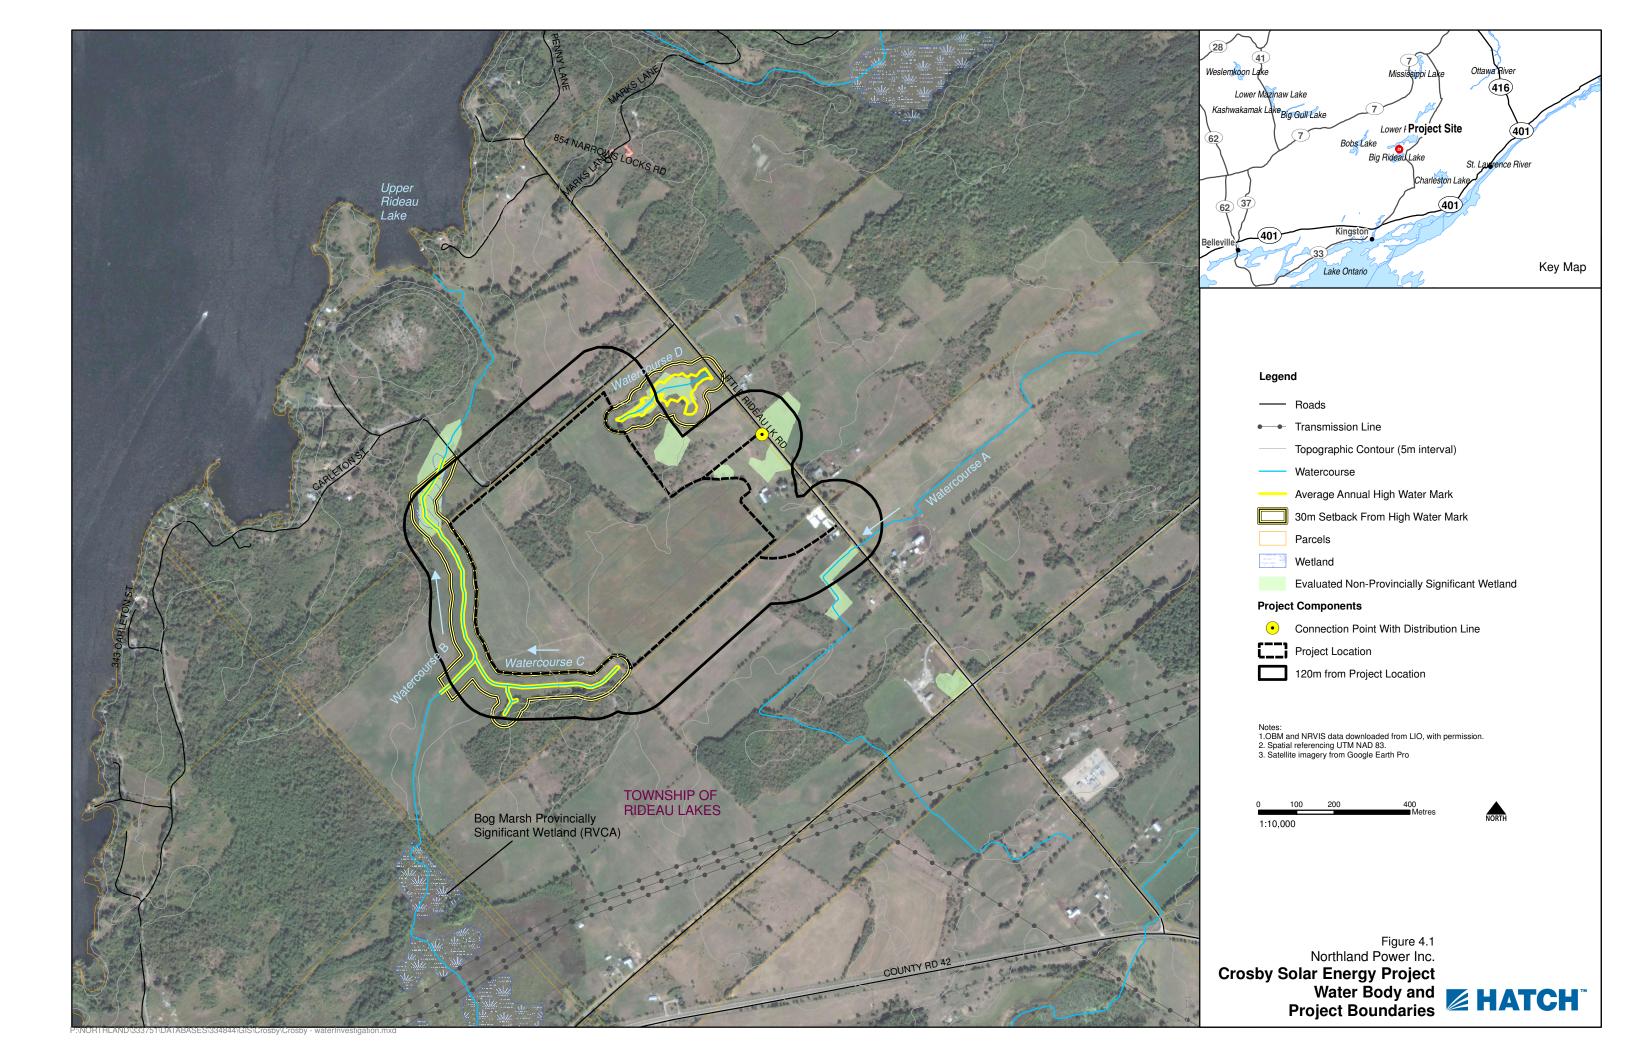
This section documents the results of the site investigation and discusses specific water features observed on and adjacent to the Project site. Features noted in the following sections, including the proposed Project footprint boundary and the average annual high water mark of watercourses on and within 120 m of the Project site, are shown in Figure 4.1. There were no lakes or seepage areas identified during the site investigation.

As shown in Figure 4.1, the Project footprint boundary is between 30 and 120 m from the average annual high water mark. Therefore, an EIS will be required to assess the potential for adverse effects and mitigation measures required to prevent/minimize these adverse effects.

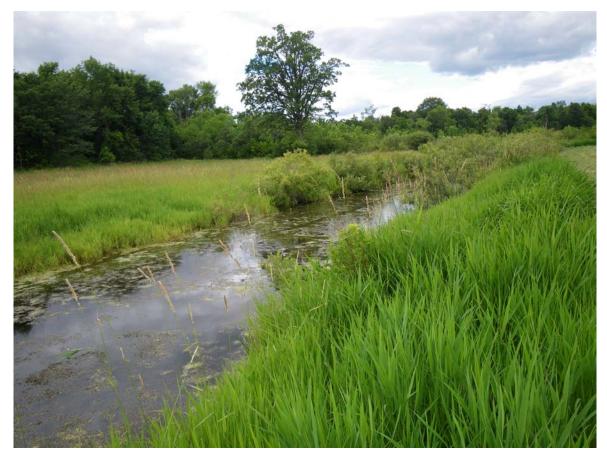
Figure 4.2 View of the Northern Portion of Watercourse B

The portion of the watercourse that flows east through the agricultural field is dominated by grasses, sedges, rushes, herbs and isolated patches of shrubs. Water was observed throughout this watercourse. Where shrub species were absent, in-stream vegetation was dominated by common cattail. A photograph of the watercourse is provided in Figure 4.2.

The site investigation has confirmed that Watercourse B is a permanent stream. The average annual high water mark was assessed during the site investigation as the top of bank of the excavated drainage channel in the upstream reaches, but as the extent of vegetation tolerant of annual inundation in the lower gradient wetland reaches (Figure 4.1).

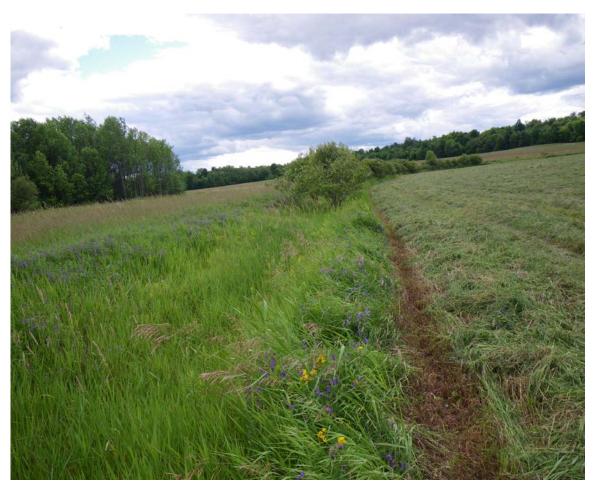
Figure 4.3 View of the Eastern Portion of Watercourse C, Facing West

The substrate consisted of shallow soils with areas of exposed bedrock at the surface. There was little to no water present within the watercourse at the time of the site investigation. The vegetated

The site investigation confirmed that Watercourse C is an intermittent stream. The average annual high water mark was determined to be the edge of the naturally vegetated riparian corridor through the surrounding agricultural fields, as shown in Figure 4.1. The proposed development area will occur within 30 to 120 m of the average annual high water mark of Watercourse C (Figure 4.1), therefore, an EIS will be required to assess potential adverse effects and mitigation and monitoring measures.

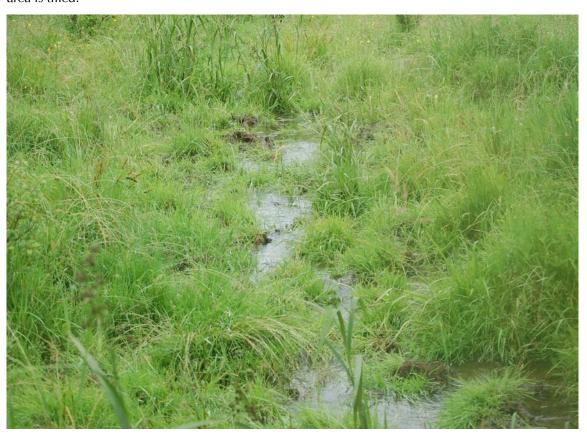
Figure 4.4 View of a Flooded Portion of Watercourse D

Watercourse D meanders west-east through the northeastern portion of the Project site and appears to be man-made as it originates in the middle of the agricultural field, west of the Project site. This is an intermittent watercourse that receives flow after heavy precipitation events and is dry the remaining months of the year. It is less than 1 m in width and follows a natural contour before draining into a catch basin located along the eastern boundary of the Project site. This watercourse flows southeast through the agricultural field through a naturally cut channel as it moves downstream. This watercourse is surrounded by a wet meadow marsh community that is dominated by grasses, sedges, rushes, herbs and shrubs. The soils in this area are shallow and areas of exposed bedrock were observed throughout. This area is also used as cattle pasture and a majority of this area is tilled.

The site investigation confirmed that Watercourse D is an intermittent stream. The average annual high water mark was determined to be the edge of the naturally vegetated riparian corridor through the surrounding agricultural fields, as shown in Figure 4.1. The proposed development area will occur within 30 to 120 m of the average annual high water mark of Watercourse D (Figure 4.1), therefore, an EIS will be required to assess potential adverse effects and mitigation and monitoring measures.
