Belleville South Solar Project Water Body Site Investigation Report

August 15, 2011

Water Body
Site Investigation Report

H334844-0000-07-124-0041

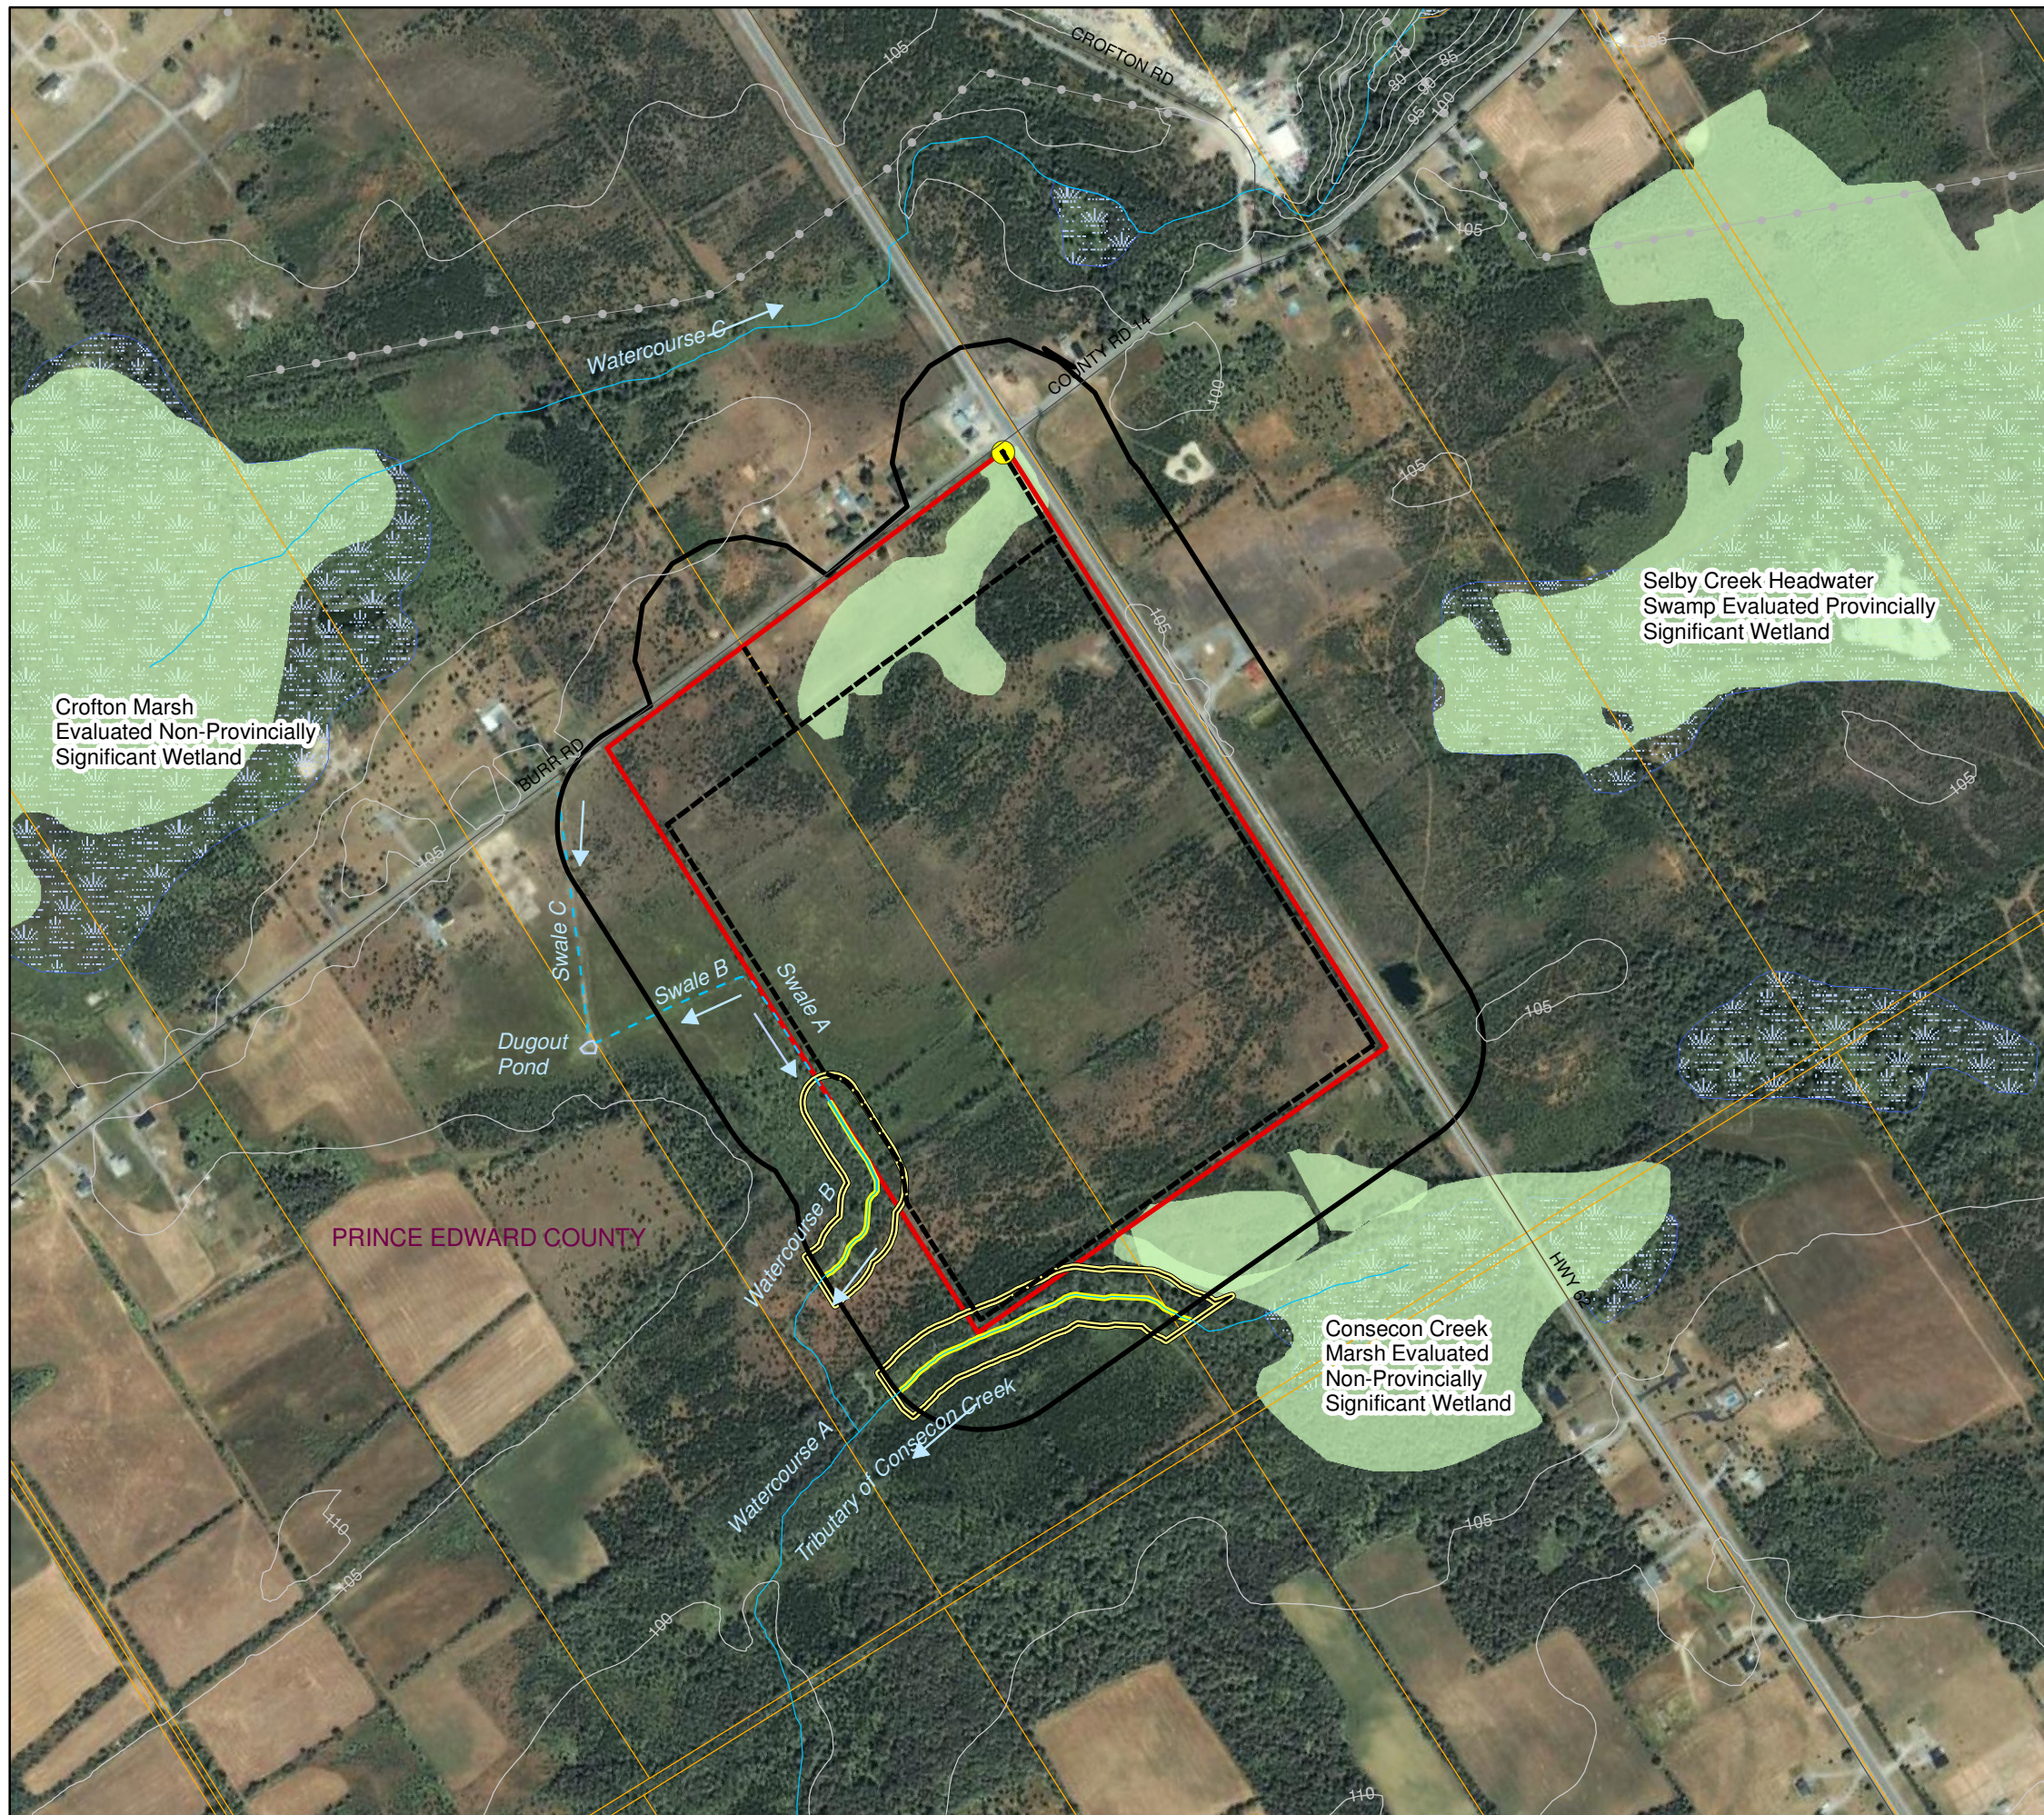
Figure 4.1
 Northland Power Inc.
 Belleville South Solar Project
 Water Body and
 Project Boundaries **HATCH™**

This section documents the results of the Site Investigation and discusses specific water features observed on and adjacent to the subject property. Features noted in the following sections, including the Project footprint boundary and the average annual high water mark and 30-m setback areas associated with watercourses are shown in Figure 4.1.

As shown in Figure 4.1, the Project footprint boundary will be located between 30 and 120 m from the average annual high water mark. Therefore, an EIS will be required to assess potential effects on this watercourse since it meets the setback requirements of the REA Regulation.

Watercourse B originates immediately west of the Project site, at approximately the mid-point of the property (Figure 4.1). It flows along the Project boundary for approximately 300 m before diverging away from the Project area and draining into Watercourse A approximately 210 m west of the Project Site.

The site investigation has confirmed that the lower portion of Watercourse B is an intermittent stream. The average annual high water mark, based on top of bank features and riparian vegetation communities is shown in Figure 4.1.

Several drainage features not noted during the records review were observed west of the Project site during the site investigation. There are two grassy swales (Swales B and C in Figure 4.1) that both run toward a dugout pond with no outflow. Swale C commences at the roadside ditch along Burr Road and flows south for approximately 300 m in an excavated linear drainage swale where it enters a dugout pond. Swale B commences the western Project site boundary and runs west toward the dugout pond. It runs through a meadow marsh type wetland area with poor drainage.

Based on the results of the site investigation and the proposed Project components and boundaries shown in Figure 4.1, the Project will be located between 30 and 120 m of the average annual high water mark of any waterbody. Therefore, an Environmental Impact Study (EIS) is required.

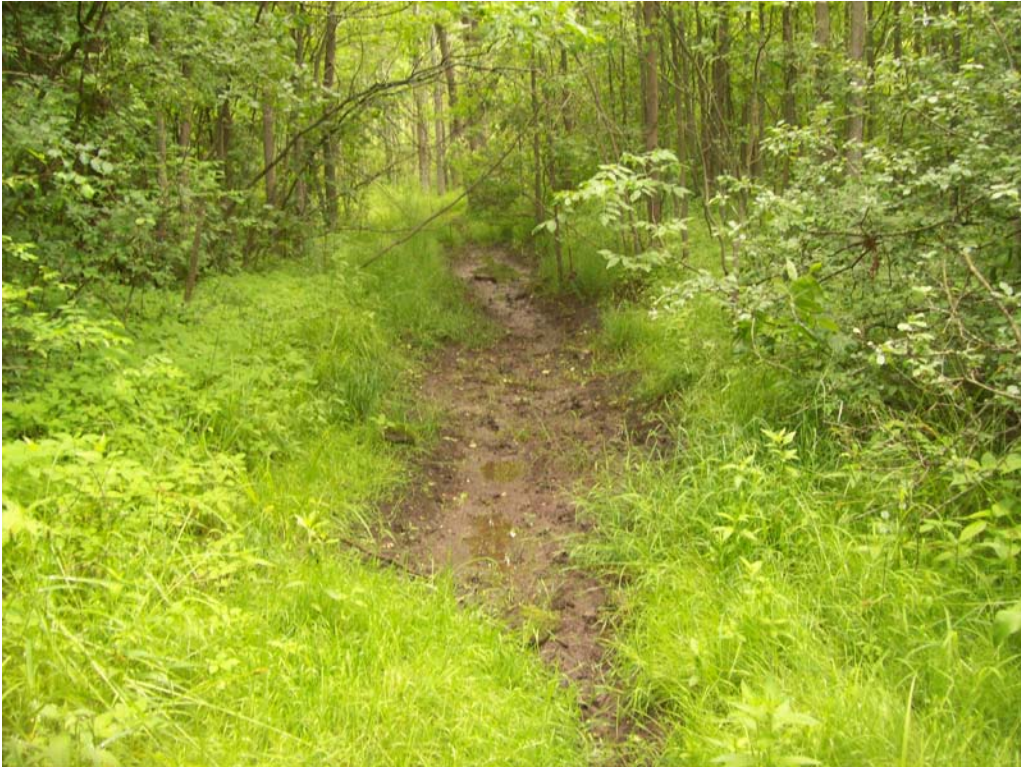
Figure 4.2 Watercourse A South of the Project Site

Watercourse A consists of a relatively linear channel that runs through the woodlot south of the Project site. The watercourse was not flowing during the June site investigation is therefore intermittent, likely serving primarily to convey stormwater flows from the surrounding lands and periodic drainage from the Consecon Creek.

The channel bed is approximately 1 to 1.5 m wide with primarily mud substrate. Sections of the bed are open with relatively little vegetation (see Figure 4.2), while others are sections have higher amounts of vegetation (primarily grasses and sedges) on the channel bed and banks (Figure 4.3). Riparian vegetation consists of grasses, sedges and ground cover species in a relatively narrow band (approximately 1 to 3 m from the channel edge), bordered by shrubs and trees. Some areas of the woodlot have high density canopy cover while others are more open.

The site investigation has confirmed that Watercourse A is an intermittent stream. There was no flow or standing water in the watercourse during the site investigation, but the channel bed was largely free of vegetation or contained vegetation that requires continuously saturated ground conditions.

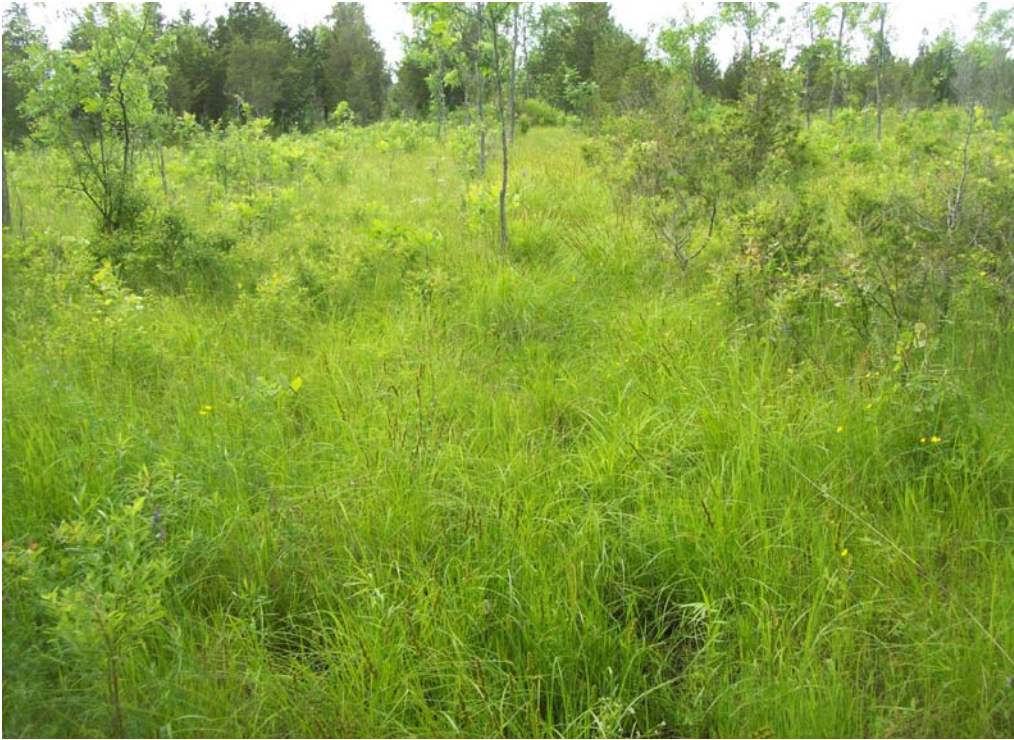
Figure 4.4 Upstream Grassy Swale Reach of Watercourse B

There was no flow or standing water in any reach of Watercourse B during the June site investigation. The upper reach of the channel consists of a poorly defined, grassy swale with a mix of vegetation species, including some upland and less water tolerant species, in addition to a variety of sedges and grasses. Given the presence of such vegetation community, this portion of the watercourse (as shown in Figure 4.1) does not meet the definition of a watercourse as per the REA Regulation. A photograph of this section of Watercourse B is provided in Figure 4.4.

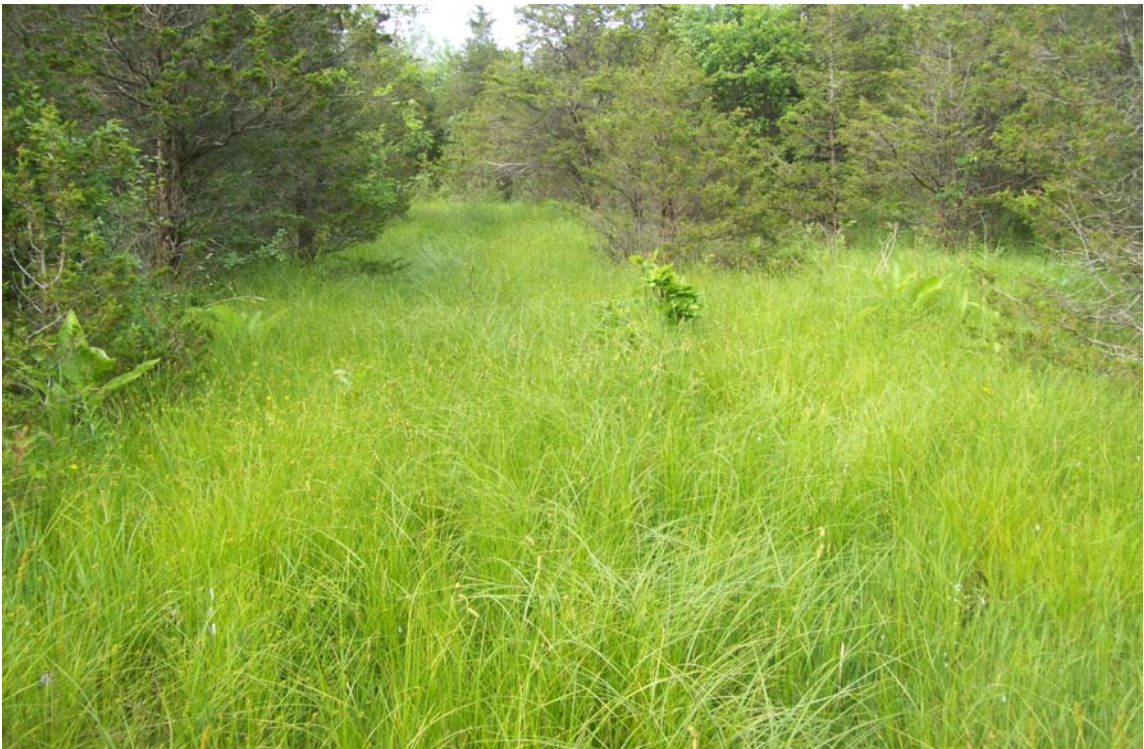
Figure 4.5 Lower Reaches of Watercourse B Adjacent to the Project Site

However, the lower section of the watercourse has vegetation communities that are more indicative of those that do require continuously saturated soils (i.e., predominantly sedges) and therefore it does meet the definition of an intermittent watercourse. The channel remains poorly defined, as it flows through a mix of relatively open shrub meadows and denser wooded areas. Substrate is predominantly mud and fine mineral soils.

This section of the channel appears to serve primarily as stormwater conveyance, but may provide some intermittent aquatic habitat for tolerant fish and invertebrates. A photograph is provided in Figure 4.5.
