Burk's Falls West Solar Project

Water Body Site Investigation Report

November 16, 2011

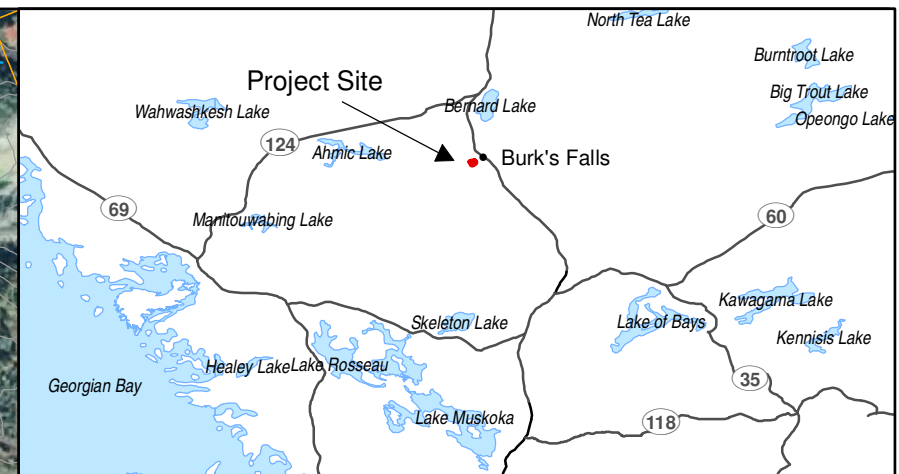
1:7,000 Figure 1.1
Northland Power Inc.

This section documents the results of the site investigation and discusses specific water features observed on and adjacent to the Project site. Features noted in the following sections, including the proposed Project footprint boundary and the average annual high water mark of watercourses and location of seepage areas on and within 120 m of the Project location, are shown in Figure 1.1.

During the site investigation, it was determined that this feature is a temporary drainage route consisting of a low lying area between adjacent rolling topographical features. There is no defined channel and there was no flow observed during the site investigation noted in Section 3, nor during any of the other site investigations conducted to assess natural heritage features of the property (as discussed in Hatch Ltd., 2011b). The low lying area predominantly consists of meadow vegetation, with a mix of upland vegetation and some sedges and rushes. The predominant function of this drainage route would be to convey overland flow during precipitation and runoff events toward the Magnetawan River. Given the vegetation community within the area, it is evident that the duration of the presence of water is limited, since the vegetation community is not dominated by hydrophilic species. The labeling on this drainage feature has therefore been changed from that in the Records Review. For the purposes of this report, it is labeled as Grassed Waterway A in Figure 1.1.

As shown in Figure 1.1, the average annual high water mark is located between 30 and 120 m from the Project location. Therefore, the potential adverse effects of the Project on the Magnetawan River and surrounding land will be assessed in the EIS.

Based on the results of the site investigation and the proposed Project location shown in Figure 1.1, some components of the Project will be located between 30 and 120 m of the average annual high water mark of the Magnetawan River, Watercourses A, C, D, F and G and two seepage areas. Therefore, an EIS will be required to assess the potential effects of the Project and the required mitigation measures to prevent or minimize adverse effects on these waterbodies.

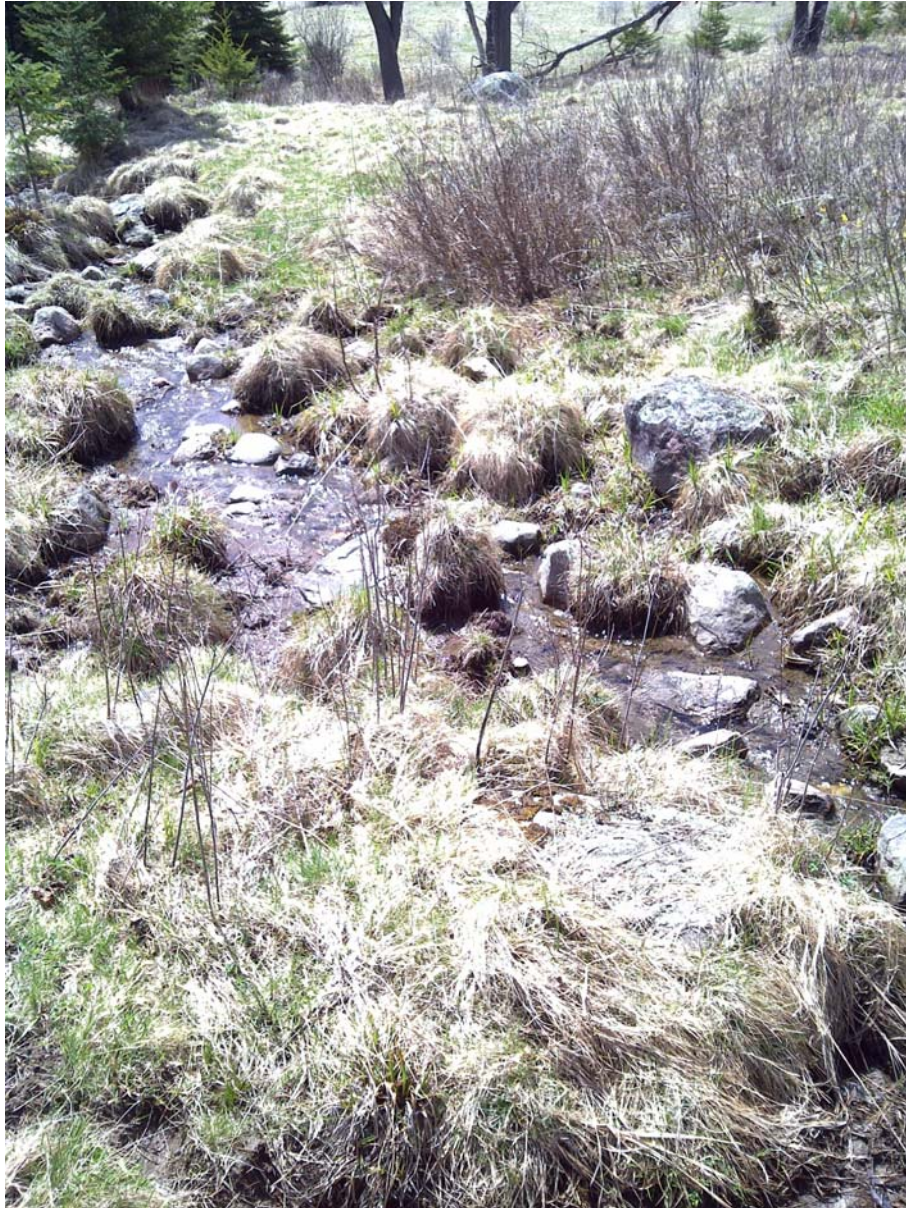
This watercourse was observed in the southwestern portion of the property. It consists of a defined watercourse channel originating from several seepage zones and flowing south toward the Magnetawan River. Flow from the seepage areas was present during the Site investigation and there was a defined channel with a variety of substrates including muck and rock (gravel and cobble). Wetland vegetation within and adjacent to the channel was predominantly meadow marsh

vegetation. This watercourse, the two seepage areas and the average annual high water mark are shown in Figure 1.1. A photograph of this watercourse is shown in Figure 4.3.

Figure 4.3 Photograph of Watercourse A

This watercourse meets the definition of a permanent or intermittent stream, since there is a defined channel present and there is no established vegetation community present within the channel. The average annual high water mark has been determined to be the top of bank of the channel. A 30-m setback has been applied, per the requirement of the REA Regulation. However, the project location is within 120 m of the average annual high water mark, therefore an EIS is required to consider to the potential adverse effects and mitigation requirements to protect this feature.
