Crosby Solar Project

Draft Water Body Site Investigation Report

December 22, 2010

H334844-0000-07-124-0065

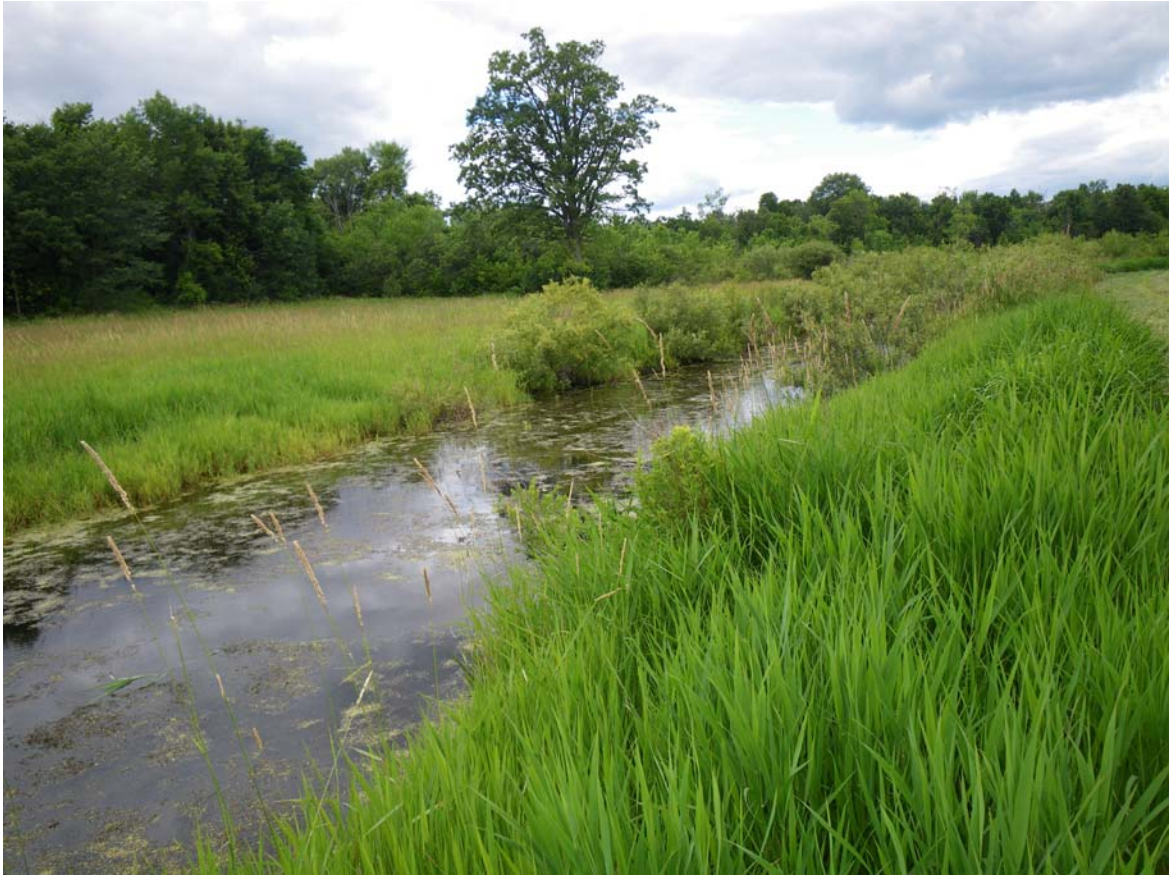
Figure 4.2 View of the Northern Portion of Watercourse B

The portion of the watercourse that flows east through the agricultural field is dominated by grasses, sedges, rushes, herbs and isolated patches of shrubs. Water was observed throughout this watercourse. Where shrub species were absent, in-stream vegetation was dominated by common cattail. A photograph of the watercourse is provided in Figure 4.2.

The watercourse becomes wider where it converges with Watercourse C (see Section 4.1.3), flowing north before discharging into Stedman's Bay on Upper Rideau Lake. This portion of the watercourse is approximately 2 to 3 m wide and consists of emergent (floating arrowhead, pondweeds), submergent and floating (e.g., lesser duckweed) aquatic vegetation. The riparian vegetation is similar to the rest of the watercourse, consisting of grasses, sedges, herbs and shrubs. The depth of water observed within this portion of the watercourse was approximately 0.3 to 1.0 m and was nearly at bankfull height. A small, drilled artesian, created during a previous geological investigation on the Project site, is located adjacent to the watercourse and does supply a small amount of groundwater directly to the stream. Several green frogs (*Rana clamitans*) and northern leopard frogs (*Rana pipiens*) were observed, and a muskrat (*Ondatra zibethicus*) den was observed at the northern portion of this watercourse along the fence line.

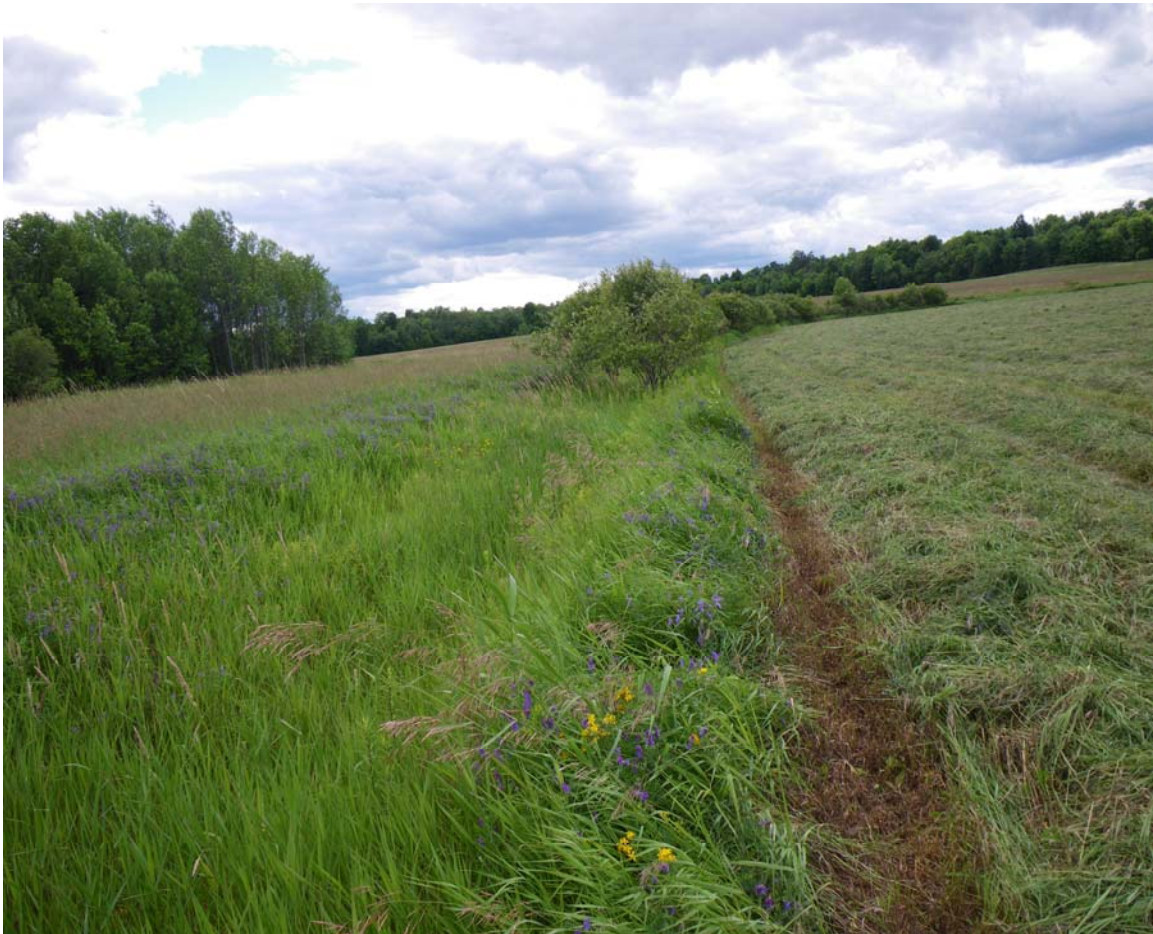
Figure 4.3 View of the Eastern Portion of Watercourse C, Facing West

Watercourse C consists of an excavated linear drainage ditch commencing in the southwestern portion of the Project site, where it flows west for approximately 400 m and then curves north where it converges with Watercourse B (Figure 4.1). This watercourse is intermittent as it receives flow from a tile drainage outlet that discharges water collected from the agricultural fields to the east. It consists of a narrow, shallow, excavated channel (< 1.5 m wide) that flows through a vegetated corridor (approximately 5 m wide) surrounded by the adjacent agricultural fields.

The substrate consisted of shallow soils with areas of exposed bedrock at the surface. There was little to no water present within the watercourse at the time of the site investigation. The vegetated

corridor is dominated by grasses and herbs such as cow vetch (*Vicia cracca*), birds-foot trefoil (*Lotus corniculatus*), clovers (*Trifolium sp.*), ox-eye daisy (*Leucanthemum vulgare*), and aster species. Tree and shrub species were also observed along the watercourse and consisted of ash (*Fraxinus sp.*) and willow species (*Salix sp.*). These trees and shrubs provide 100% canopy cover throughout the majority of the lower reach of the watercourse. A photograph of Watercourse C is provided in Figure 4.3.

The site investigation confirmed that Watercourse C is an intermittent stream. The average annual high water mark was determined to be the edge of the naturally vegetated riparian corridor through the surrounding agricultural fields, as shown in Figure 4.1. The proposed development area will occur within 30 to 120 m of the average annual high water mark of Watercourse C (Figure 4.1), therefore, an EIS will be required to assess potential adverse effects and mitigation and monitoring measures.

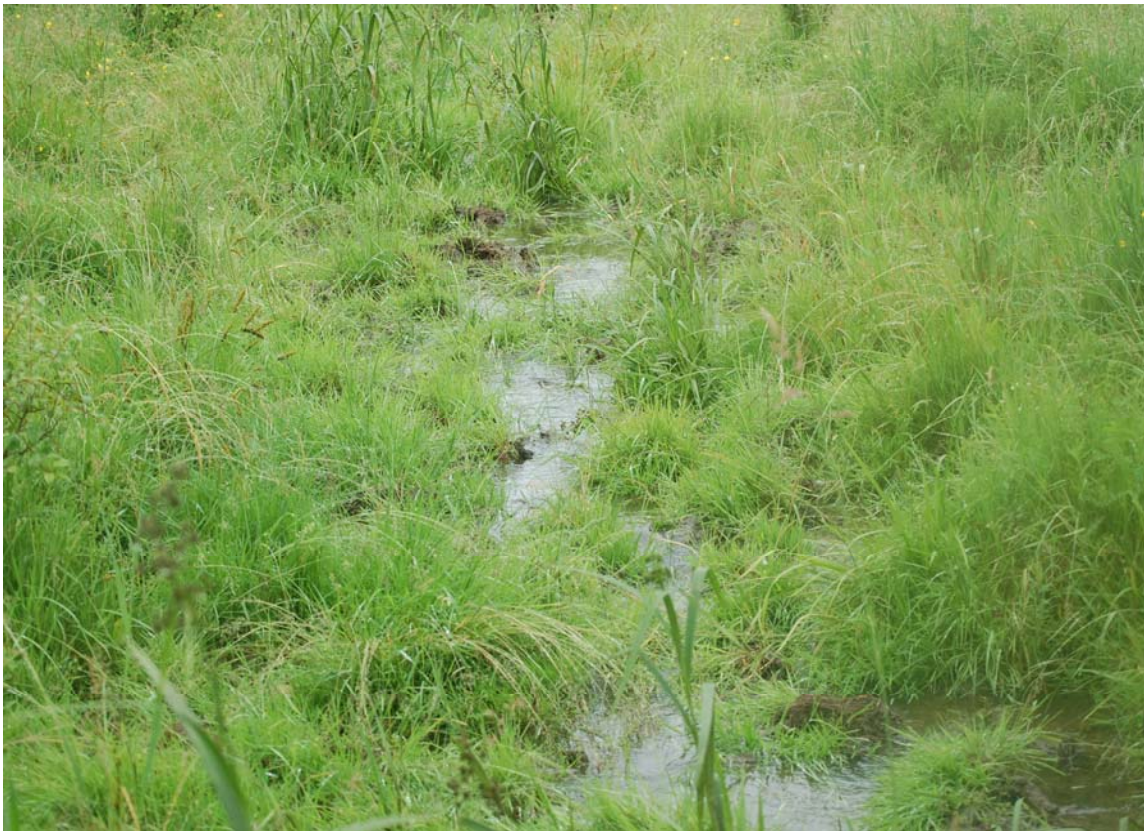
Figure 4.4 View of a Flooded Portion of Watercourse D

Watercourse D meanders west-east through the northeastern portion of the Project site and appears to be man-made as it originates in the middle of the agricultural field, west of the Project site. This is an intermittent watercourse that receives flow after heavy precipitation events and is dry the remaining months of the year. It is less than 1 m in width and follows a natural contour before draining into a catch basin located along the eastern boundary of the Project site. This watercourse flows southeast through the agricultural field through a naturally cut channel as it moves downstream. This watercourse is surrounded by a wet meadow marsh community that is dominated by grasses, sedges, rushes, herbs and shrubs. The soils in this area are shallow and areas of exposed bedrock were observed throughout. This area is also used as cattle pasture and a majority of this area is tilled.

The site investigation confirmed that Watercourse D is an intermittent stream. The average annual high water mark was determined to be the edge of the naturally vegetated riparian corridor through the surrounding agricultural fields, as shown in Figure 4.1. The proposed development area will occur within 30 to 120 m of the average annual high water mark of Watercourse D (Figure 4.1), therefore, an EIS will be required to assess potential adverse effects and mitigation and monitoring measures.
