North Burgess Solar Project Draft Water Body Site Investigation Report

August 25, 2011

North Burgess Solar Project

H334844-0000-07-124-0113

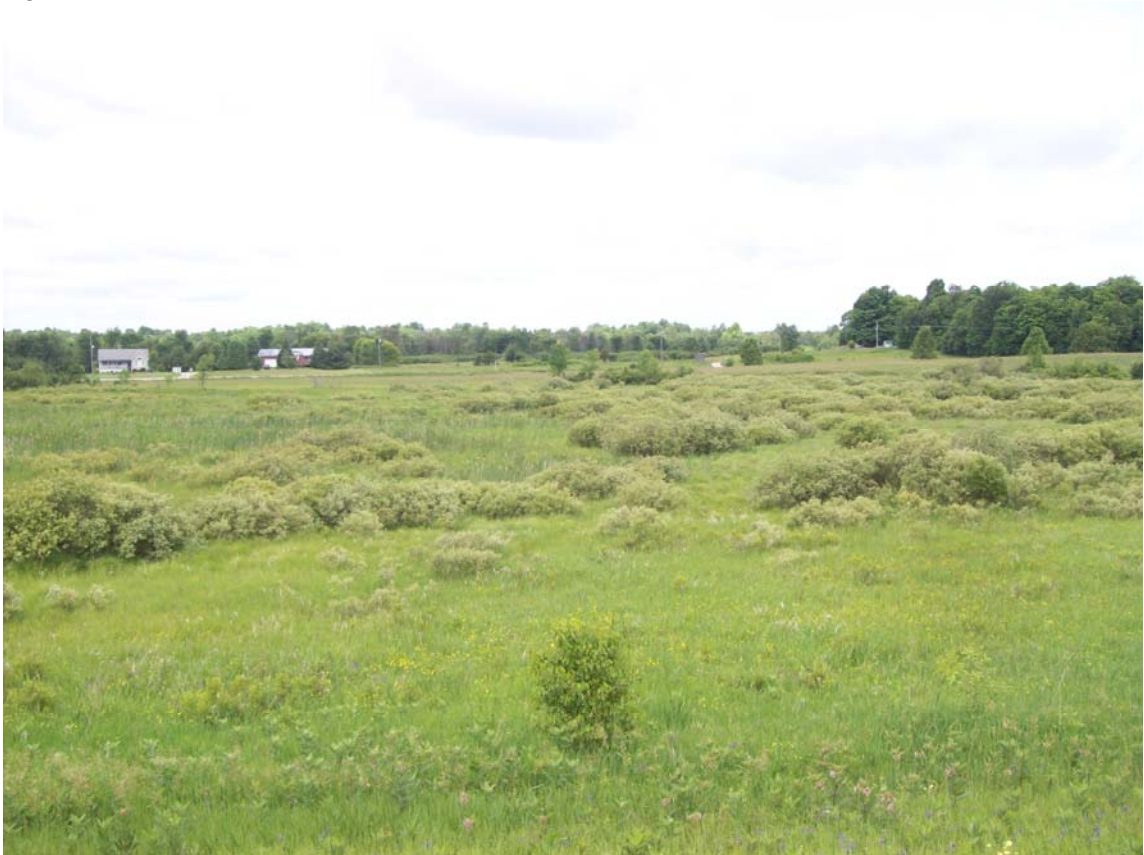
Figure 4.5 Photograph of Shrub Thicket and Cattail Marsh Surrounding Tributary C where it Flows onto the Project Site

A photograph of the shrub thicket where Tributary C enters the Project site is provided in Figure 4.5.

Tributary C appears to be an intermittent watercourse, but it likely provides a number of ecological functions including provision of wildlife habitat and regulation of hydrology and surface water quality in downstream reaches.
