# North Burgess Solar Project Water Body Site Investigation Report

North Burgess Solar Project

H334844-0000-07-124-0113

**Water Body Site Investigation Report**

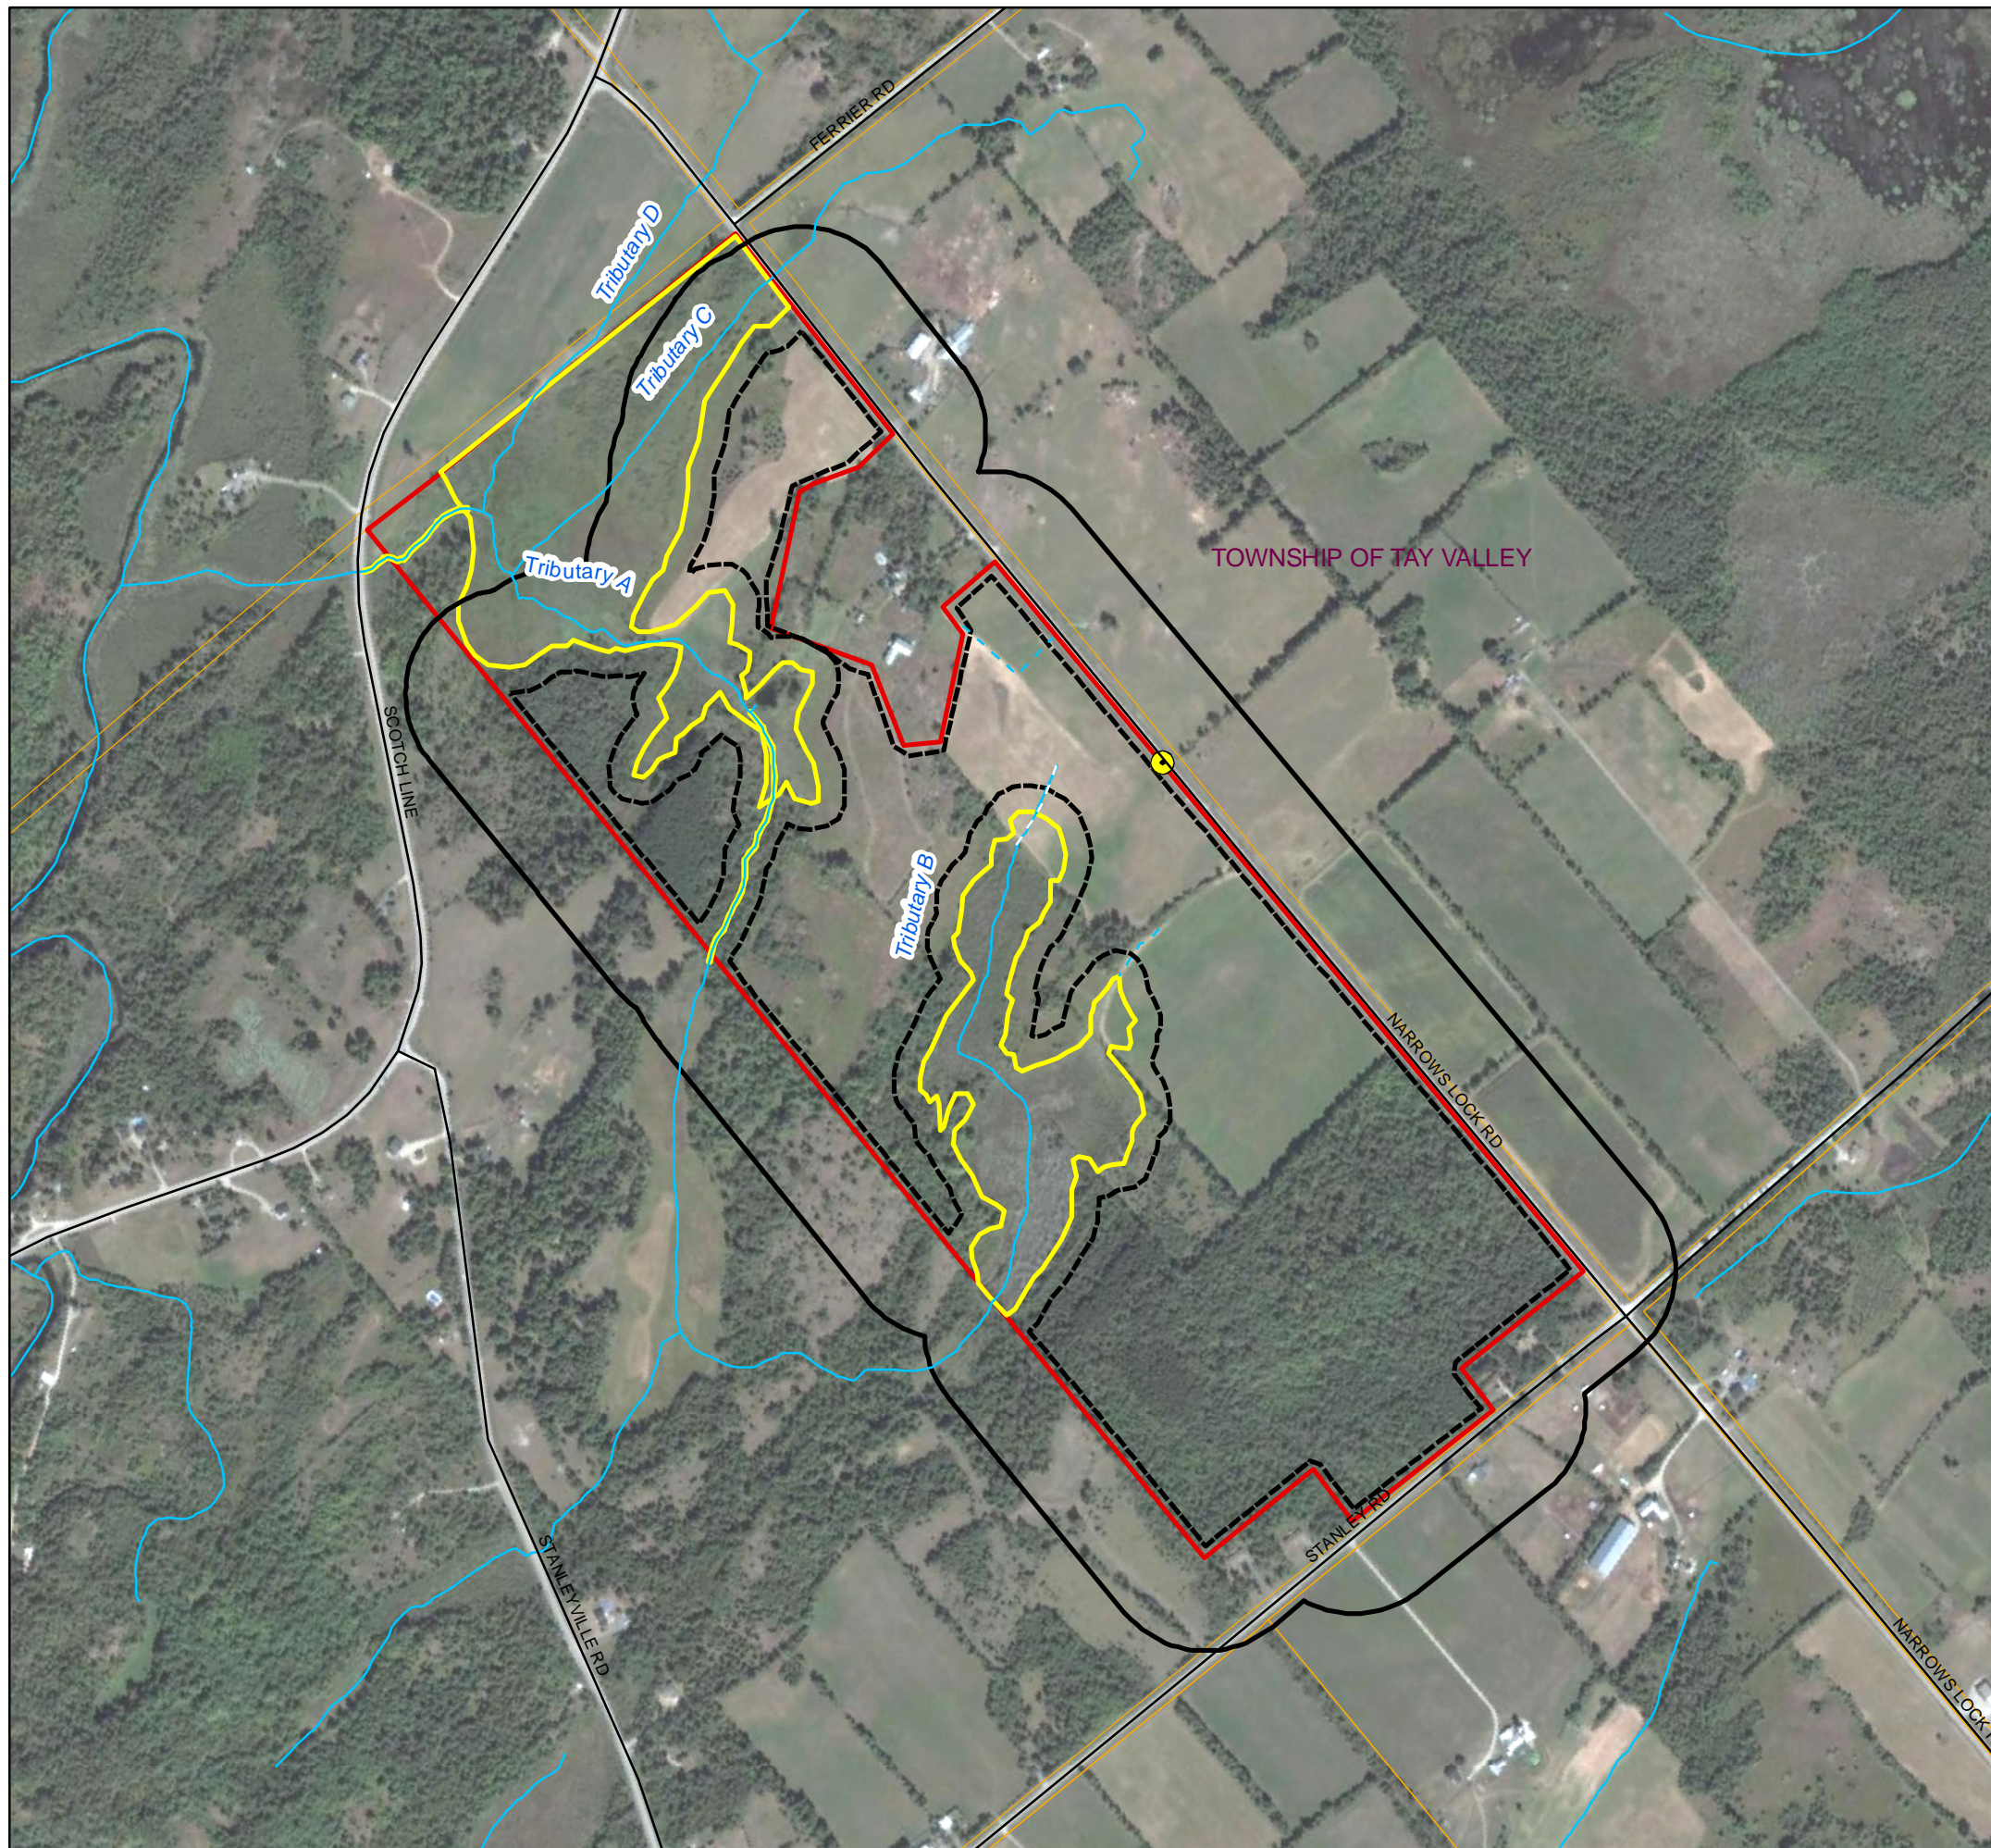
Figure 4.1  
 Northland Power Inc.  
**North Burgess Solar Project**  
**Water Body and Project Boundaries**

This section documents the results of the Site Investigation and discusses specific water features observed on and adjacent to the subject property. Features noted in the following sections, including the Project footprint boundary and the average annual high water mark and 30-m setback areas associated with watercourses are shown in Figure 4.1.

The Water Body Records Review (Hatch Ltd., 2010a) noted the presence of four unnamed watercourses on the Project site (labelled as Tributaries A to D in Figure 4.1), all of which form part of the drainage of Grant's Creek, which is located approximately 350 m west of the Project site. The site investigation confirmed the presence of these watercourses. No other permanent or intermittent streams were observed during the site investigation.

The site investigation has confirmed that Tributary A is a permanent stream, comprised predominantly of wetlands on the Project site. To establish the average annual high water mark (as per the REA requirement), (i) riparian vegetation was assessed to establish the boundary of vegetation species tolerant of annual flooding and (ii) valley and topographic features such as the top of bank were observed. Based on these observations made during the site investigation, the high water mark along Tributary A was primarily assessed as the edge of the wetland vegetation adjacent to the main channel of tributary A. The average annual high water mark, associated 30-m setback (as required by the REA Regulation) and proposed development footprint boundary are shown in Figure 4.1.

Based on the results of the site investigation and the proposed Project footprint shown in Figure 4.1, some components of the facility will be located between 30 and 120 m of Tributaries A, B and C. Therefore, an EIS will be required.

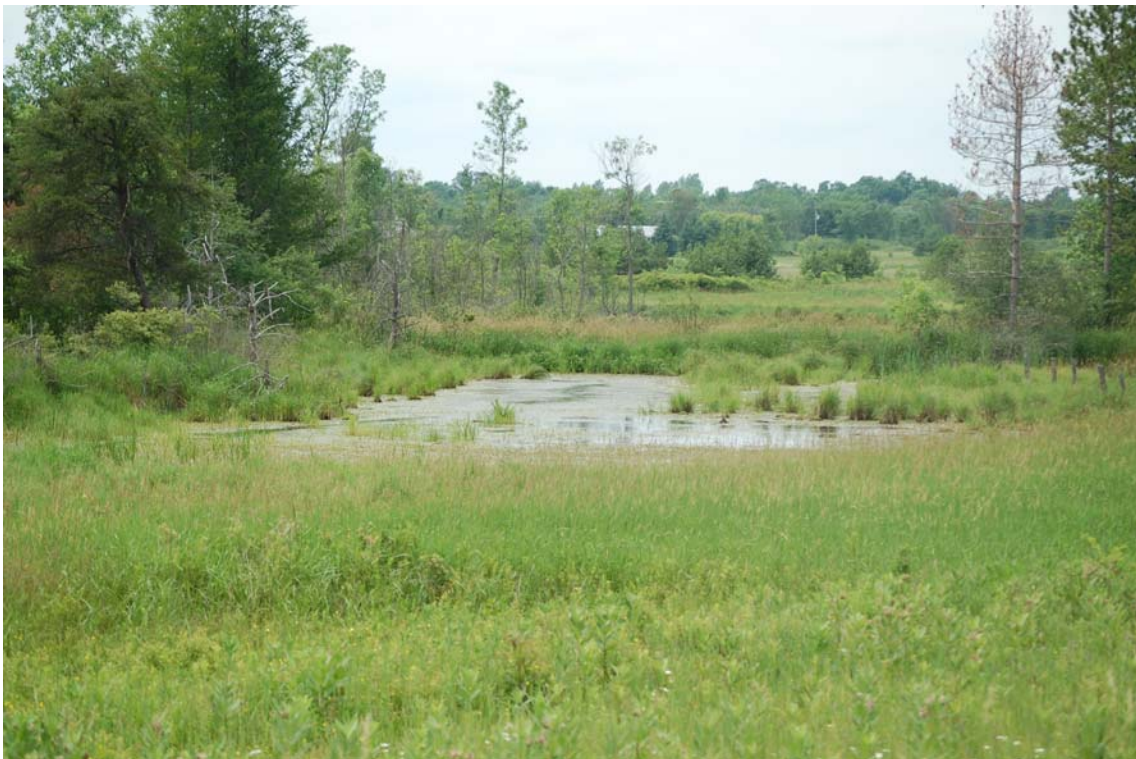
Before flowing onto the Project site, Tributary A runs through several wooded areas and a large open wetland immediately adjacent to the western Project boundary. It enters a wooded area on the Project site and flows for approximately 300 m before emerging into an open wetland with a large on-line pond, created by a beaver dam across the tributary. The pond is approximately 20 m wide by 60 m long. It is surrounded by a hummocky meadow marsh comprised of a variety of grasses [e.g., Canada blue-joint (*Calamagrostis canadensis*)], sedges and forbs. There is dense submergent and floating leaved vegetation throughout much of the open water area. A photograph of the pond and surrounding wetland vegetation is provided in Figure 4.2.

Figure 4.2 Photograph of On-line Pond on Tributary A on the Project Site

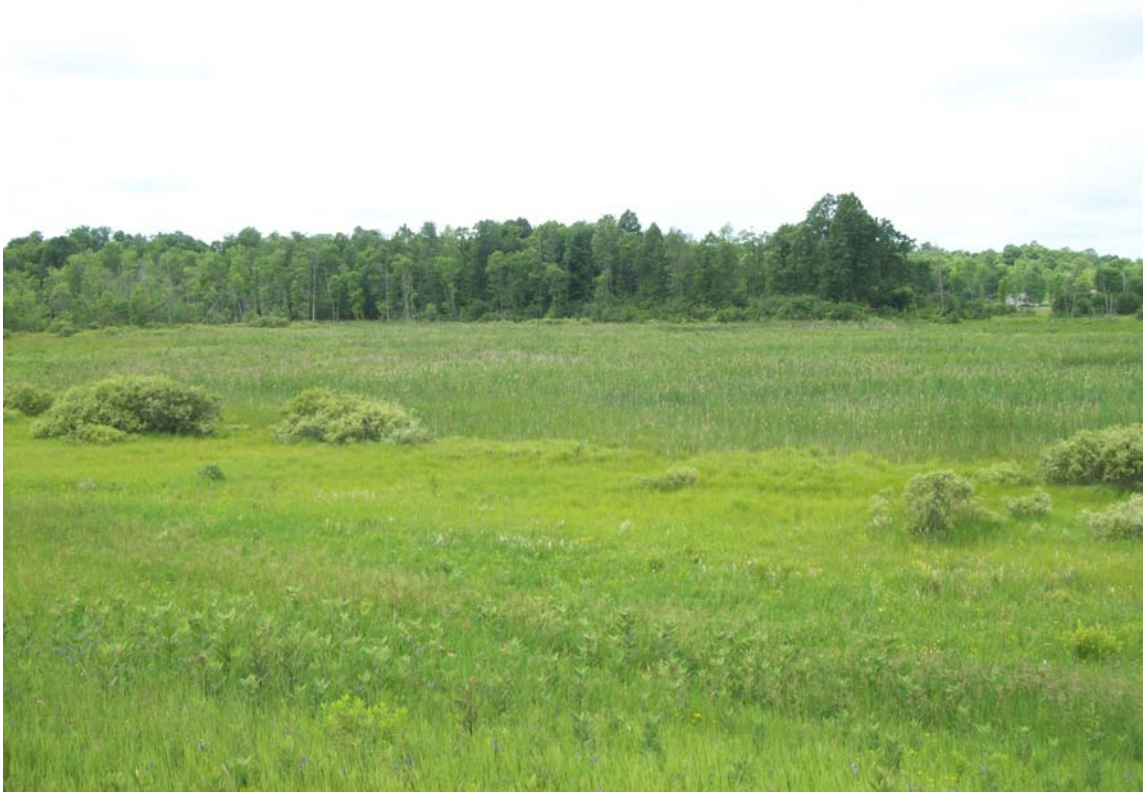
After flowing out of the pond, Tributary A flows into an expansive marsh, dominated primarily by cattails (*Typha sp.*) in the area surrounding the tributary channel. A photograph of the cattail marsh on Tributary A in the northwest corner of the Project site is provided in Figure 4.3.

**Figure 4.3 Photograph of Large Cattail Marsh on Tributary A on the Project Site – View Toward Northwest**

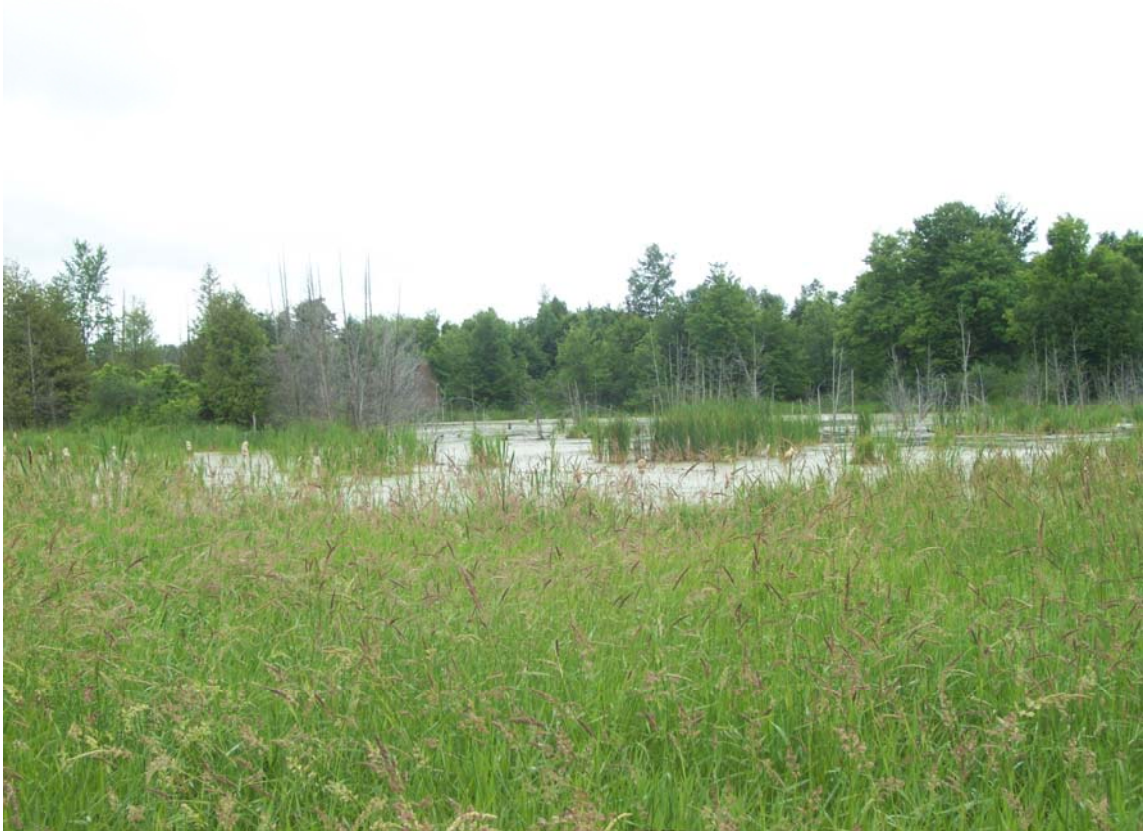
The grassed waterway discharges to a relatively open wetland, consisting of a series of open water ponds, joined by short reaches through wet meadow and shrub thicket wetlands. A large area of open water, bordered by wet meadow, shrub thicket and swamp forest communities is present in the last several hundred meters before the tributary flows off the Project site. A photograph of this wetland area is provided in Figure 4.4.

**Figure 4.4** Photograph of On-line Open Water Marsh on Tributary B on the Project Site

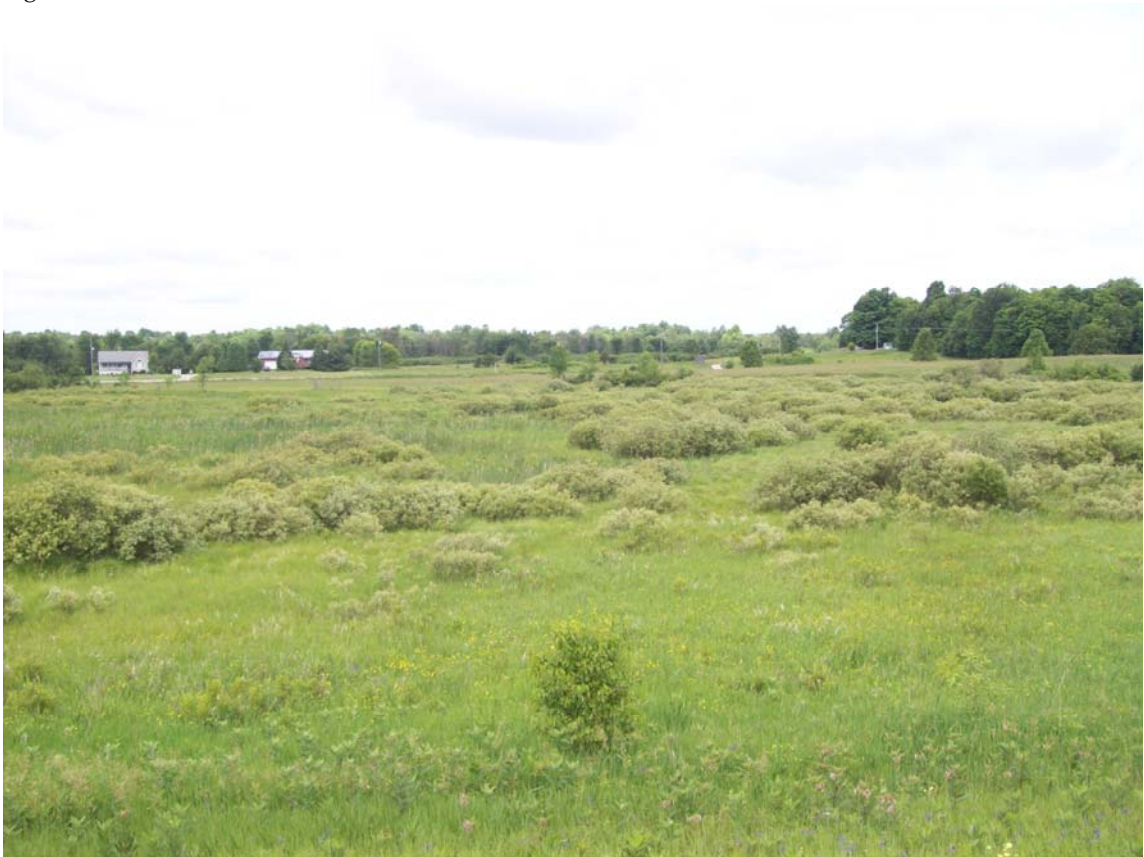
A photograph of the shrub thicket where Tributary C enters the Project site is provided in Figure 4.5.

**Figure 4.5 Photograph of Shrub Thicket and Cattail Marsh Surrounding Tributary C where it Flows onto the Project Site**
