**Grand Bend Wind Farm**  
**Water Assessment and**  
**Water Body Draft Report**

**Grand Bend Wind Limited Partnership,**  
**c/o Northland Power Inc.**

**Grand Bend Wind Limited Partnership  
Water Assessment and  
Water Body Draft Report**

Draft Water Assessment and Water Body Report  
August 2012

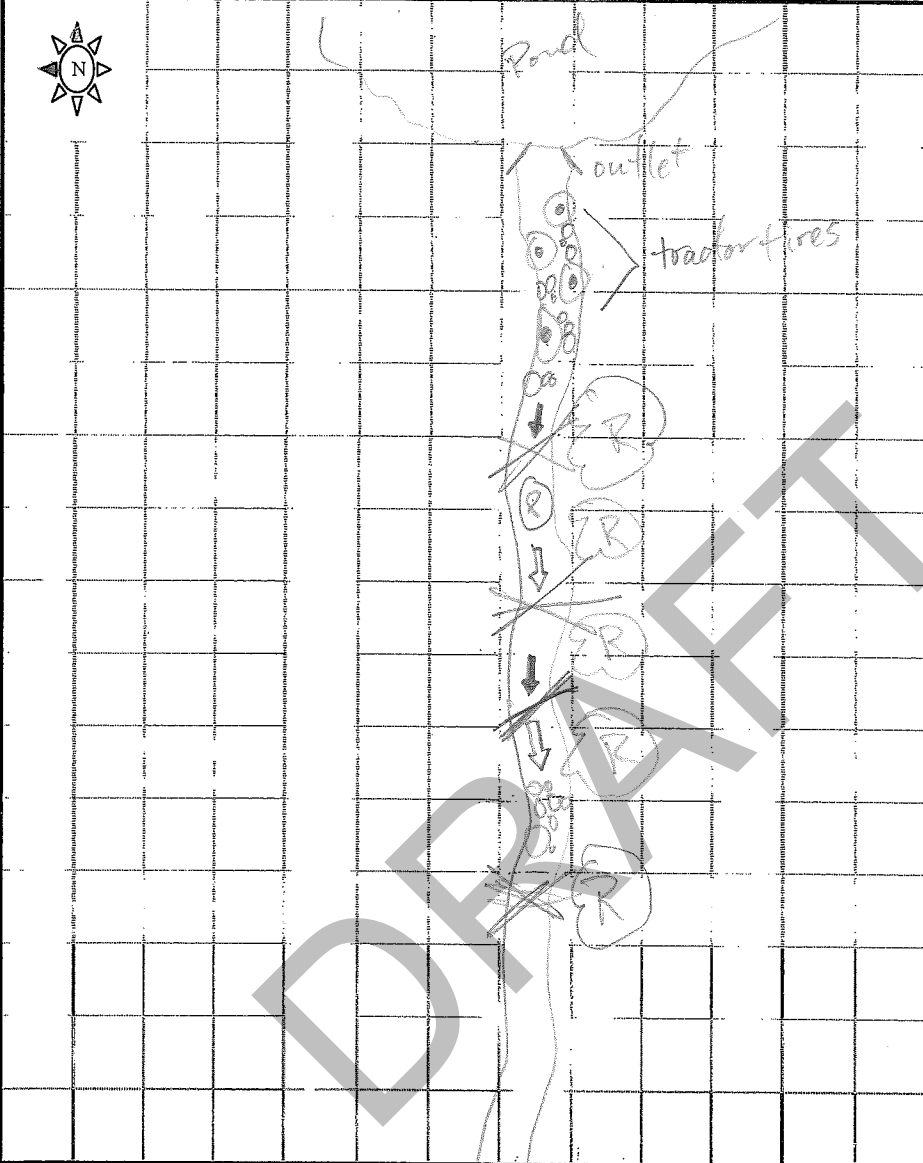
PROJECT #: PIA00991	
		MAPPER: CP	
		NAME OF WATERBODY: Charette Drain	
		CROSSING #: CR-026	
		STATION #:	
		DATE: DD-MMM-YY 20-03-12	
		<p align="center"><b>LEGEND</b></p> <p>10d depth (cm) 6w width</p> <p>➔ Riffle                  ⇨ Run/Glide                  ○ Pool                  ■ Island/Bar                  ● Fine Substrate                  ### Gravel Substrate                  oOooO Cobble / Boulder                  *** Debris                  CT Cattail                  SV/FV Submerg/Float Veg                  EV Emergent Vegetation                  W Watercress                  Fe Iron Staining                  // // // // Eroded Bank                  xxx Riprap / Other Stabilization                  ○ Instream Log/Tree                  ^^^ Dam/Weir/Obstruction                  ® Riparian Tree                   ▶ Seep/Spring                  - - - - Undercut Bank                  — Barrier to Fish Movement                  -S- Seasonal Barrier                  -x-x- Fence line                  ┌└ Culvert</p>

- potential seasonal habitat depending on d/s barriers - culvert d/s on non participating landowner								
Additional Notes Appended?    No    Yes    number of pages _____

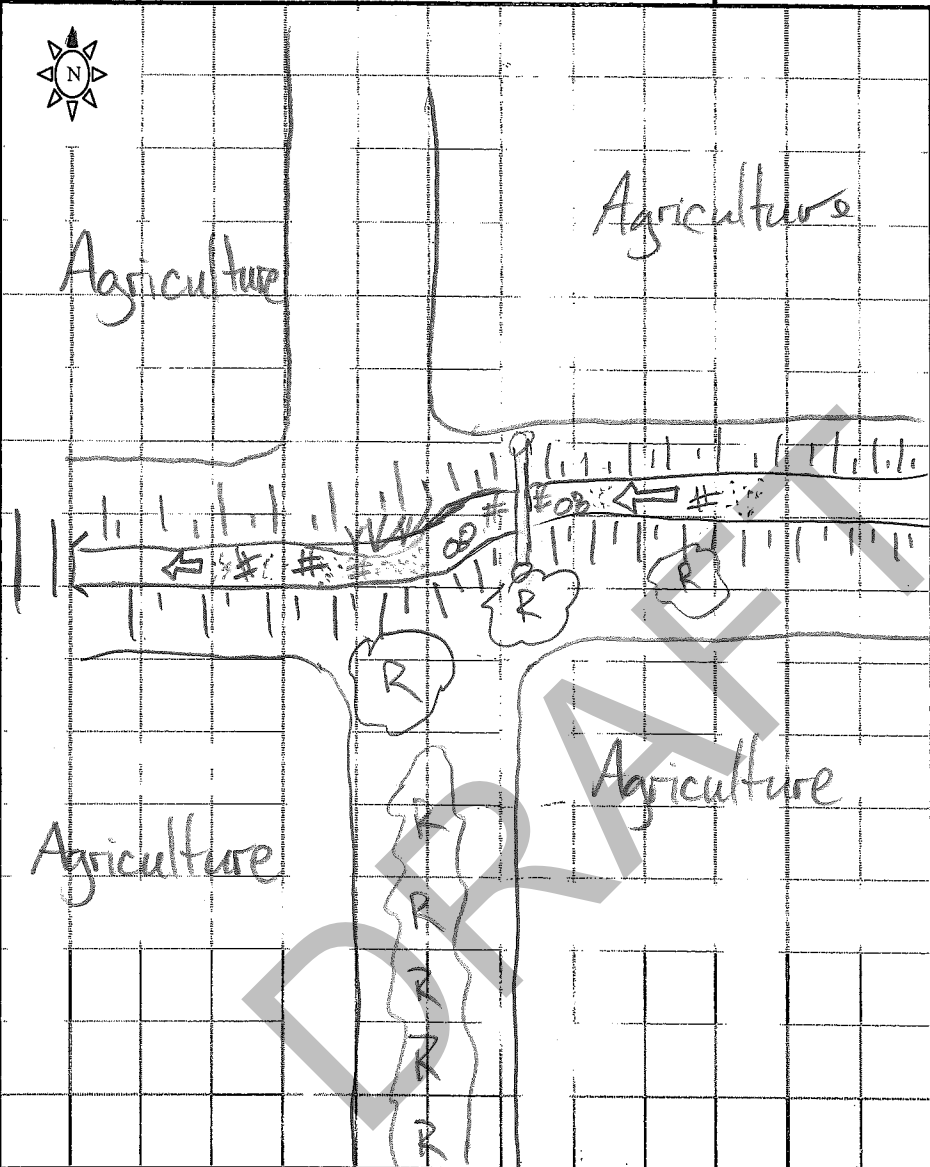
PROJECT #: P1A019991
			MAPPER: CP
			NAME OF WATERBODY: Hay Drain B North
			CROSSING #: CR-031
			STATION #:
			DATE: DD-MMM-YY 14-12-2011
<p style="text-align: center;"><b>LEGEND</b></p> <p>10d depth (cm) 6w width</p> <p>➔ Riffle              ⇨ Run/Glide              ○ Pool              ■ Island/Bar              ● Fine Substrate              ### Gravel Substrate              oOoO Cobble /Boulder              * * * Debris              CT Cattail              SV/FV Submerg/Float Veg              EV Emergent Vegetation              W Watercress              Fe Iron Staining              // // // Eroded Bank              xxx Riprap / Other Stabilization</p>			
PROFILE:	Horz. Scale	Vert. Scale	<p>○ Instream Log/Tree              ^^^ Dam/Weir/Obstruction              ⊗ Riparian Tree               ▶ Seep/Spring              - - - Undercut Bank              — Barrier to Fish Movement              -S- Seasonal Barrier              -x-x- Fence line              □ Culvert</p>

The south branch of the Hay B Drain will need to be crossed (CR-032) to access and construct turbine T-06. The mainstem of the Hay B Drain flows west under the Bluewater Highway and into Lake Huron. The Hay B Drain is classified as an F Drain providing seasonal intermittent flows. This drain may provide seasonal fish habitat depending on downstream barriers. Channel morphology is trapezoidal with a linear alignment and a low flow channel meandering within the base. Some large woody debris was observed upstream of the proposed crossing location along with a tile outlet entering from the south. Moderate erosion was noted on the left bank looking downstream. A limited riparian width exists with primarily grasses lining the banks and sporadic mature deciduous trees that provide shade. Water clarity was good during the survey although no fish were observed in December 2011.

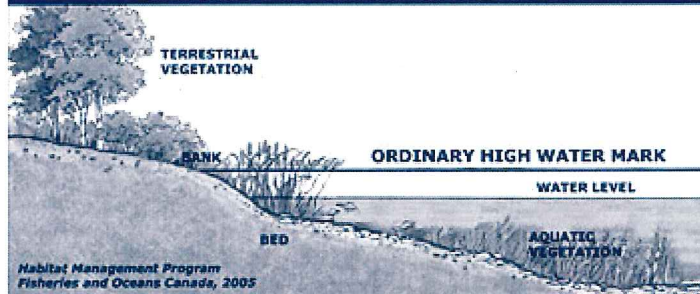
## CROSS-SECTION OF INLAND LAKES, WETLANDS OR MARINE ENVIRONMENTS

For the Great Lakes this refers to the 80th percentile elevation above chart datum as described in DFO’s *Fish Habitat and Determining the High Water Mark on Lakes*.
