McCann Solar Project

Draft Water Body Site Investigation Report

H334844-0000-07-124-0137

April 11, 2011

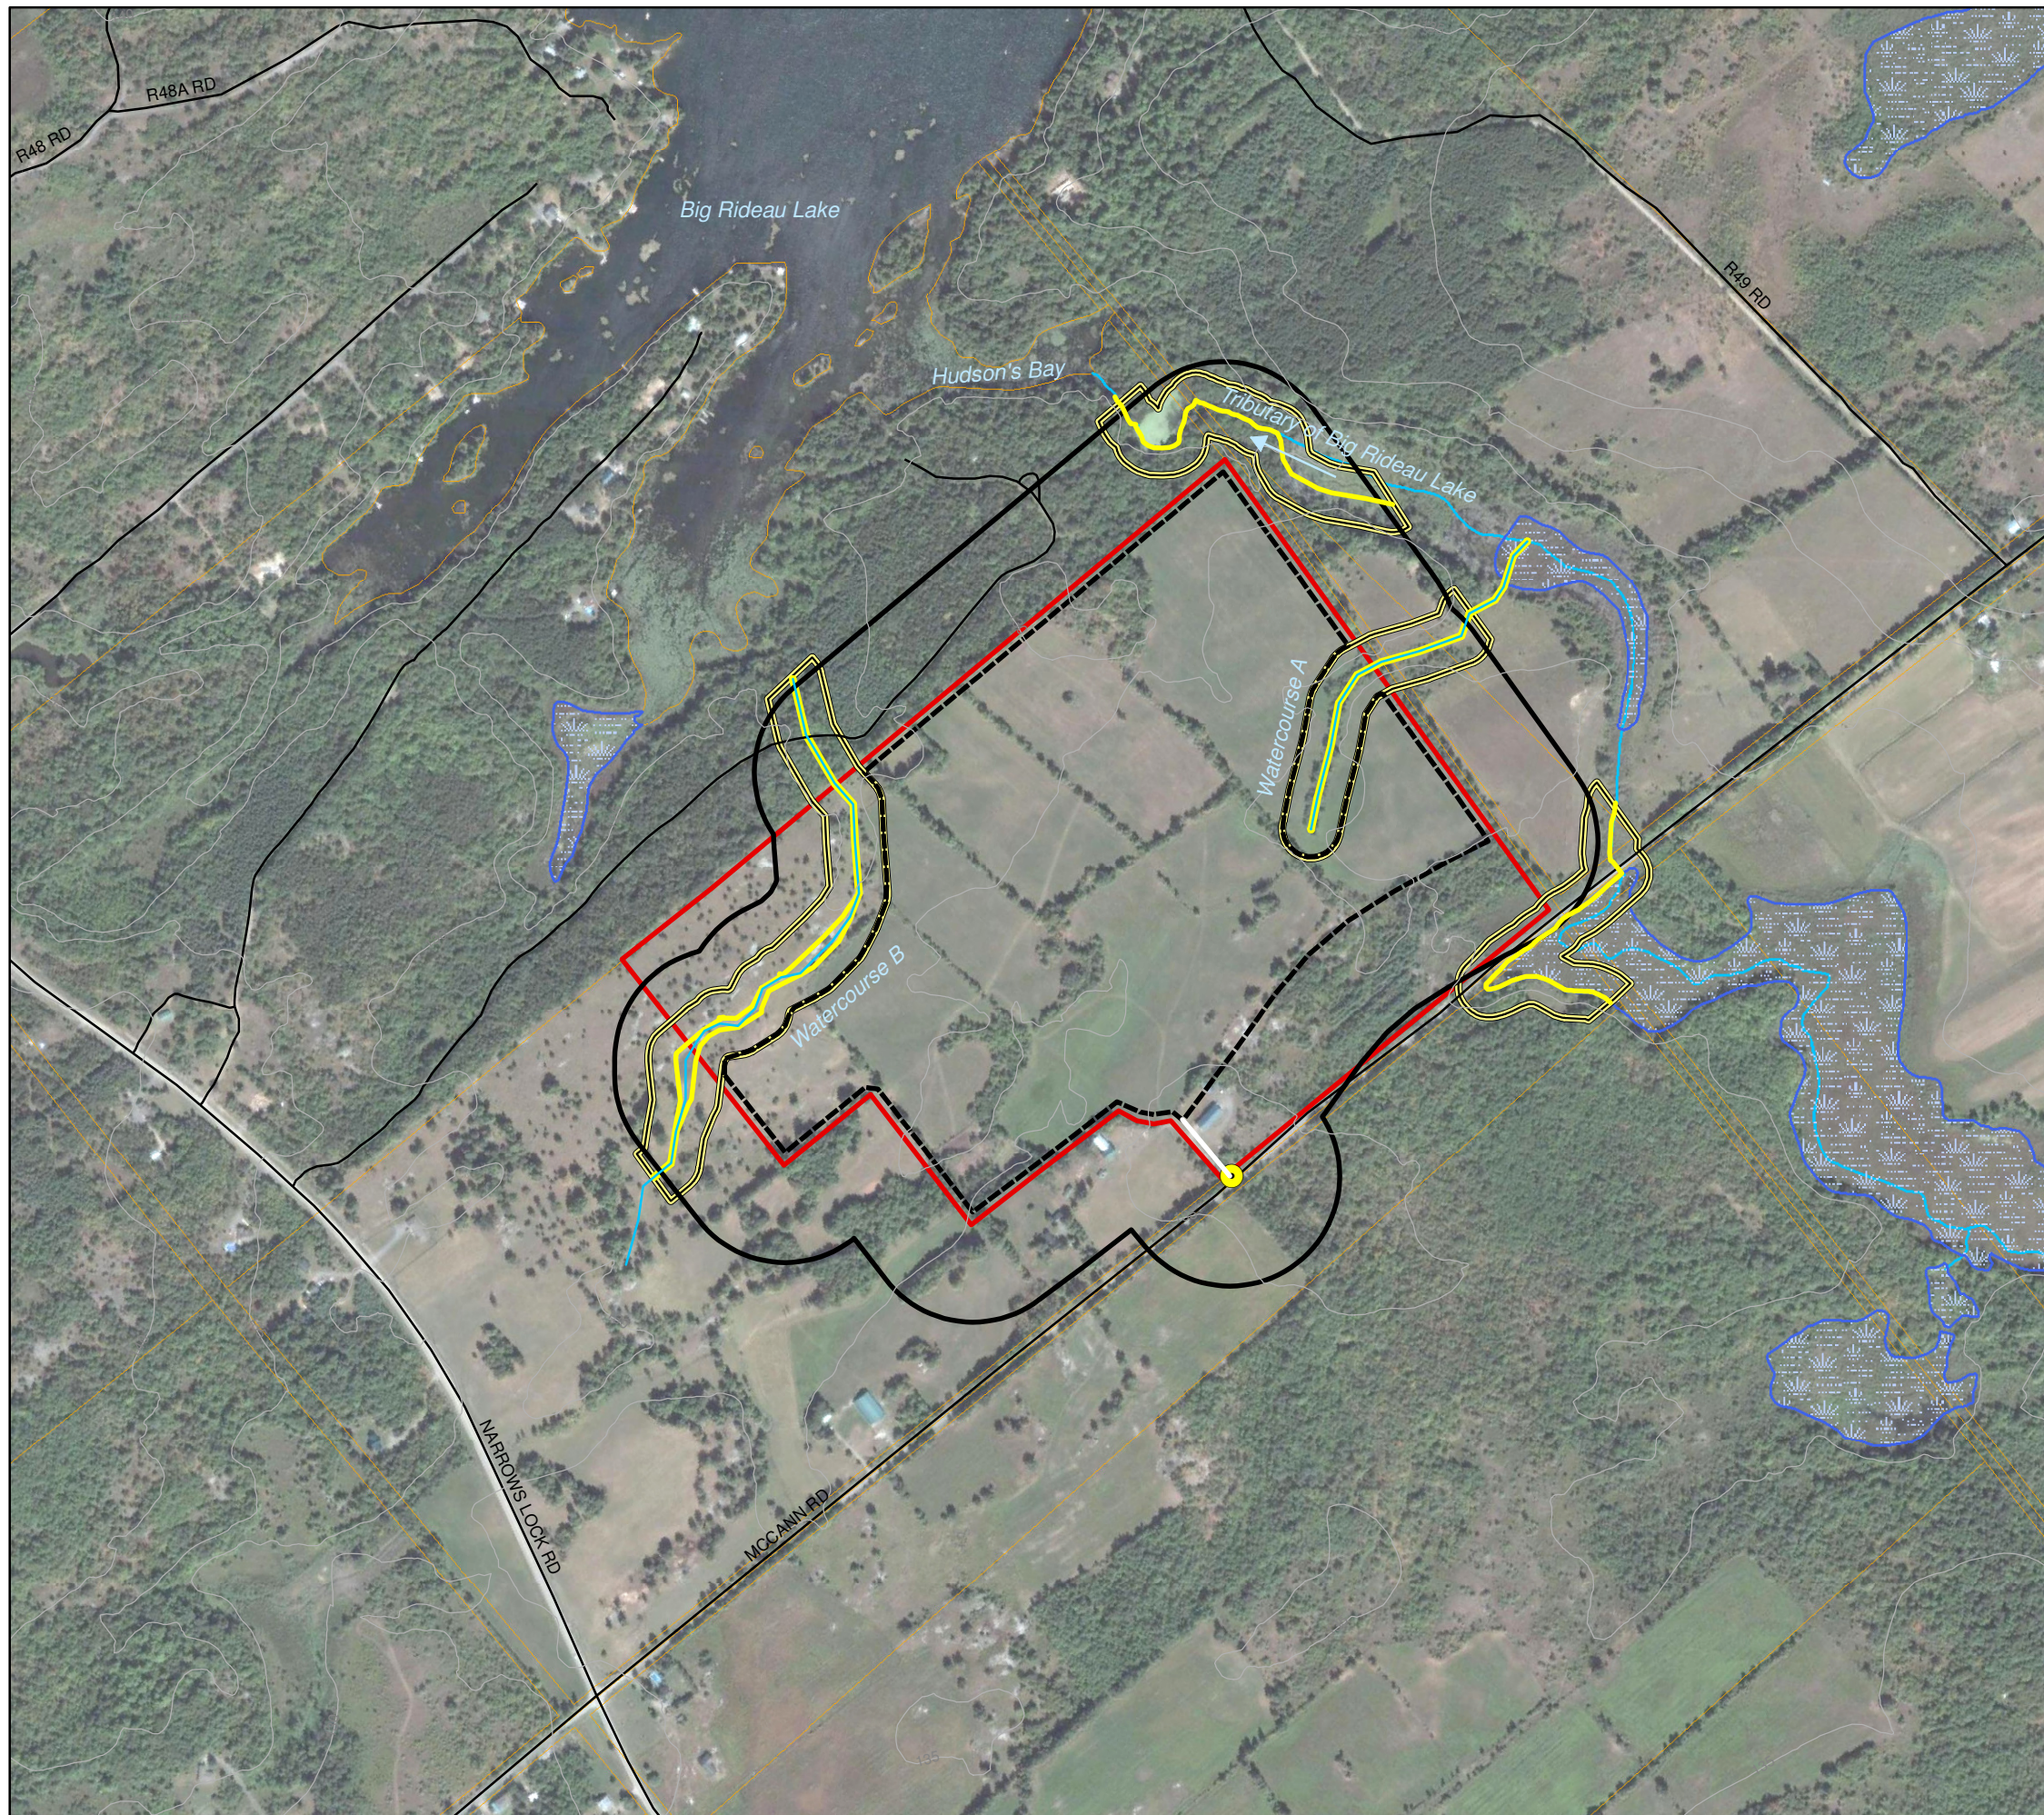
Figure 4.1
Northland Power Inc.
McCann Solar Energy Project
Water Body and Project Boundaries

The Water Body Records Review (Hatch Ltd., 2010) identified one permanent watercourse (an unnamed tributary of Big Rideau Lake), located within 120 m of the Project site (Figure 4.1). During the site investigation, two additional watercourses were identified adjacent to the Project site (Watercourses A and B in Figure 4.1). These watercourses are described in the following sections.

As shown in Figure 4.1, the proposed Project may be constructed between in the area less than 120 m away from the average annual high water mark of the tributary of Big Rideau Lake adjacent to

the Project site. Therefore, an Environmental Impact Study (EIS) is required to assess the potential for adverse effects of the Project and mitigation measures necessary to prevent or minimize these effects.

Based on the results of the site investigation and the proposed Project components and boundaries shown in Figure 4.1, an EIS will be required.

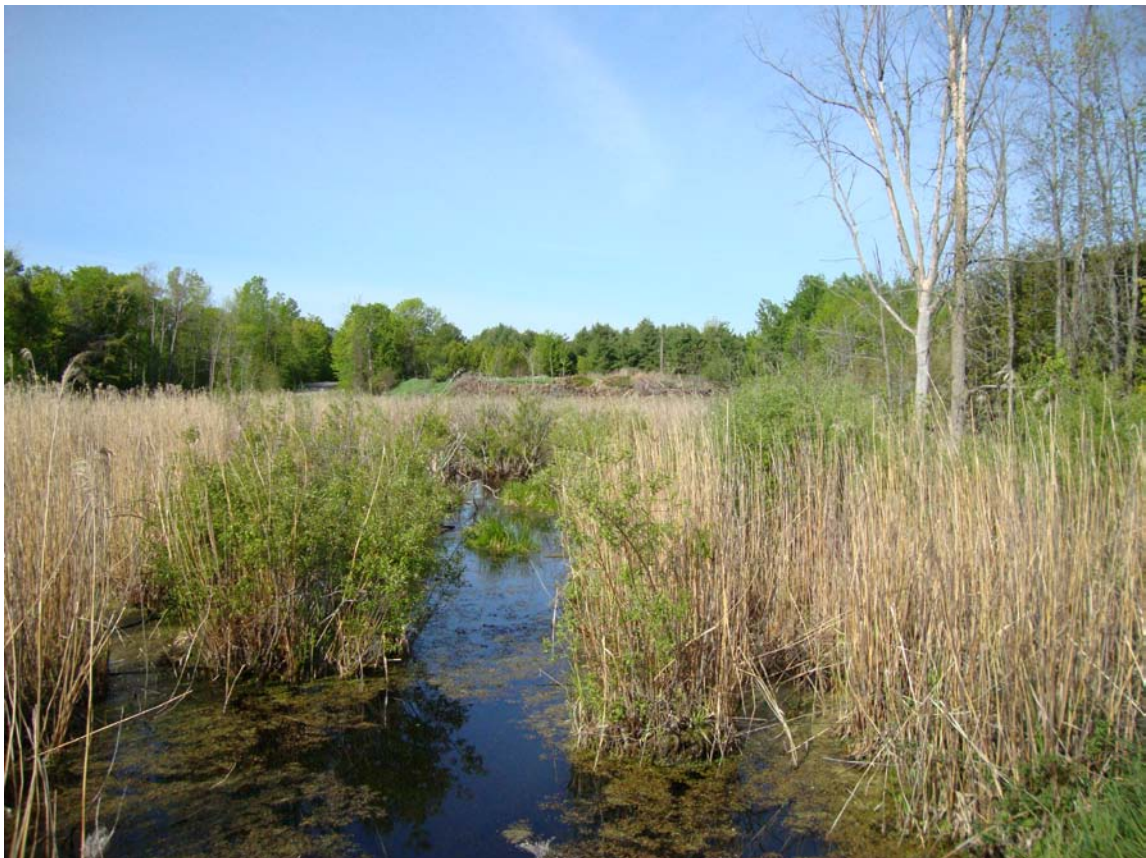
Figure 4.2 Wetland Area on Unnamed Tributary of Big Rideau Lake Southwest of the Project Site

In the area adjacent to the southwestern corner of the Project site, the watercourse flows through wide, low-lying marshy wetland. There is a small main channel (approximately 2 to 4 m wide) bordered by inundated shrubs and emergent vegetation, consisting of tall grasses and sedges (*Carex* sp.). A photograph of the wetland area is shown in Figure 4.2.

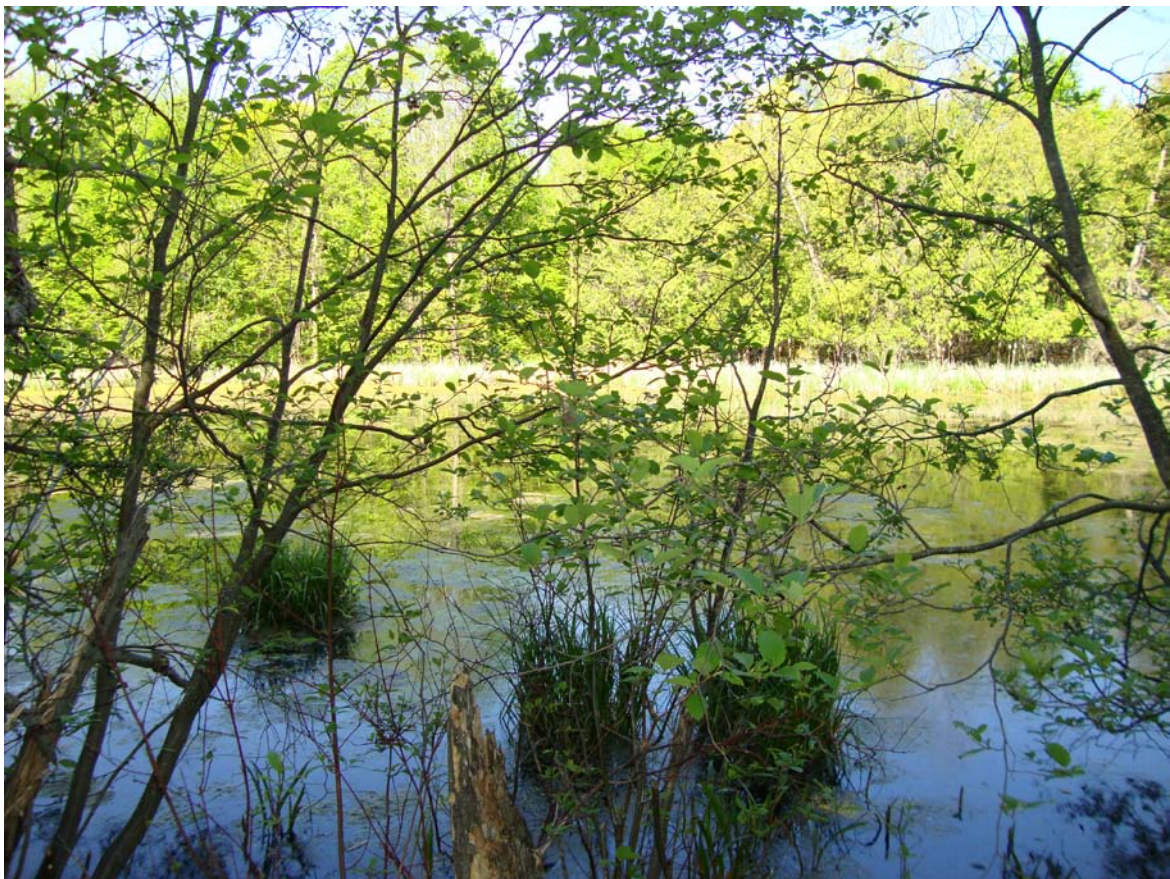
Figure 4.3 Photograph of On-line Pond on Tributary of Big Rideau Lake

From this wetland, the tributary crosses through a culvert beneath McCann Road. It then enters a narrow naturally vegetated corridor that flows between two open agricultural fields adjacent to the Project site. The watercourse remains low-lying and is dominated by a small narrow wetland through a portion of this reach (Figure 4.1). Farther downstream, the watercourse enters the woodland that surrounds Big Rideau Lake. There is a small, approximately 80-m by 100-m on-line pond located within 100 m of the Project boundary. The pond consists of open water, bordered by a relatively narrow band of red-osier dogwood (*Cornus sericea*) and steep banks dominated by upland tree species including white birch (*Betula papyrifera*) and ironwood (*Ostrya virginiana*). Outflow from the pond runs for approximately 100 m before draining into Big Rideau Lake. A photograph of the pond is provided in Figure 4.3.

The pond and reaches of this tributary likely provide aquatic habitat for a variety of fish species. The lower reaches in particular may provide spawning and foraging habitat for species residing in Big Rideau Lake. This tributary may also provide forage (e.g., benthic invertebrate drift and allochthonous materials) to the Big Rideau Lake fish community and it likely affects water quality in the discharge zone in the lake itself.

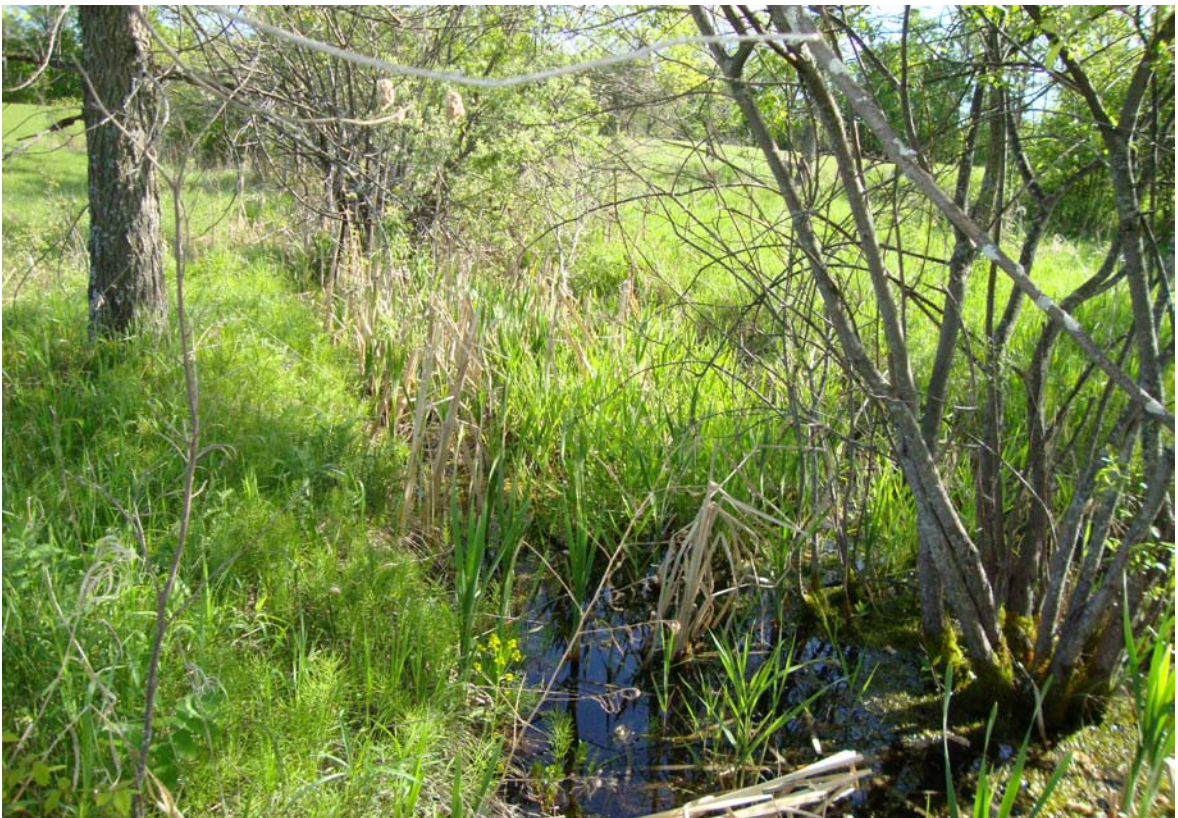
Figure 4.4 Photograph of Watercourse A on the Project Site

Watercourse A consists of a drainage tributary originating on the Project site and flowing for approximately 500 m before draining into the tributary of Big Rideau Lake (Figure 4.1). The tributary runs on the Project site for approximately 200 m. It flows through a narrow naturally vegetated corridor, surrounding by grassed fields used as cow pastures. The channel bottom is comprised of a mix of organic and mineral soils and the channel is approximately 1.5 to 2 m wide. Water depth during the site investigation was <0.30 m and no flow was evident. It appears as though this watercourse primarily flows during precipitation and snow melt events and it is likely intermittent during the drier parts of the year. Algae was abundant throughout the channel on the Project site.

There were some bulrushes (*Scirpus sp.*) and cattails (*Typha sp.*) and some inundated willow shrubs (*Salix sp.*) within the main channel. The riparian areas of the channel are dominated by a variety of shrubs and trees including trembling aspen (*Populus tremuloides*) and raspberries (*Rubus sp.*) in the upland areas near the border of the Project site.

Watercourse A may provide seasonal aquatic habitat for fish residing within the tributary of Big Rideau Lake, although it appears to be intermittent and would not provide direct habitat on a year-round basis. It also likely provides habitat for benthic invertebrates, which may provide a source of forage for the downstream fish community, and seasonal habitat for frogs, which were observed during the site investigation. The watercourse also provides some hydrology and water quality regulation for the downstream watercourse.

The site investigation has confirmed that Watercourse A is an intermittent watercourse, which runs through a portion of the Project site. The average annual high water mark was determined to be the top of bank feature, given that riparian vegetation was not indicative of communities tolerant of any annual inundation. The high water mark and associated 30-m setback are shown in Figure 4.1. Development of the proposed solar facility will occur between 30 and 120 m away from the average annual high water mark. Therefore, an EIS will be required to assess potential adverse effects and required mitigation and monitoring measures to protect this water body.

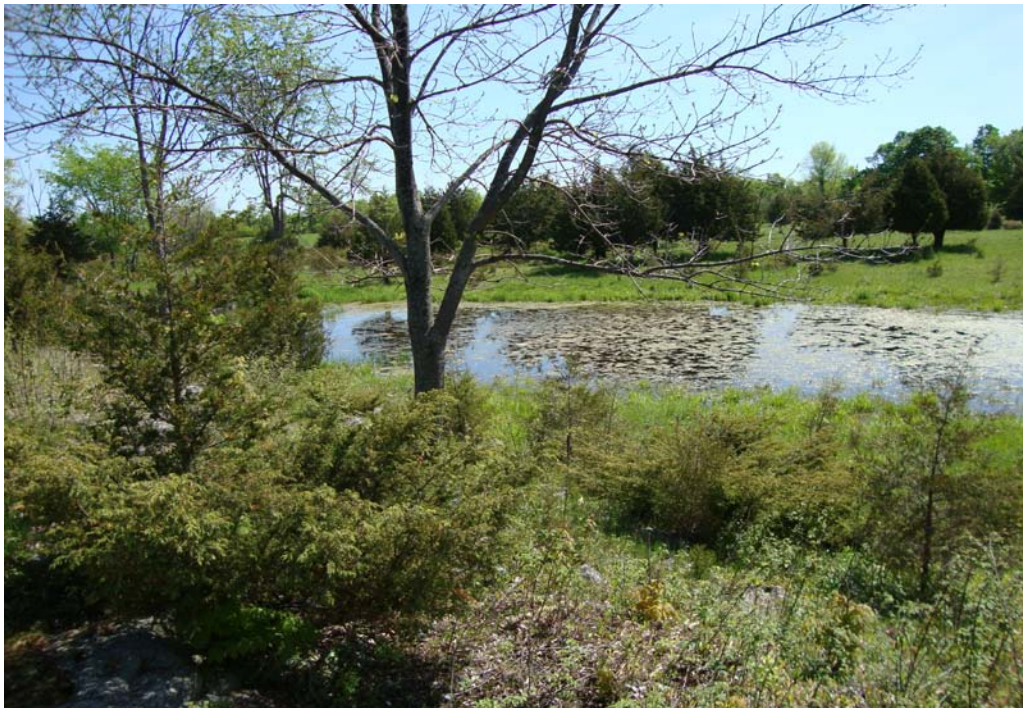
Figure 4.5 On-line Pond on Watercourse B Immediately Adjacent to the Project Boundary

There is a small, on-line, open water, low lying pond surrounded by an open meadow adjacent to the Project site boundary. The pond is approximately 50 m long and 20 m wide and consists of relatively stagnant water with abundant algae. A photograph of the pond is provided in Figure 4.5.

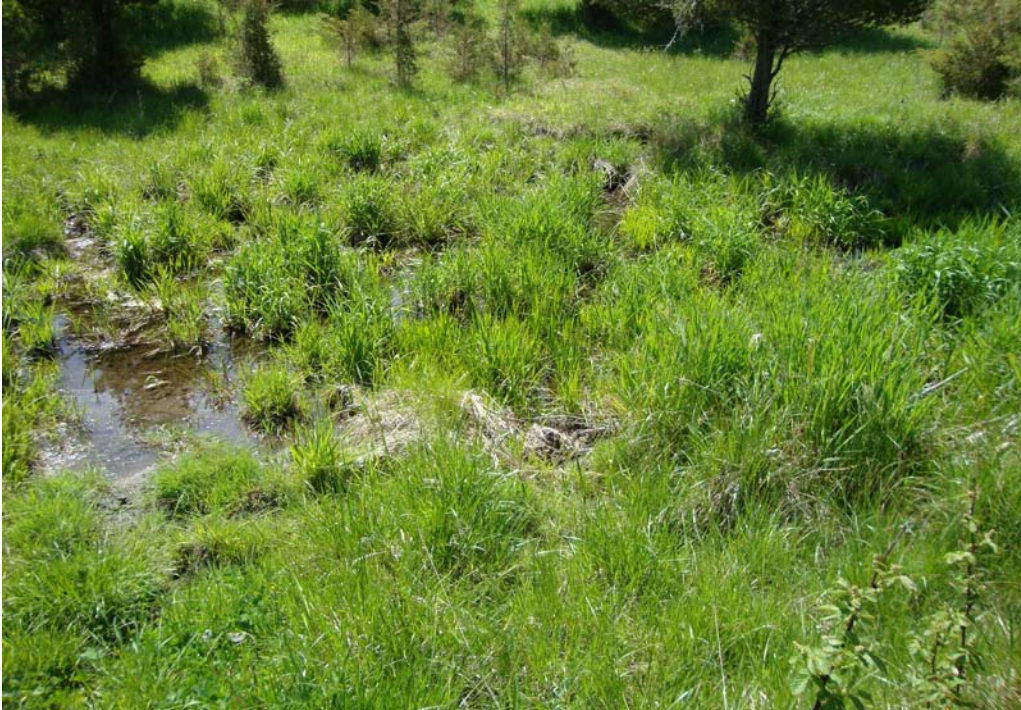
Figure 4.6 Photograph of Poorly Defined Watercourse B Channel on Western End of Project Site

Outflow from the pond enters the Project site in a poorly defined channel that flows through a low lying meadow area. There was some standing water in and around the sedges and grasses that make up the meadow. A photograph of this area is provided in Figure 4.6.

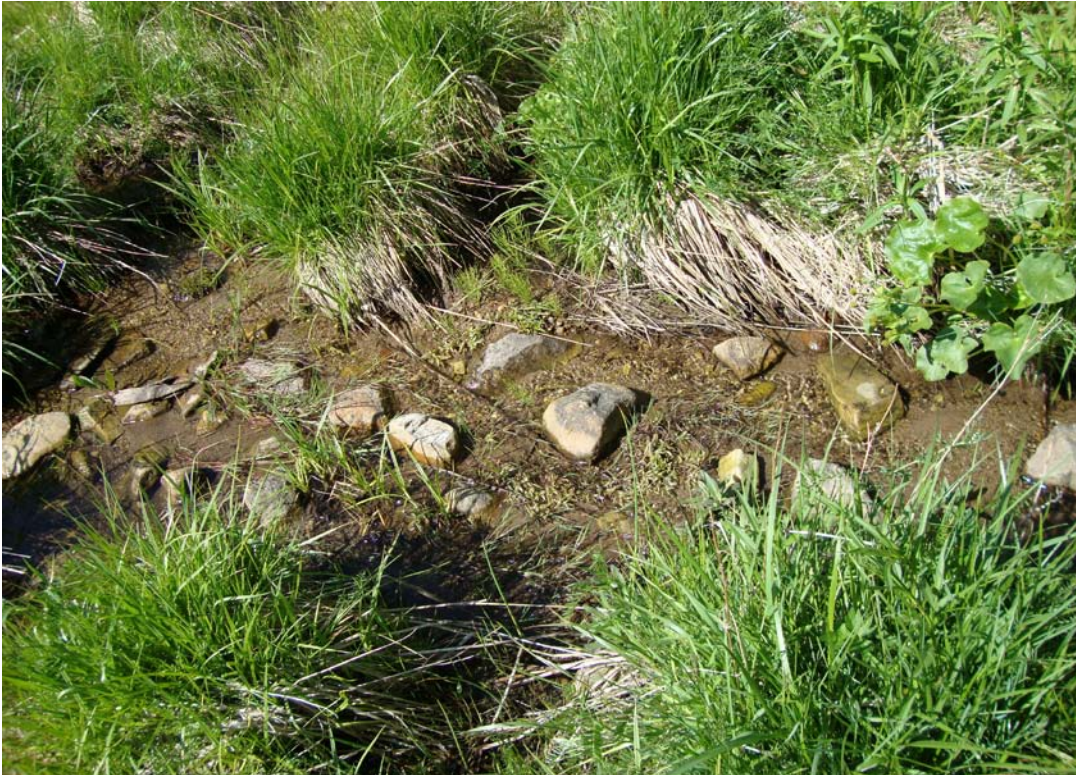
Figure 4.7 Photograph of Watercourse B at Downstream End Near Project Boundary

Approximately 150 m upstream from the Project boundary, the watercourse channel becomes well defined, consisting of an approximately 1-m wide channel with a mix of mineral soil, gravel and small cobbles on the channel bed. Water was flowing in this area during the site investigation and flow velocity was evident, indicating an increase in gradient in this lower reach of the channel. Riparian areas are dominated by grass and sedge meadows with some shrubs. A photograph of the watercourse in this area is provided in Figure 4.7.

Therefore, the site investigation has confirmed that Watercourse B appears to be an intermittent watercourse. It is relatively small and shallow and does not appear capable of providing any direct habitat for fish, although it may provide habitat for tolerant invertebrate species. It would also assist in regulating hydrology and surface water quality in Big Rideau Lake in the discharge zone.

The average annual high watermark of Watercourse B was primarily assessed as being the border of inundation tolerant and non-tolerant vegetation species, since the channel is poorly defined along much of its length and appears to inundate a lower lying area. The average annual high water mark, 30-m setback line and proposed development footprint are shown in Figure 4.1. The proposed development will occur between 30 and 120 m away from the average annual high water mark. Therefore, an EIS will be required for this water body.
