Martin's Meadows Solar Project

Water Body Site Investigation Report

October 18, 2012

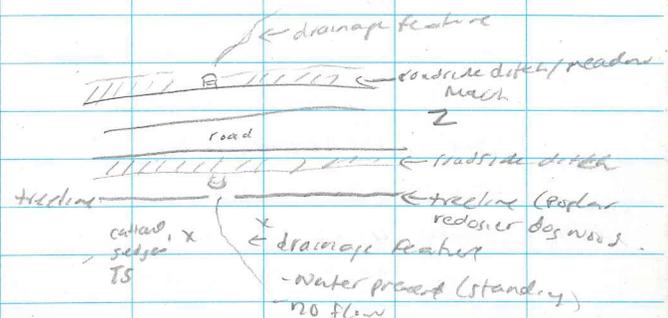
Drainage Feature / Wetland
culvert under road - east + west

- west side - ~~no~~ defined bank, low-lying area / meadow-march - grasses, sedges, cattail

- East side

- drainage swale exit into "meadow-march"

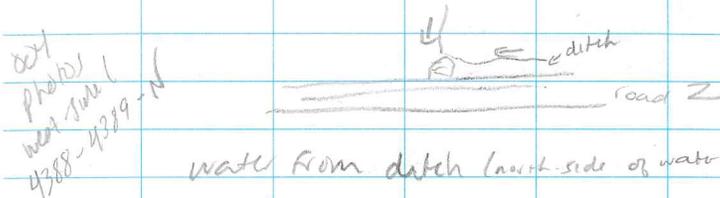
④ Water Feature (Fower Creek?)

④ west-side 4390-4395

water from ditch (north side of water feature)
flows south into water feature; water
feature flows east

- water present - ~4" deep?
- channel width 1.5-2m
- shrubs, sedges & grasses along bank
- organic substrate

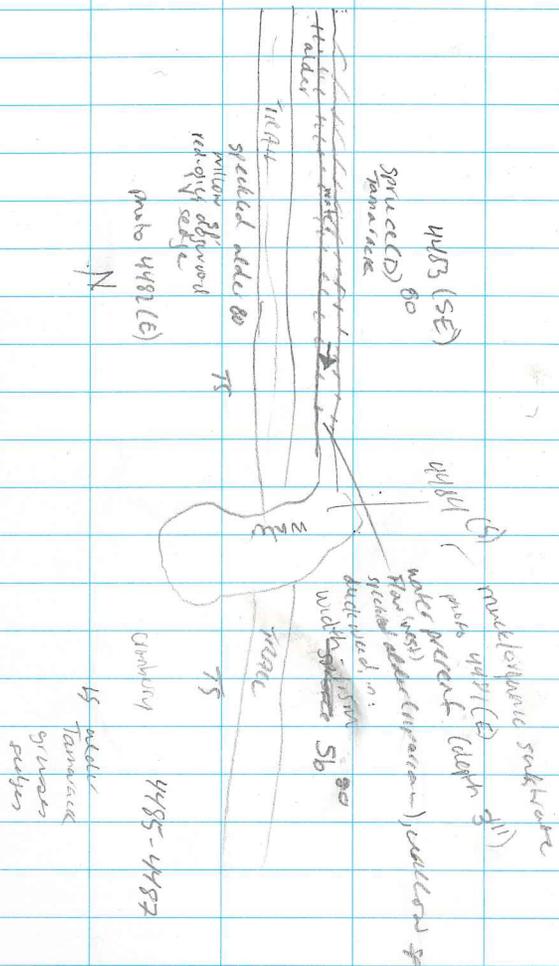
(16) Water Feature / Wetland
- water present (permanent)
