# Empire Solar Project Water Body Site Investigation Report

Empire Solar Project

H334844-0000-07-124-0274

October 18, 2012

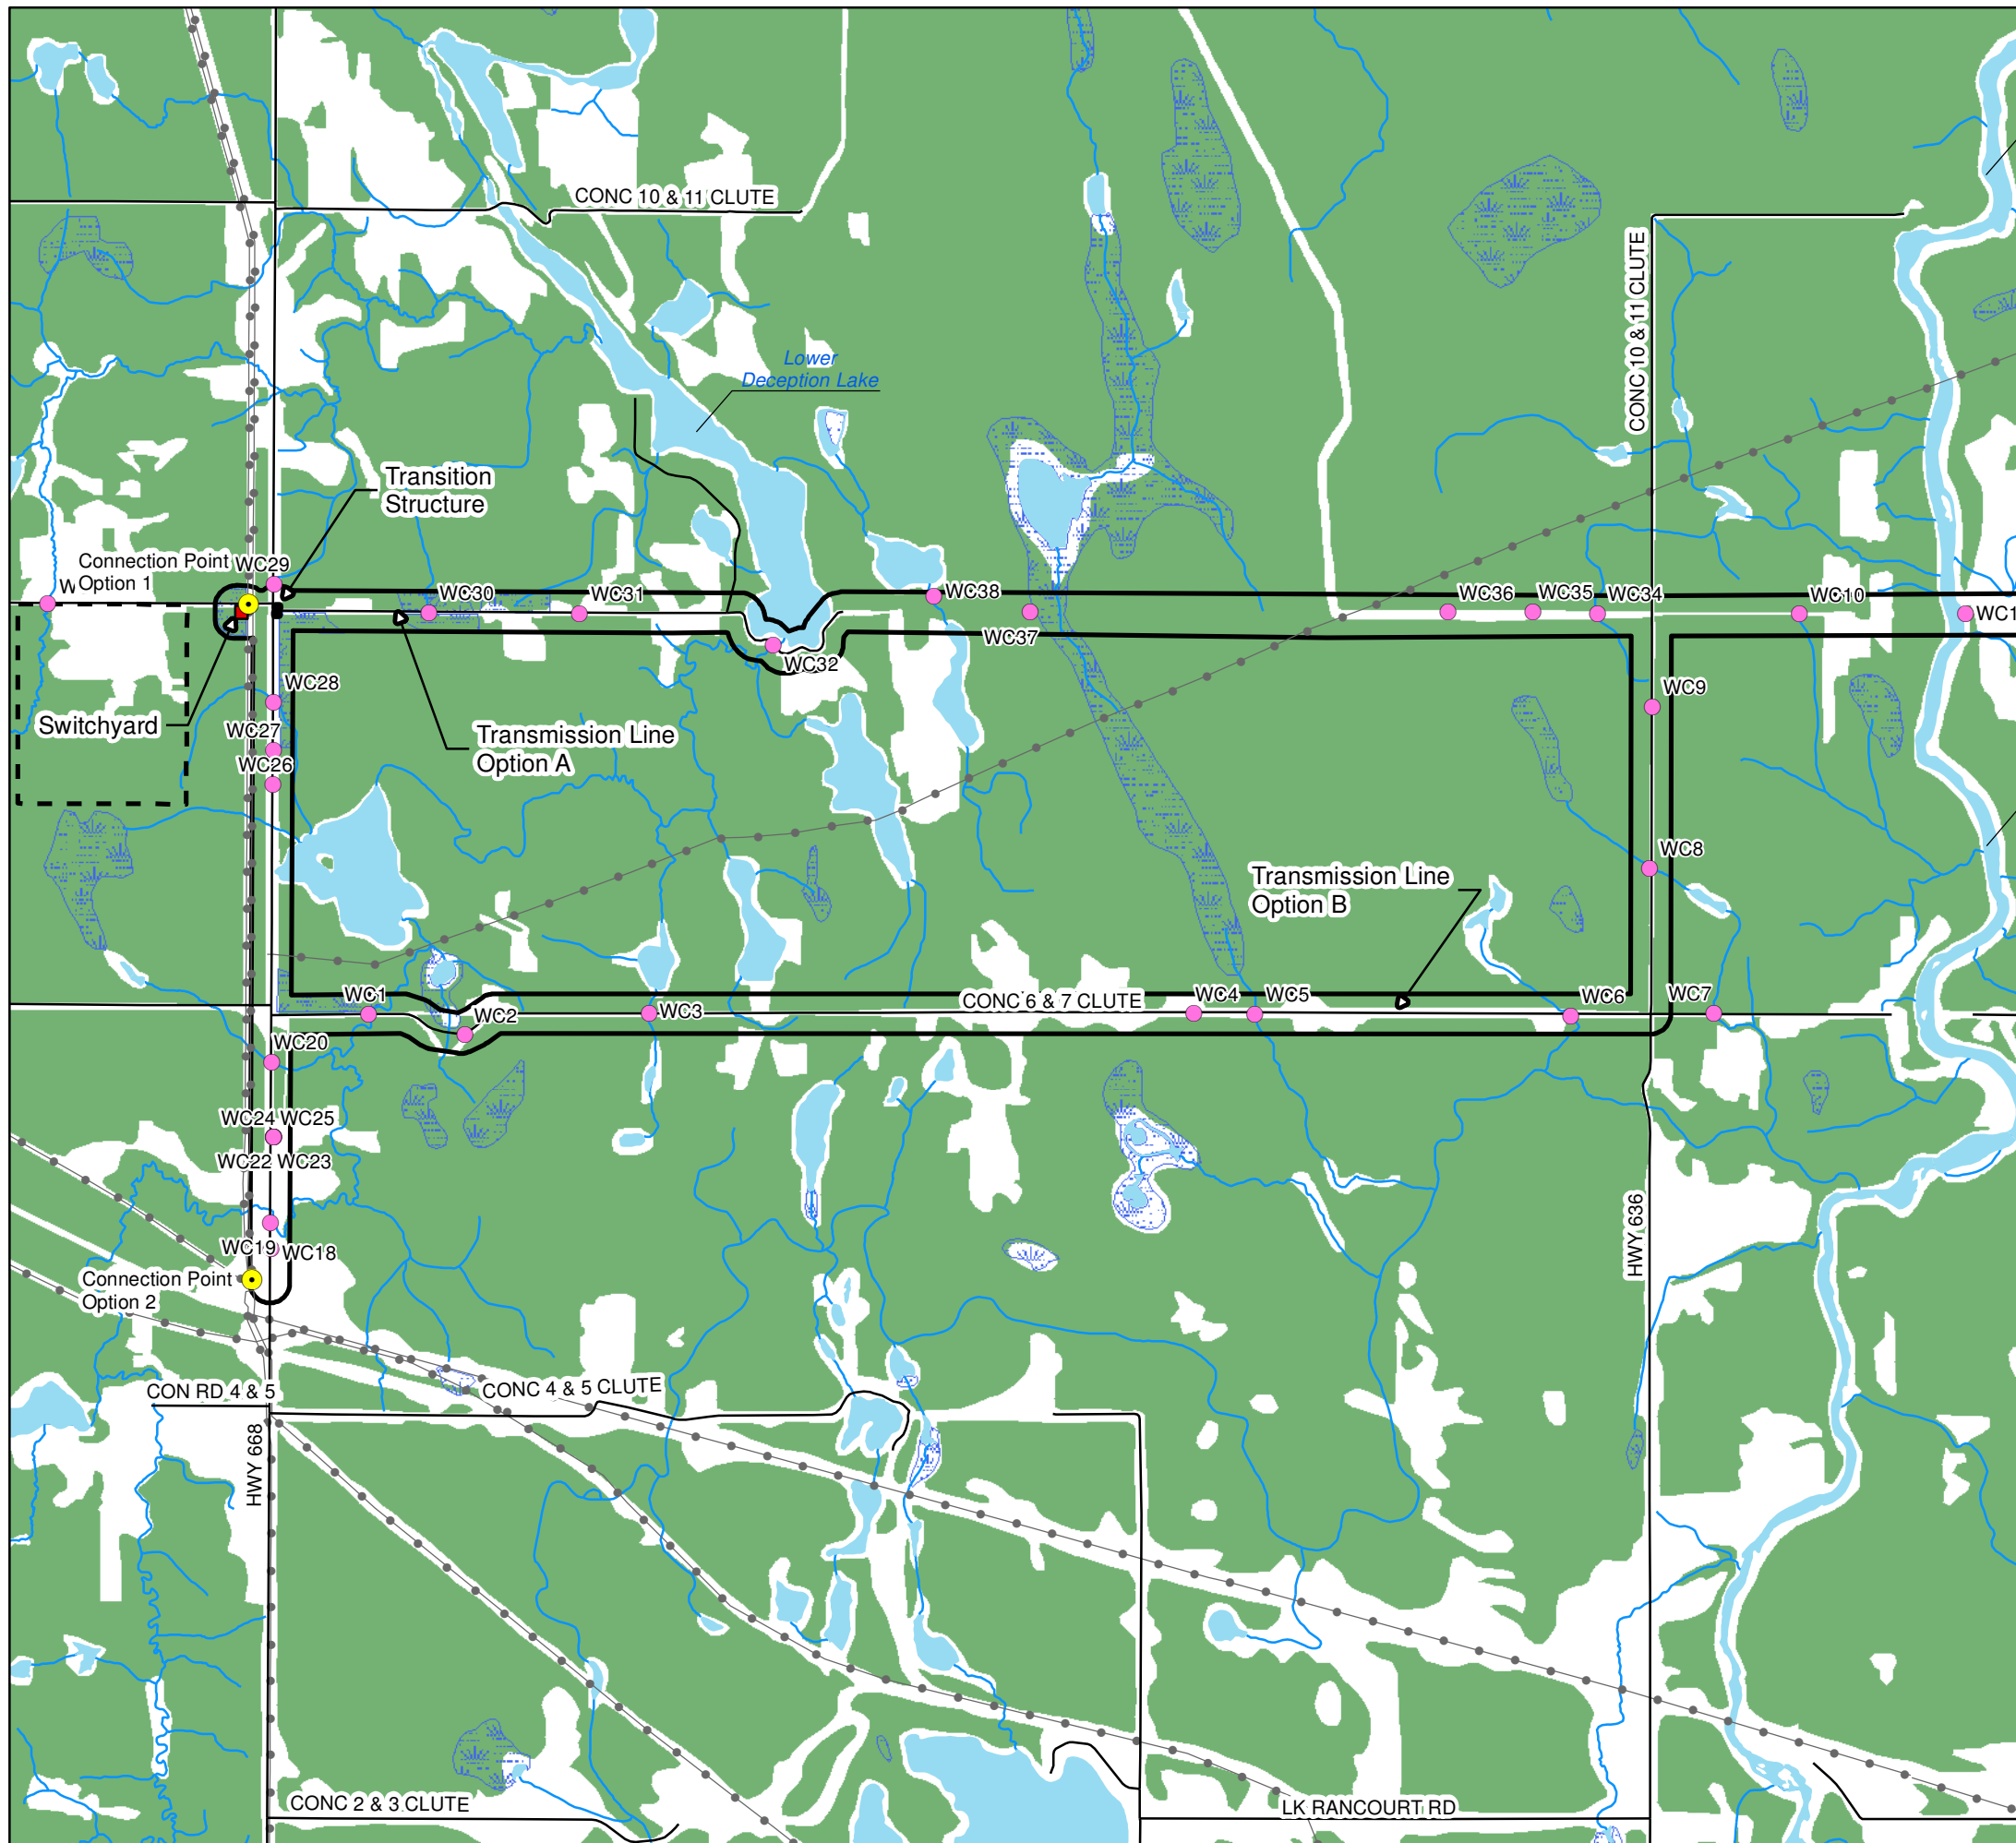
Figure 1.2  
 Northland Power Inc.  
**Transmission Line Project Location  
 (Eastern Half) - Waterbody  
 Site Investigation Results**

A total of 36 waterbodies were observed along the transmission line route options, as shown in Figures 1.2 and 1.3, and summarized in Table 4.1, which presents the watercourse identifier (as labelled in Figures 1.2 and 1.3), summary of watercourse observations (watercourse type, average width and depth, substrate, bank vegetation and other observations). There were 34 unnamed watercourses, the Frederickhouse River and Deception Creek. In addition, the proposed transmission line will pass within 120 m of Lower Deception Lake.

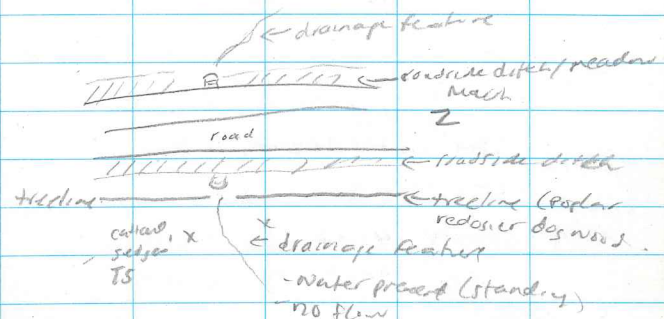
Drainage Feature / Wetland  
culvert under road - east + west

- west side - ~~no~~ defined bank, low-lying area / meadow-march - grasses, sedges, cattail

- east side

- drainage swale exit into "meadow-march"

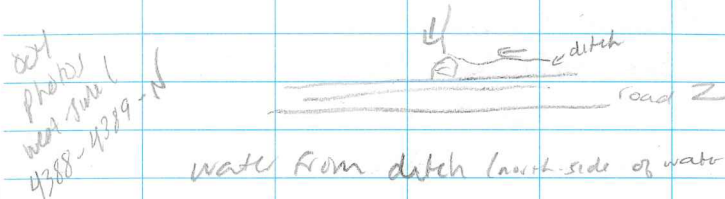
④ Water Feature (Fower Creek?)

④ west-side 4390-4395

water from ditch (north side of water feature)  
flows south into water feature; water

feature flows east

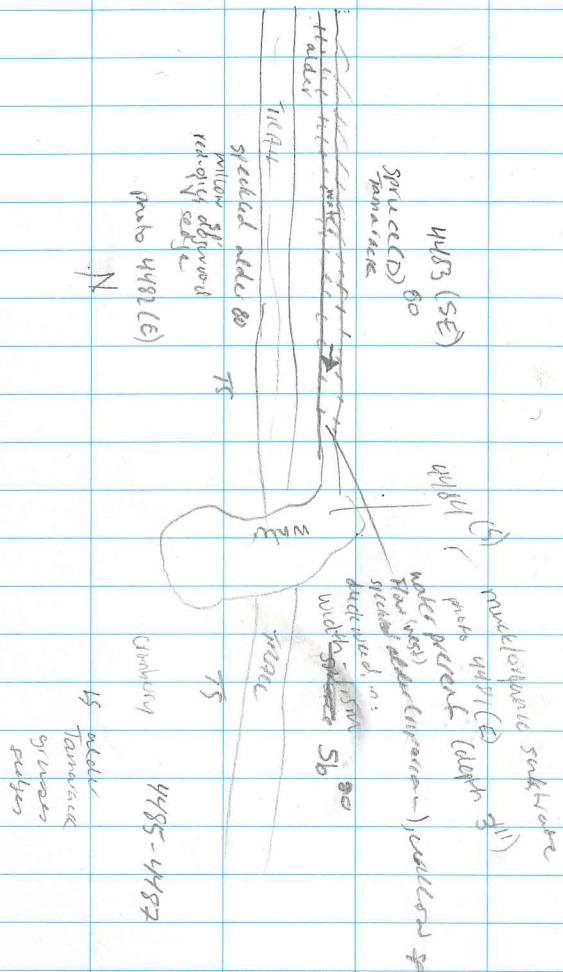
(16) Water Feature / Wetland  
- water present (permanent)
