# McCann Solar Project

## Natural Heritage Environmental Impact Study

July 8, 2011

H334844-0000-07-124-0135

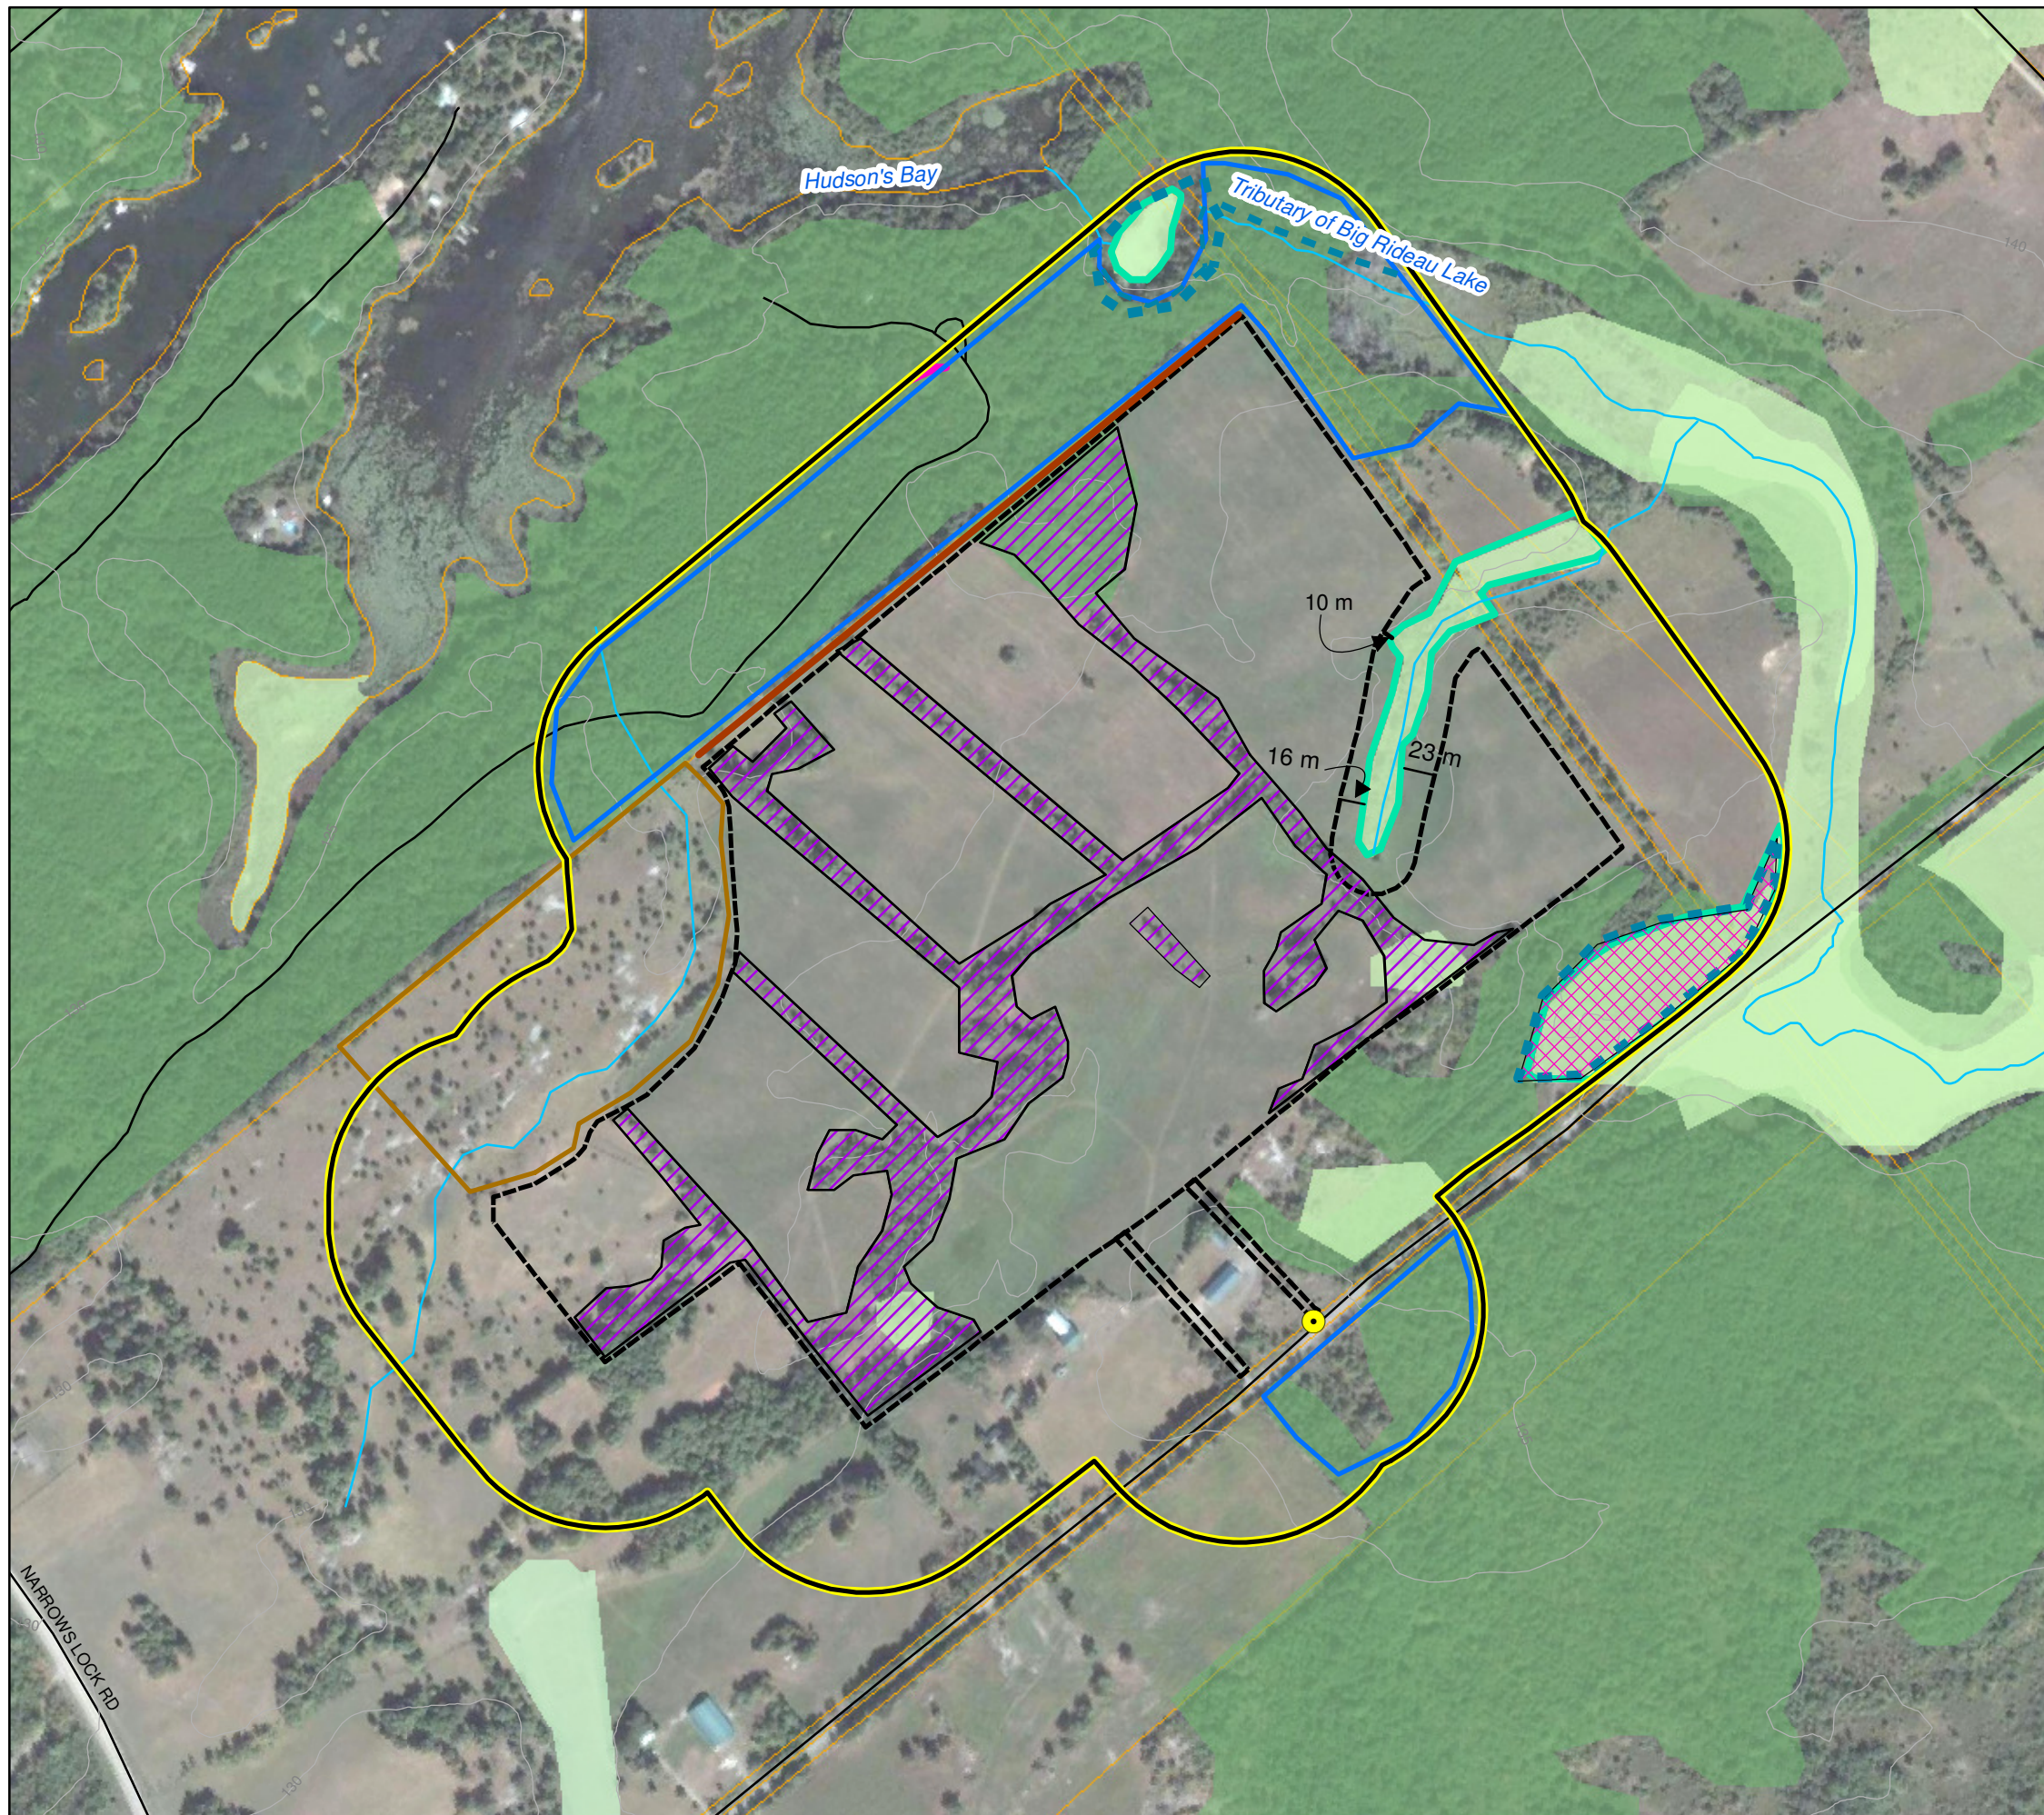
Figure 1.1  
 Northland Power Inc.  
**McCann Solar Energy Project**  
**Project Location and Significant**  
**Natural Heritage Features**

These significant natural heritage features and their locations in relation to the Project location are shown in Figure 1.1.

Northland Power Solar McCann L.P. (hereinafter referred to as “Northland”) is proposing to develop a 10-megawatt (MW) solar photovoltaic Project, titled the McCann Solar Project (hereinafter referred to as the “Project”). The Project will be located on approximately 40 hectares (ha) of land, located just south of Big Rideau Lake in the Township of Rideau Lakes, within the United Counties of Leeds and Grenville (Figure 1.1).

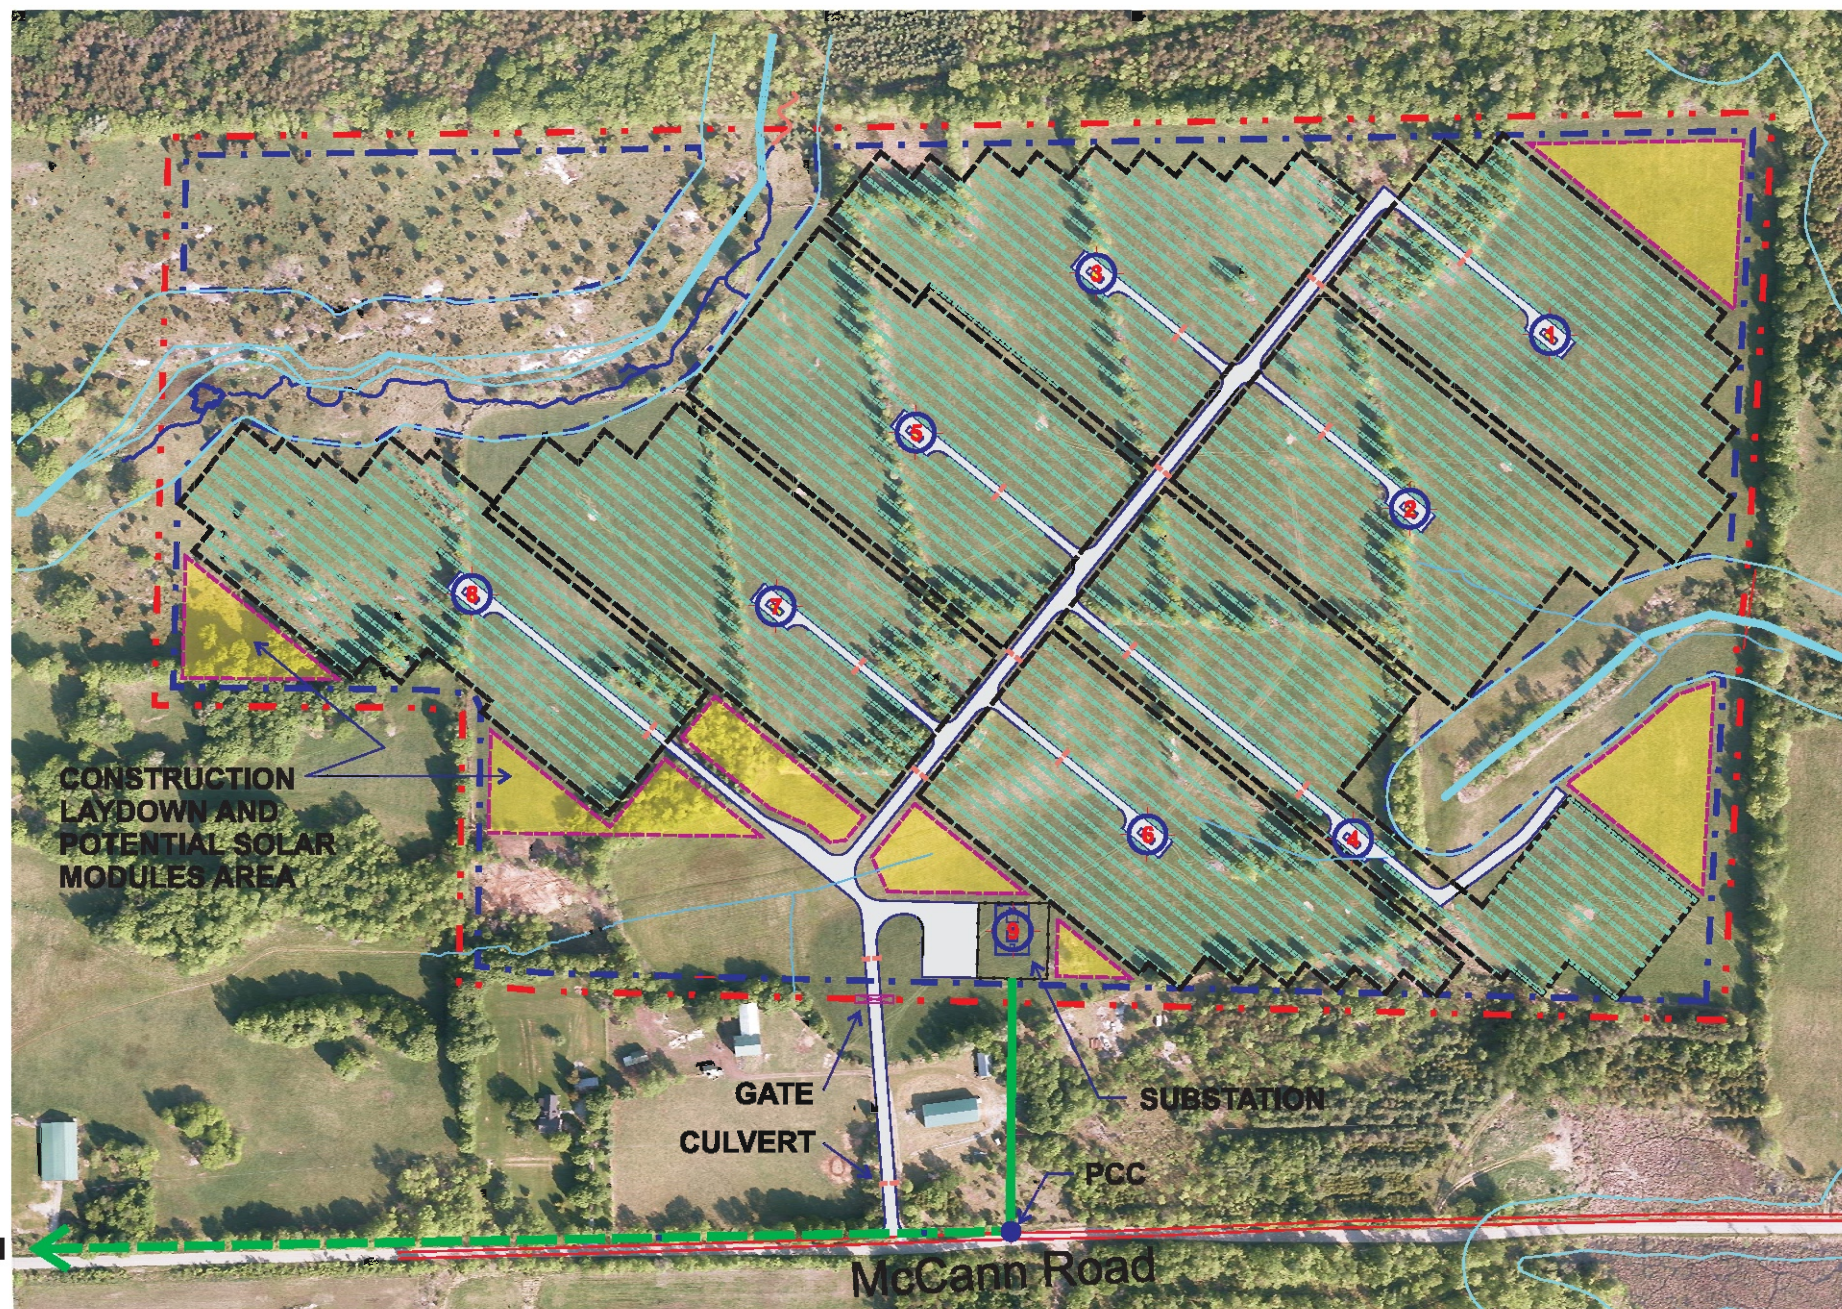
**Appendix A**  
**Site Layout from the Construction Plan Report**  
**(Hatch Ltd., 2010d)**

TO POINT OF CONNECTION  
APROX. 407 m  
(44.675992, -76.280417)

The following sections briefly describe the construction, operation and decommissioning phases of the Project. The information is taken from the Project Description Report (Hatch Ltd., 2010h). More detailed information can be found in the Construction Plan Report (Hatch Ltd., 2010d), Design and Operations Report (Hatch Ltd., 2010e) and Decommissioning Plan Report (Hatch Ltd., 2010f). The Site Layout from the Construction Plan Report (Hatch Ltd., 2010d) is provided in Appendix A to show the detailed components of the facility including solar panel, inverter, transformer and access road locations.
